**S-08572. McLaren House, 10769 DuPont Highway  
(PIN: 230-19.00-85.00)  
(Detail Map #1)**

**S-08574. Coleman Farmstead, Route 16**  
**(PIN: 230-26.00-15.00 and 230-26.00-18.00)**  
**(Detail Map #2)**

**S-08575. Cornelius Sutton House, DuPont Highway  
(PIN: 230-26.00-23.00)  
(Detail Map #1)**

**S-08576. Preston Evans House, 12241 U.S. 113**  
**(PIN: 230-26.00-32.00)**  
**(Detail Map #1)**

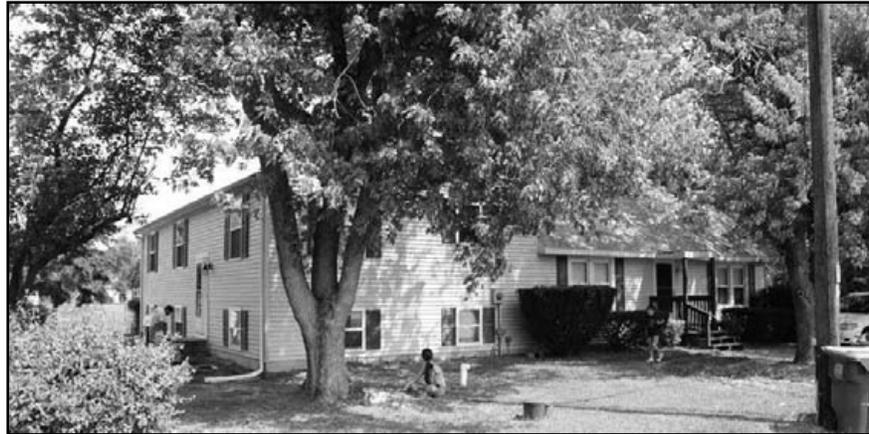
S-08572

This house has been greatly altered since it was first surveyed in 1992, when it was described as “a small one-story side-gable Craftsman-style house, dating to the late 1920s or 1930s, set on a cast concrete block foundation. The exterior walls are covered with asbestos shingle siding with scalloped lower edges....The floor area of this diminutive dwelling is almost doubled by the flat-roofed modern addition at the rear” (LeeDecker et al. 1992:71). It is unlikely the house was built that early, but regardless of its construction date, it has been altered almost beyond recognition since 1992. The massive northern addition overwhelms the historic, main block of the dwelling, and the building can no longer convey any significance it may have once possessed. The property is therefore recommended not eligible under Criterion C.

main building (.001) façade and north side, view to SE

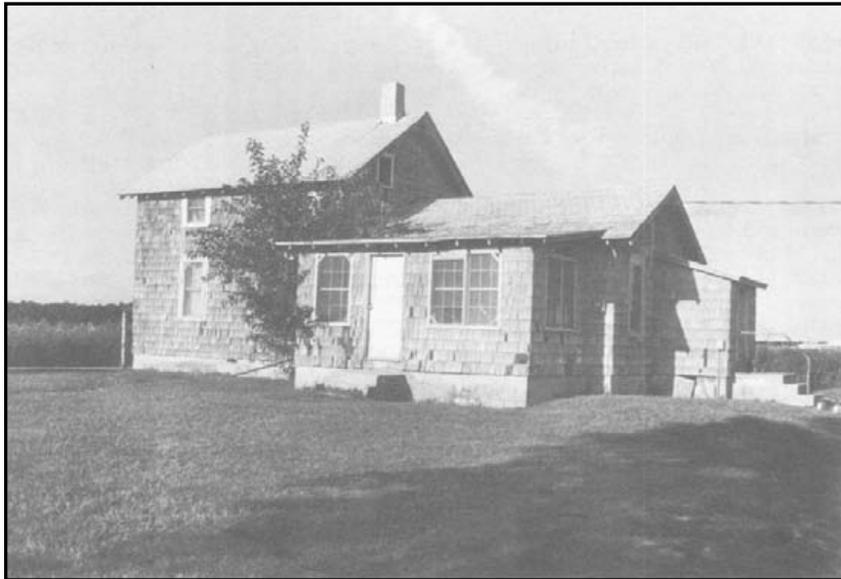
Coleman house in 1992 (LeeDecker et al. 1992:124)

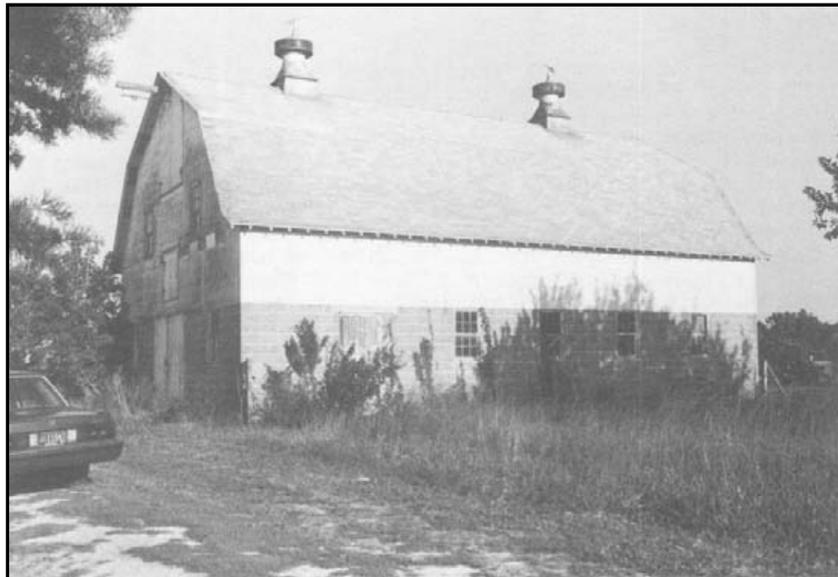
Coleman barn in 1992 (LeeDecker et al. 1992:125)

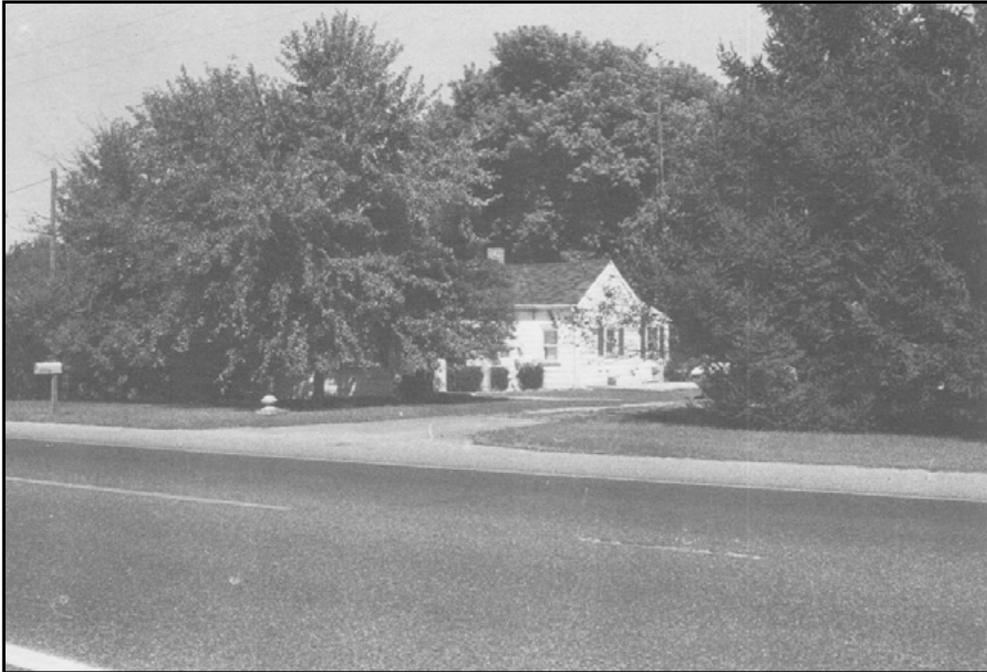
As noted, the house is in near ruinous condition. Previous survey photographs revealed it to be an L-plan cottage of little architectural distinction. Due to both lack of architectural significance and lack of architectural integrity, the house is recommended not eligible for the National Register under Criterion C.

Cornelius Sutton house in 1992 (LeeDecker et al. 1992:72)
