CHAPTER 4

THE LOG BUILDING

B. DESCRIPTION OF THE BUILDING, ITS DATE AND ITS EVOLUTION

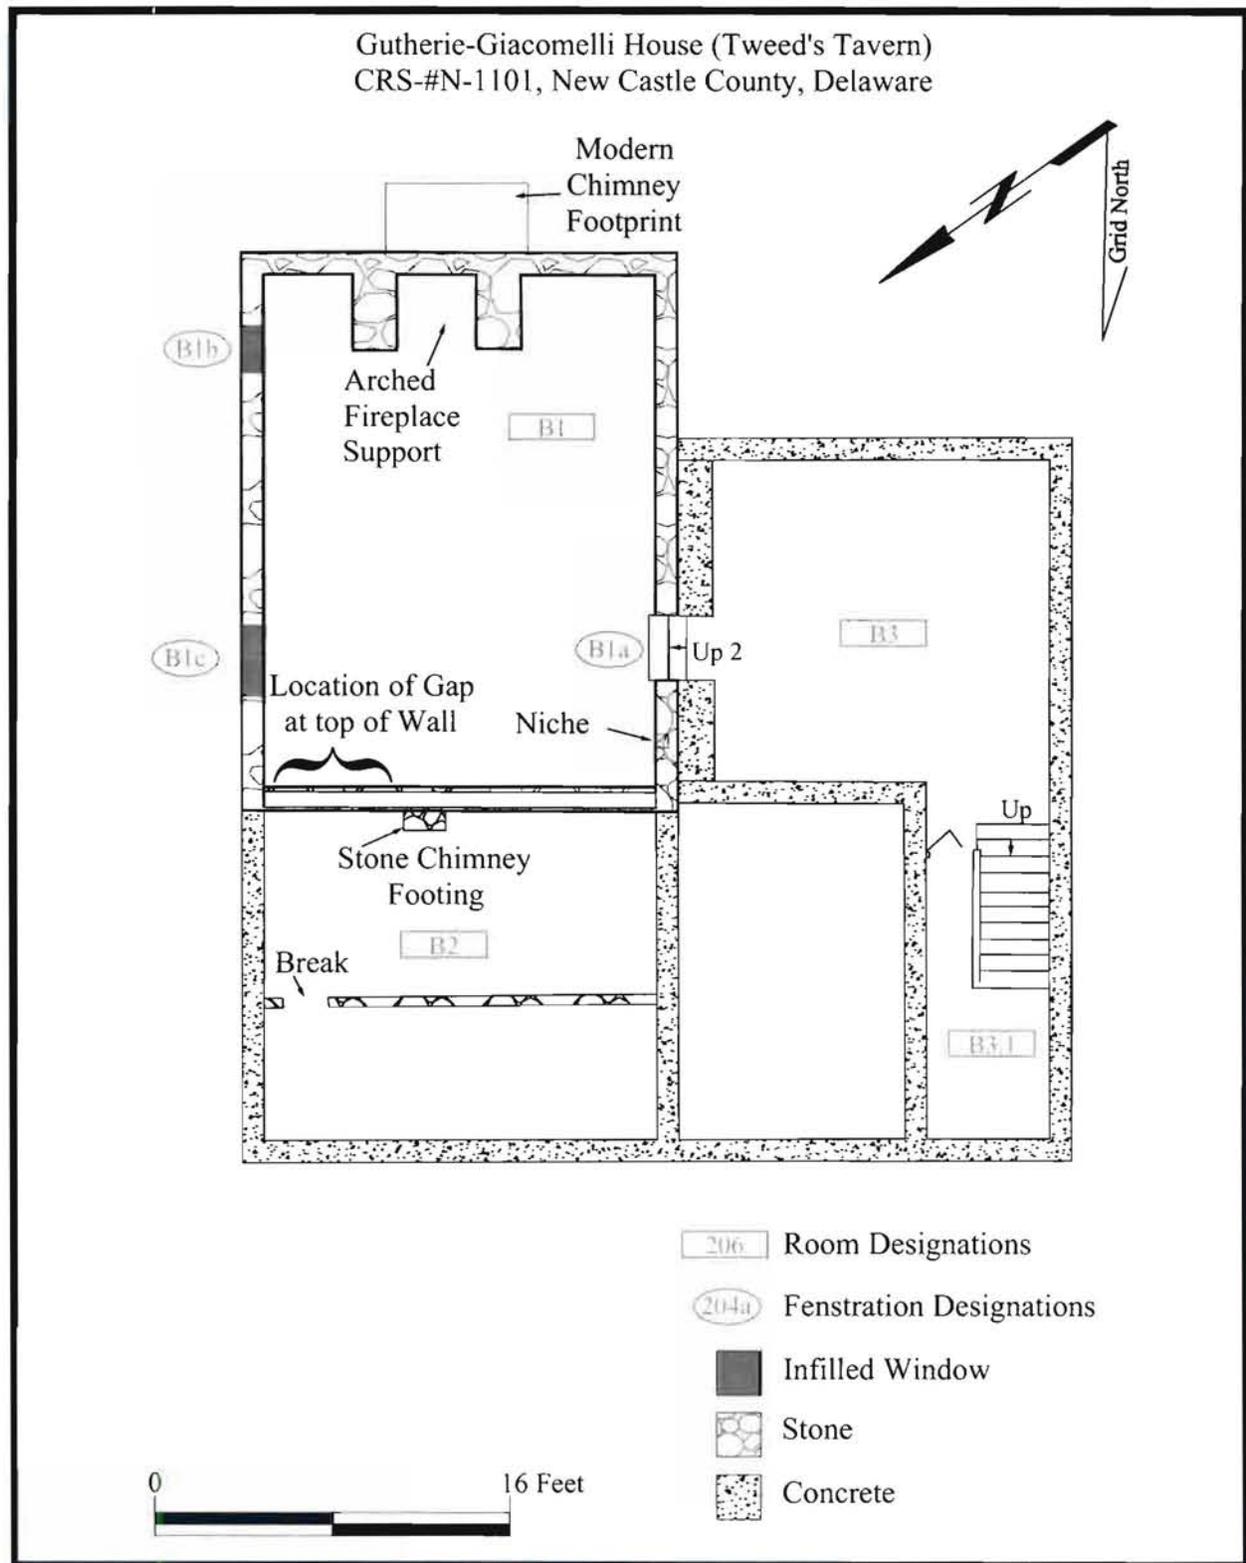
Figure 4.11. Basement Plan.

Room B-1 represents the cellar of the earliest portion of the house (Plate 4.4). The space measures approximately 23' x 18' and contained the building's modern furnace and fuel oil tanks. A large arched stone support for the original chimney stack and hearth survived along the southern wall (Plate 4.5).

The walls of Room B-1 were constructed of fieldstone and had been lightly parged although much of this finish was worn or spalled. The bottom logs of the original building's upper walls rested directly on the top course of the cellar walls. Stones had been removed from the top of the northern cellar wall near the northeast corner of the building. These later modifications (Plate 4.6) appear to have been made in order to provide access into Crawl Space B-2 and to provide a space for ductwork added during the construction of the northern addition. A small niche was visible in the western wall to the north of Door B1a. Niches such as this one are found relatively frequently in the basement walls of buildings of this age and it has been

Although currently a window-less space, two window openings (Windows B1b and B1c) that formerly provided light to room were observed near the top of the east wall. The southernmost of these, Window B1b appears in a historic photograph of Tweed's Tavern to the left of the concrete block porch deck in Plate 3.6. The photograph shows the opening prior to infilling with stone. These openings were centered on each side of original first floor door openings and topped by a wooden lintel. No evidence of the sash type was identified either through first hand inspection or from detailed examination of historic photographs. Window B1c, filled in and topped by a wood lintel appears in Plate 4.7. Windows B1b and B1c would likely have consisted of a simple casement fixture or, alternatively since these were basement windows, they may have barred with wood or iron and lacked a sash entirely.

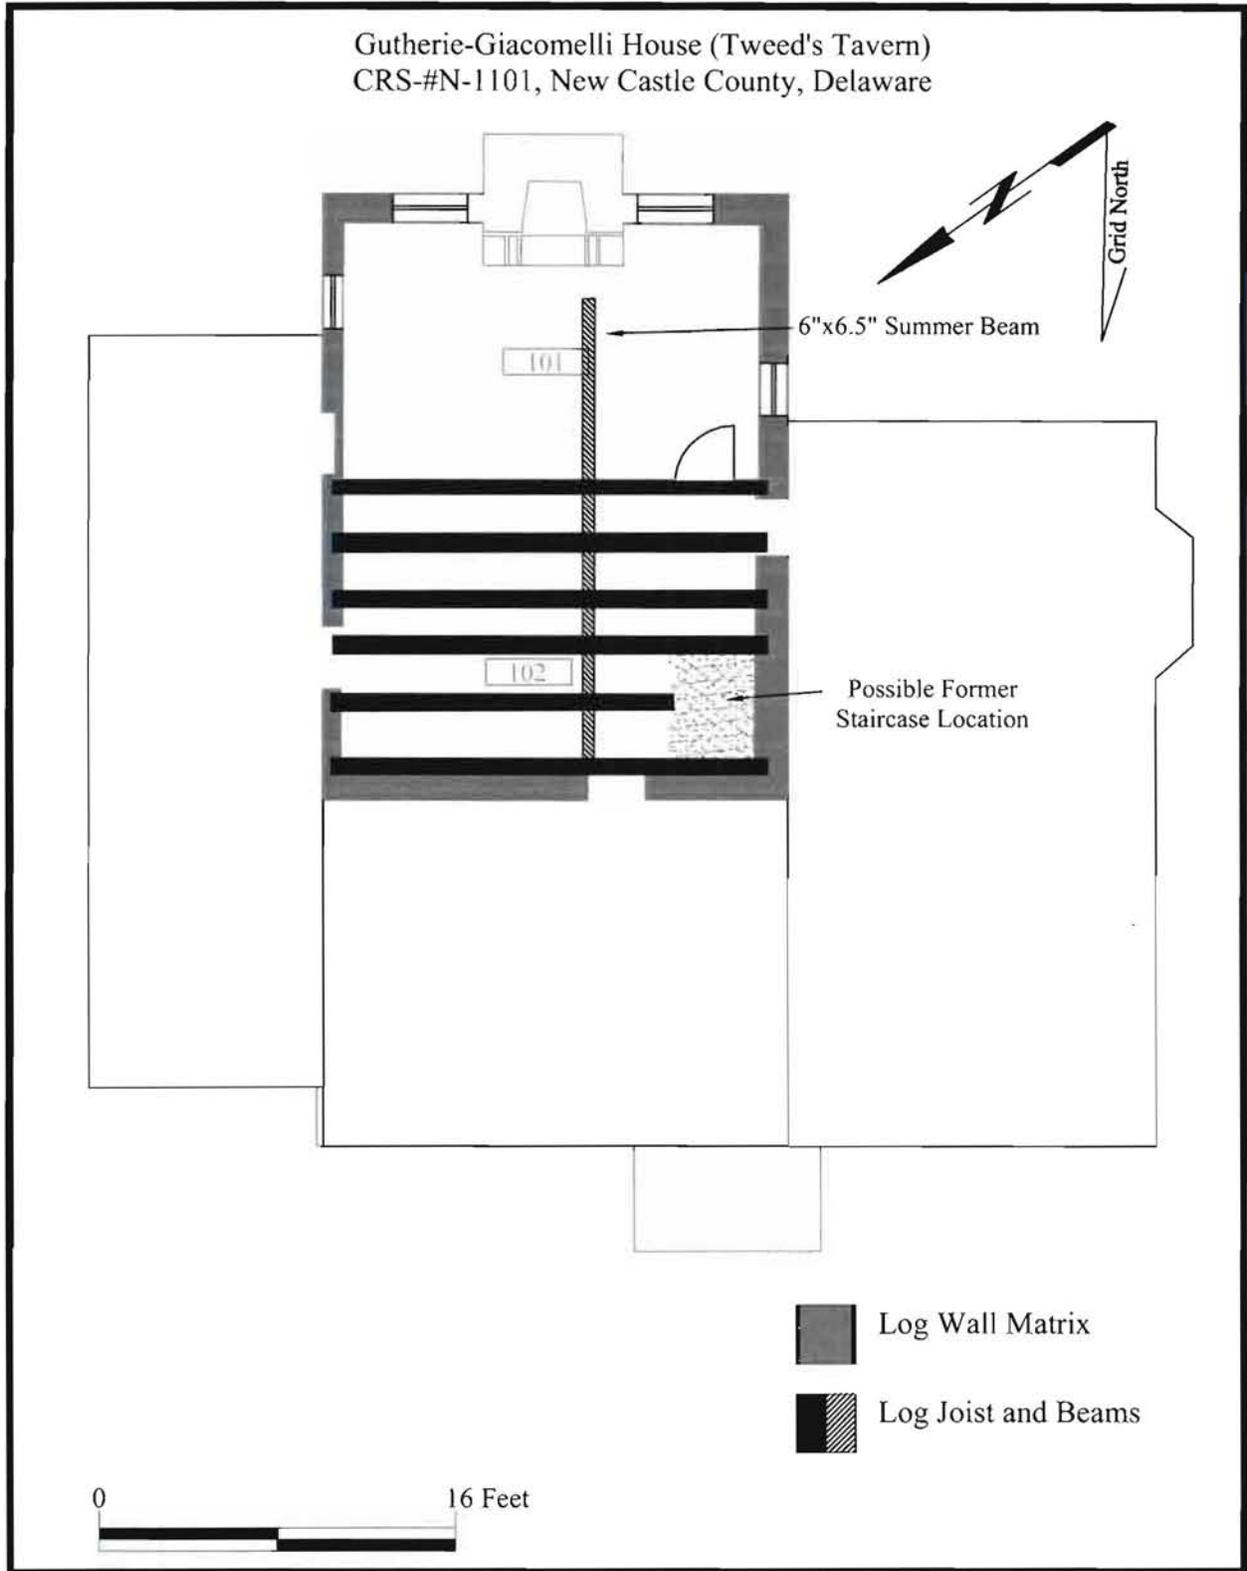
Figure 4.12. First Floor Joist Plan.

Joist framing for the first floor was exposed (Plate 4.9). A 20 foot long summer beam (6" x 6.5") rested atop the southwestern jamb of the fireplace support and extended the full length across the room resting atop the northern wall just west of center. Original joists had been removed from the southern half of the room and replaced by modern members carrying a plywood subfloor. Joists above the northern half of the room consisted of five irregularly-spaced fully round logs. These log joists rested atop the eastern and the western walls and are carried by the summer beam. The northernmost log joist has been cut off approximately 4 feet short of the western wall. This beam may have been left shorter than the others in order to accommodate the well hole of a winder staircase providing interior access to the basement.

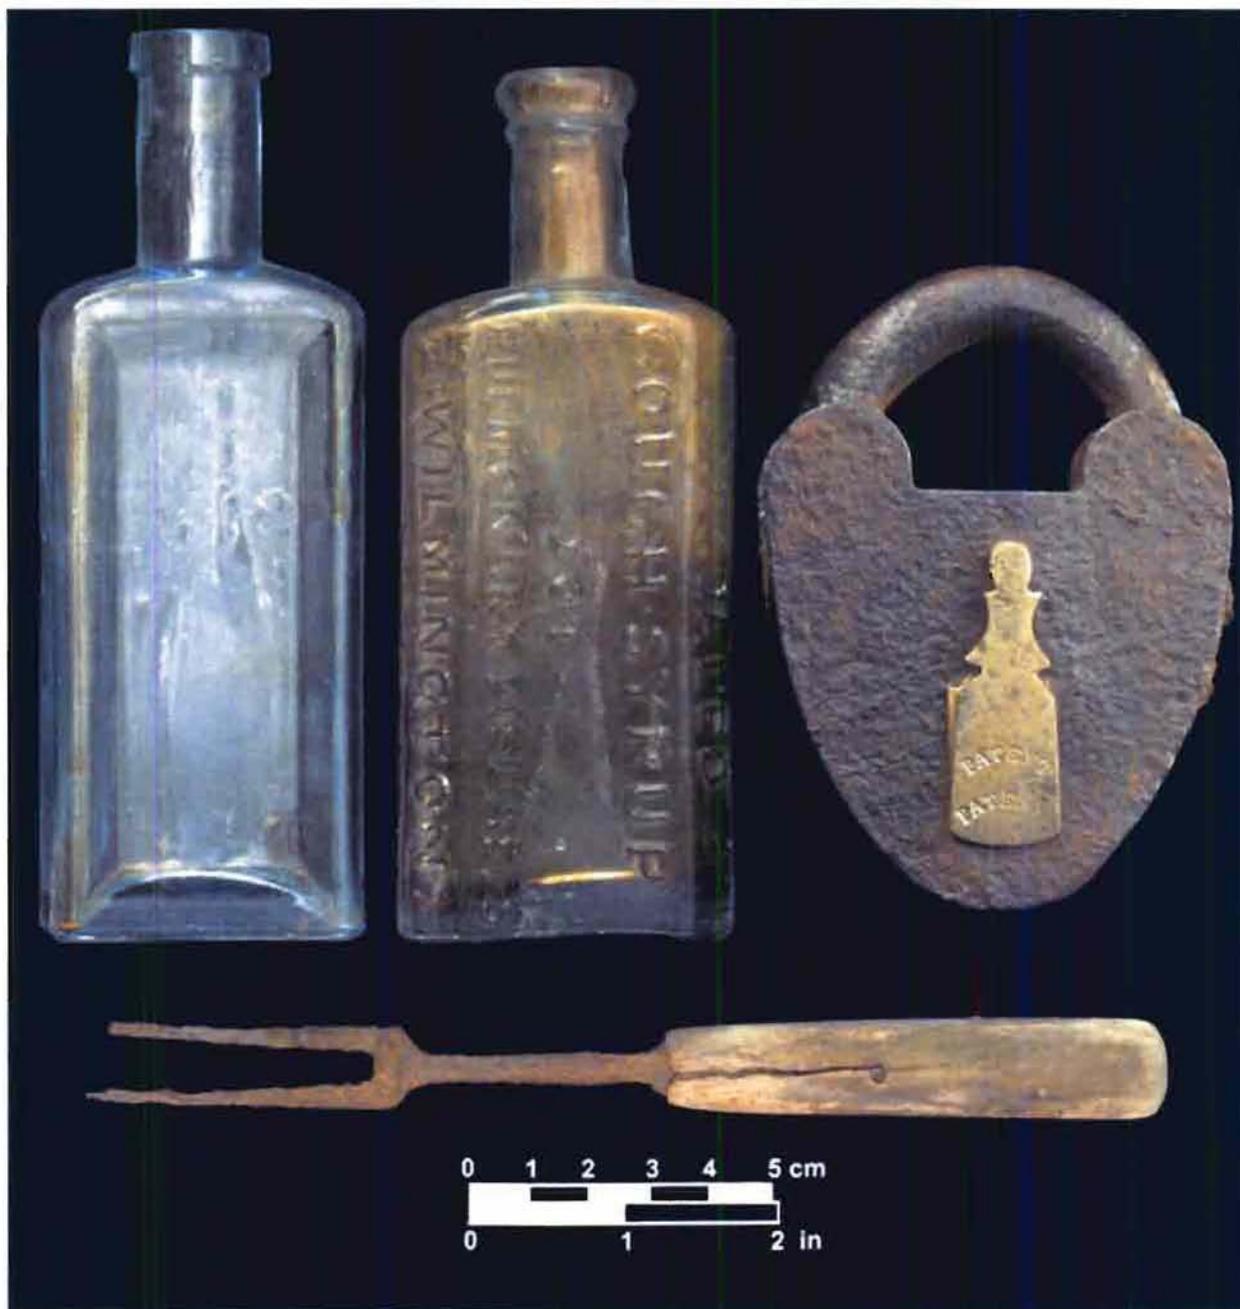
Plate 4.8 Guthrie-Giacomelli House (Tweed's Tavern) CRS-#N-1101, and Tweed's Tavern Archaeological Site [7NC-A-18]. Artifacts recovered from between horizontal timbers sealed inside of the walls. The top row from left to right shows a pale aqua rectangular paneled bottle with a recessed label plate for a paper lable, now gone, a clear rectangular medicine bottle embossed "Dr J. SIMMS & SON UNEQUALED COUGH SYRUP FOR PULMONARY DISEASES WILMINGTON DEL" and iron heart-shaped padlock with a brass keyhole cover plate stamped "PATENT", "PATENT". The bottom row shows an iron two tine fork with a bone handle (Photographer: Michael Murphy, June 2003)[HRI Neg.# 02095/D1:23].

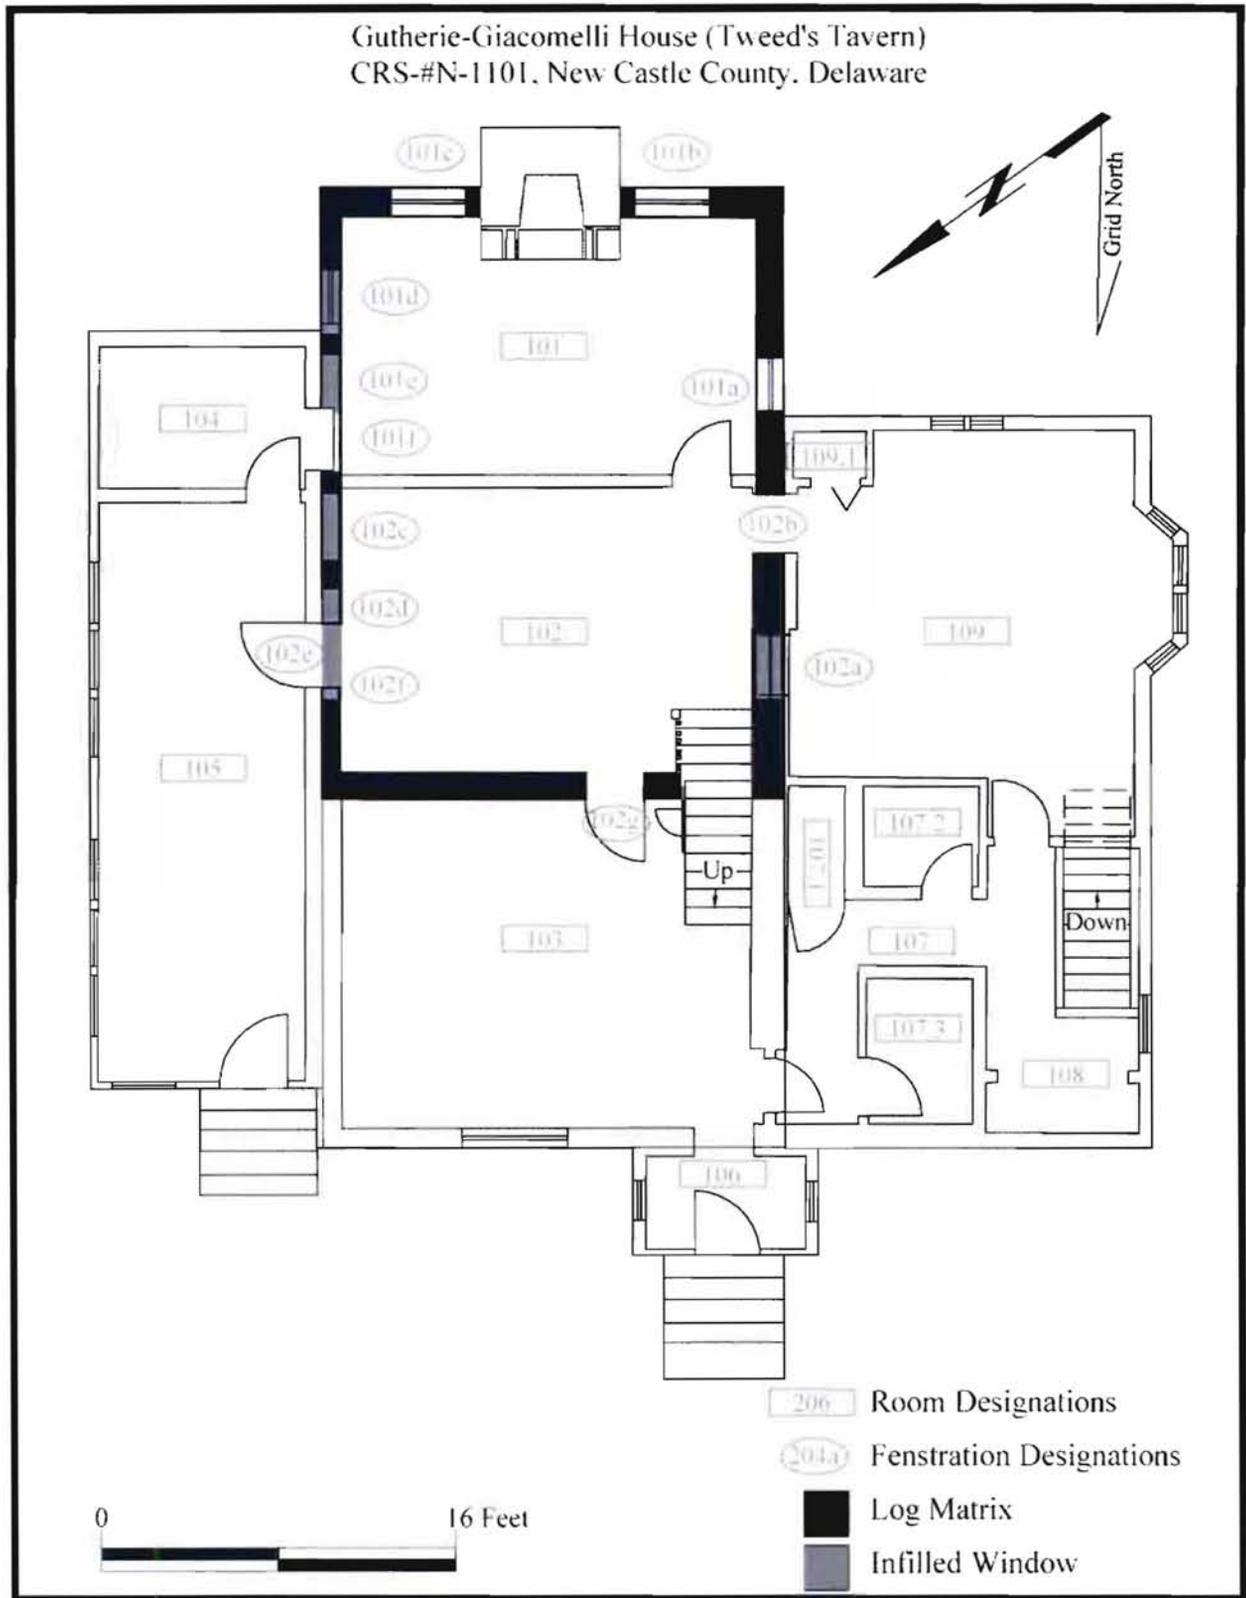
Figure 4.13. First Floor Plan.

Room 101 (Plates 4.10-4.14) is part of the original *circa* 1795 section of the house and is a component of the principal tavern space. It is believed to have contained both the tavern "bar cage" and the building's primary hearth. The historic firebox and its brick chimneystack were removed in the 1950s and replaced with the present exterior concrete block chimney and firebox. The earlier interior fireplace and chimneystack appear in a historic photograph of the interior of Room 101 (Plate 3.2).

Window 101d is modern double hung sash of the same type as 101a. Like 101a this fixture has been set into a preexisting window opening but unlike Window 101a the wall fabric above and below this fixture shows no evidences of notching. The log member above the window opening displays empty vestigial peg holes cut with an auger bit. While these auger holes are clearly evidence of an earlier window fixture in this location the lack of notching such as seen as is associated with the other known original window locations suggests that the opening in which Window 101d currently sits represents a historic modification to the original door and window arrangement.

Evidence of an earlier window location survives to the north (left) of Window 101d. A partial relict window opening (Window 101e) is visible in the log wall fab-
