ENCLOSURE 8
Integrity Factors Of Antonini Mushroom Building and
Dwelling (N-14127)

N-14127 Antonini Mushroom Building and Dwelling

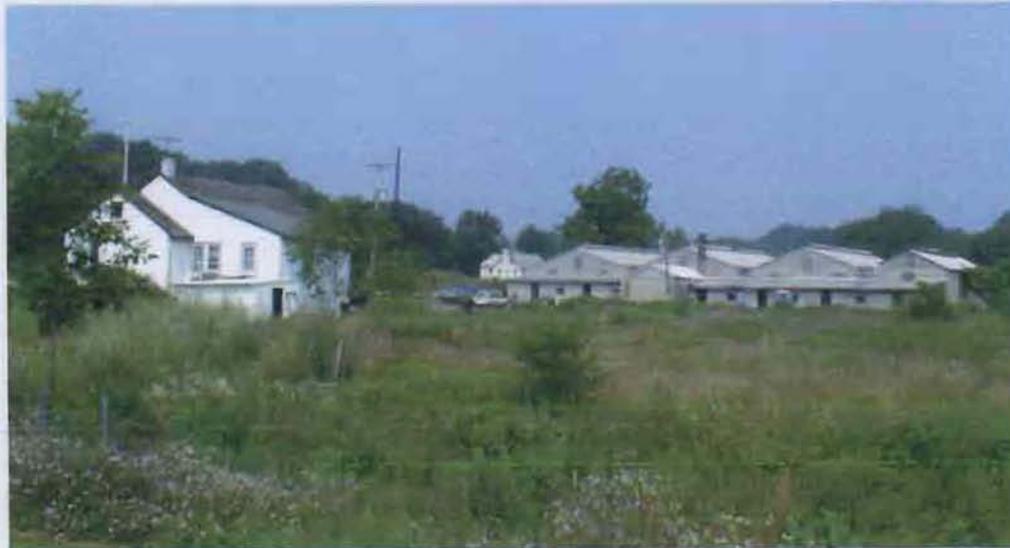
The property's setting and the property, itself, are no longer characterized by active mushroom farming operations. However, soil borings indicate that the property area was a heavy disposal area and stripped of natural top soils. This is typical of early and past mushroom operations where bedding and manure was recycled and disposed. Many older mushroom farms of the same region have also evolved or changed with adaptive alterations through ordinance controls, industry progression, and technological upkeep. This specific property has not.

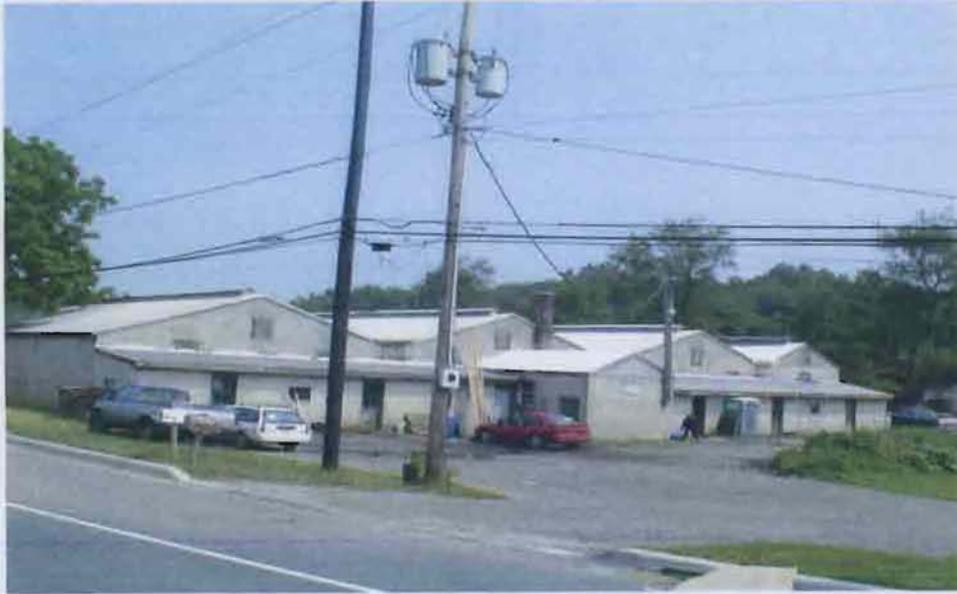
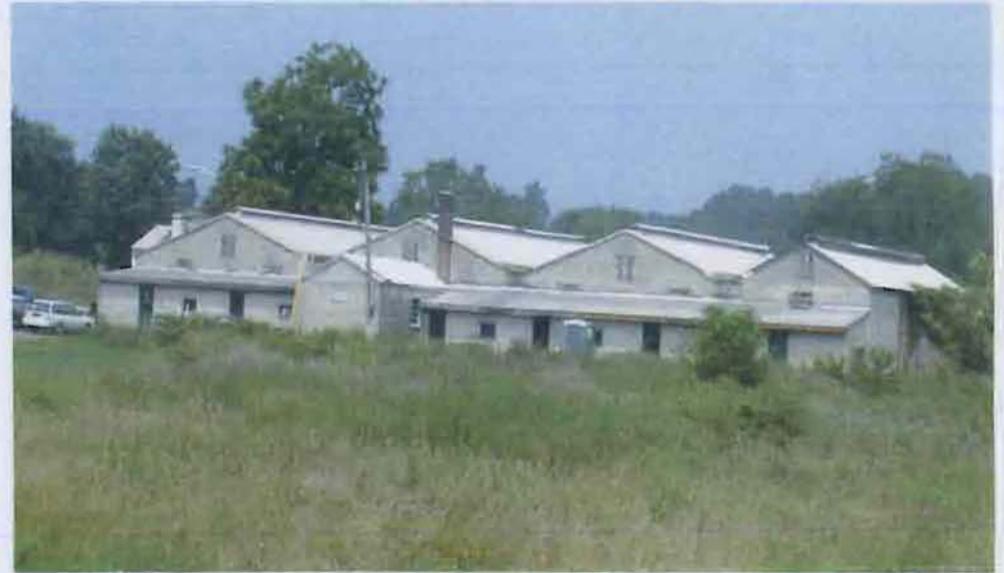
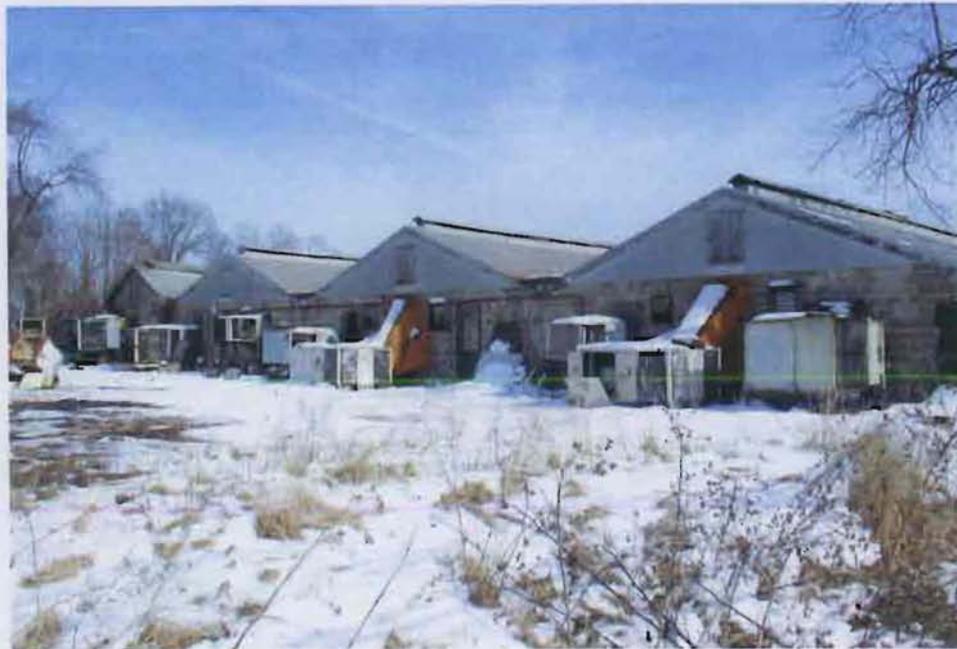
Most surrounding mushroom houses still extant and/or operable are larger facilities with multiple bays of doubles and supporting building operations and grounds. This is a smaller and isolated property example that is missing many other key elements and supporting buildings that are commonly situated on that same property. Other supporting elements may include garage and storage bays, the main office, compost storage areas, worker/tenant housing, and a central or fully tiered facility layout with access and circulation of the operational grounds and buildings. The Permit Area and building are only a smaller portion of a much larger facility which was later constructed and improved in the late 20th century
