**Kitchen/Dining Hall
(CRS # N-14422.04)**

KITCHEN/DINING HALL

CRS # N-14422.04

Detailed Building Description

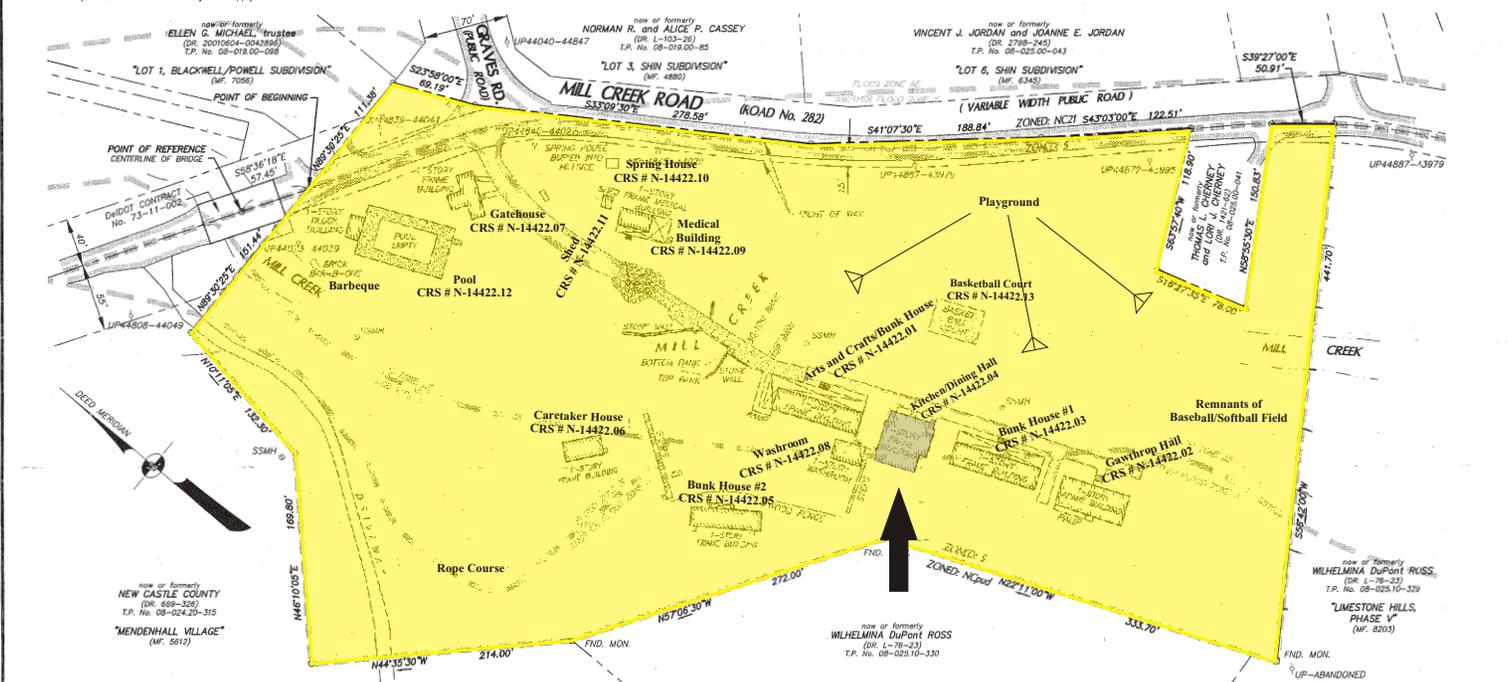
PROPERTY PLAN
3850 MILL CREEK ROAD
 MILL CREEK HUNDRED - NEW CASTLE COUNTY
 DELAWARE
 SCALE: 1"=60'
 DECEMBER 13, 2005
 GRAPHIC SCALE (IN FEET)

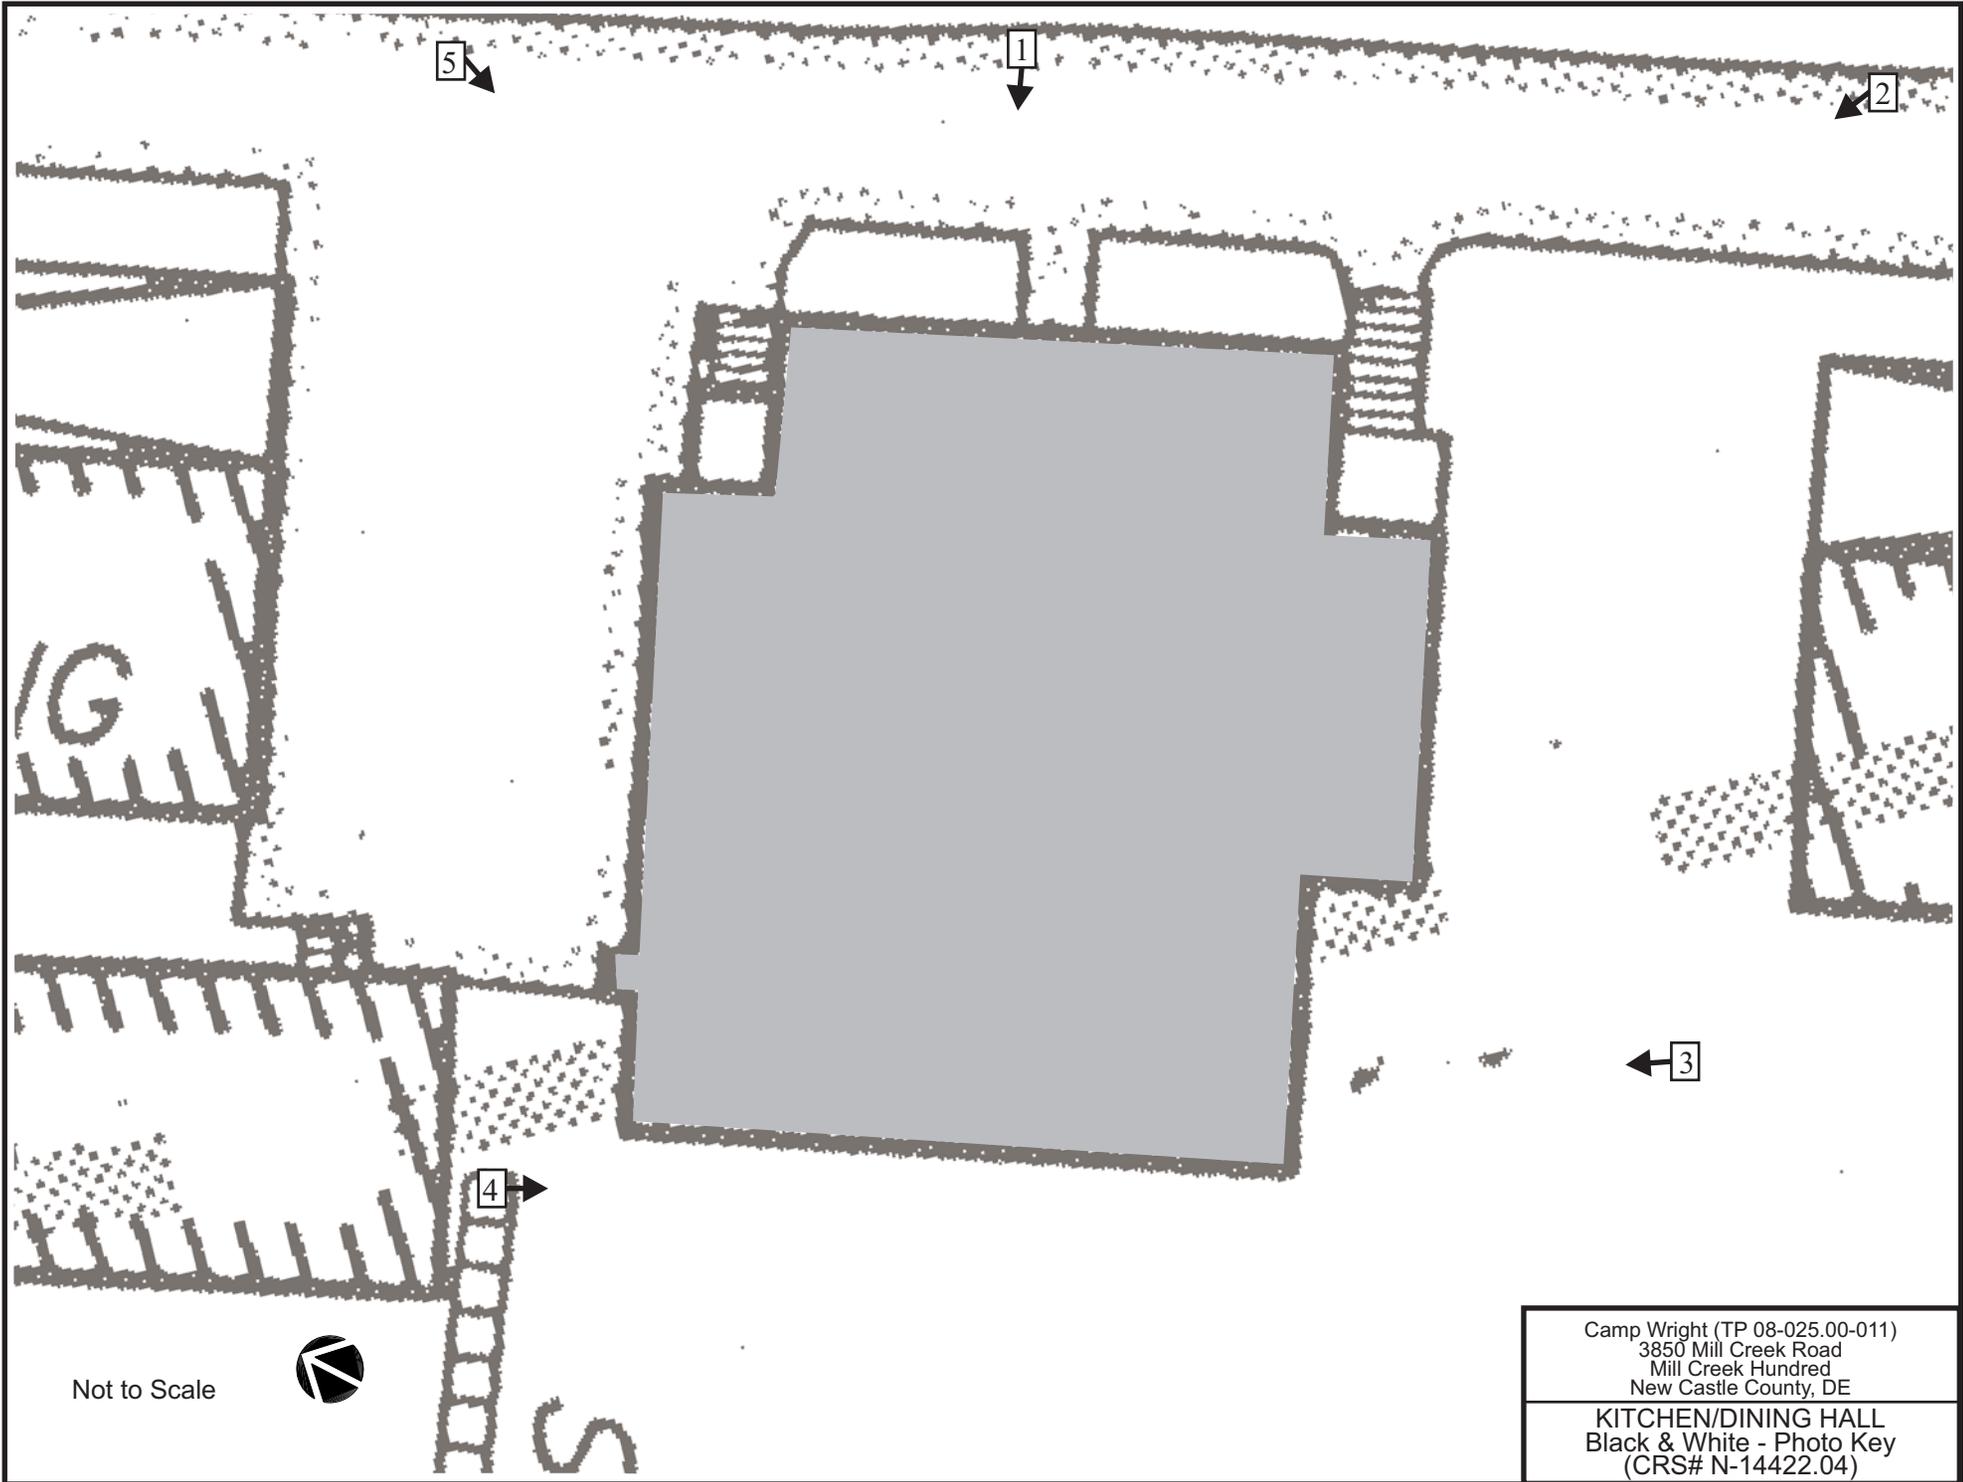
Camp Wright (TP 08-025.00-011) 3850 Mill Creek Road Mill Creek Hundred New Castle County, DE
KITCHEN/DINING HALL Black & White - Photo Key (CRS# N-14422.04)

- Plate 01: View looking west at the east façade elevation.
- Plate 02: View looking northwest at the south side elevation.
- Plate 03: View looking north at the south side elevation.
- Plate 04: View looking southeast at the west rear elevation.
- Plate 05: View looking southwest at the north side elevation.

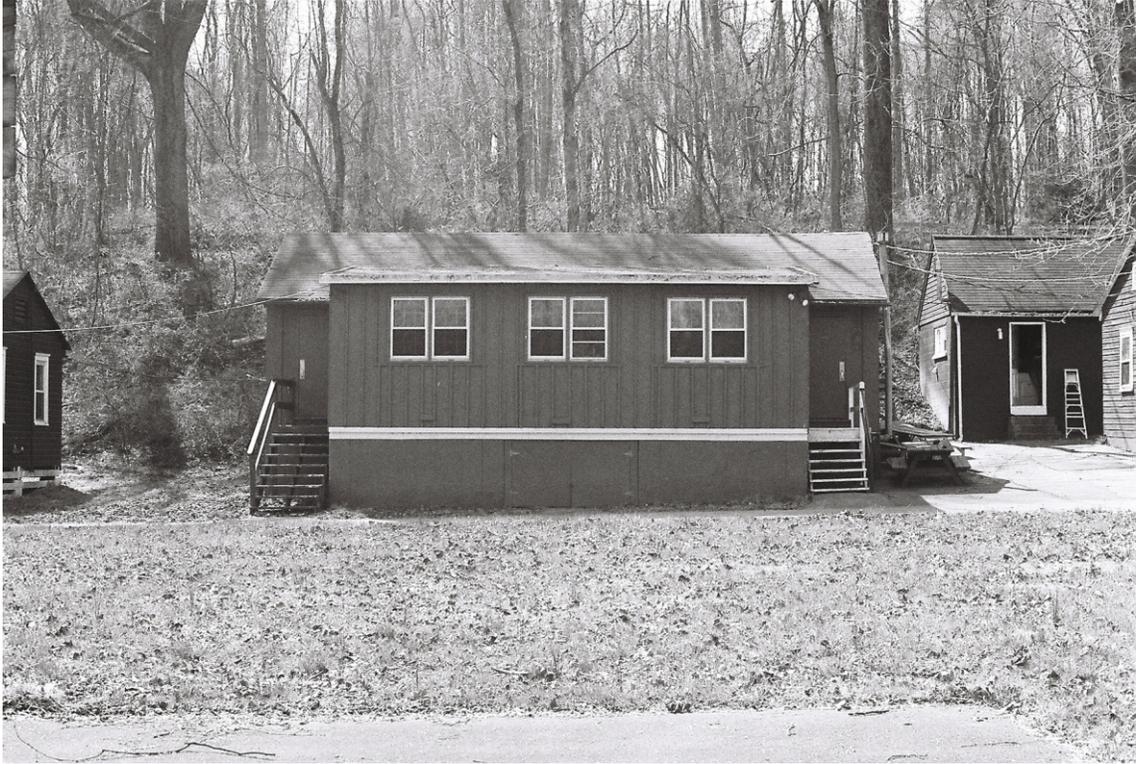
Plate 01: View looking west at the east facade elevation.

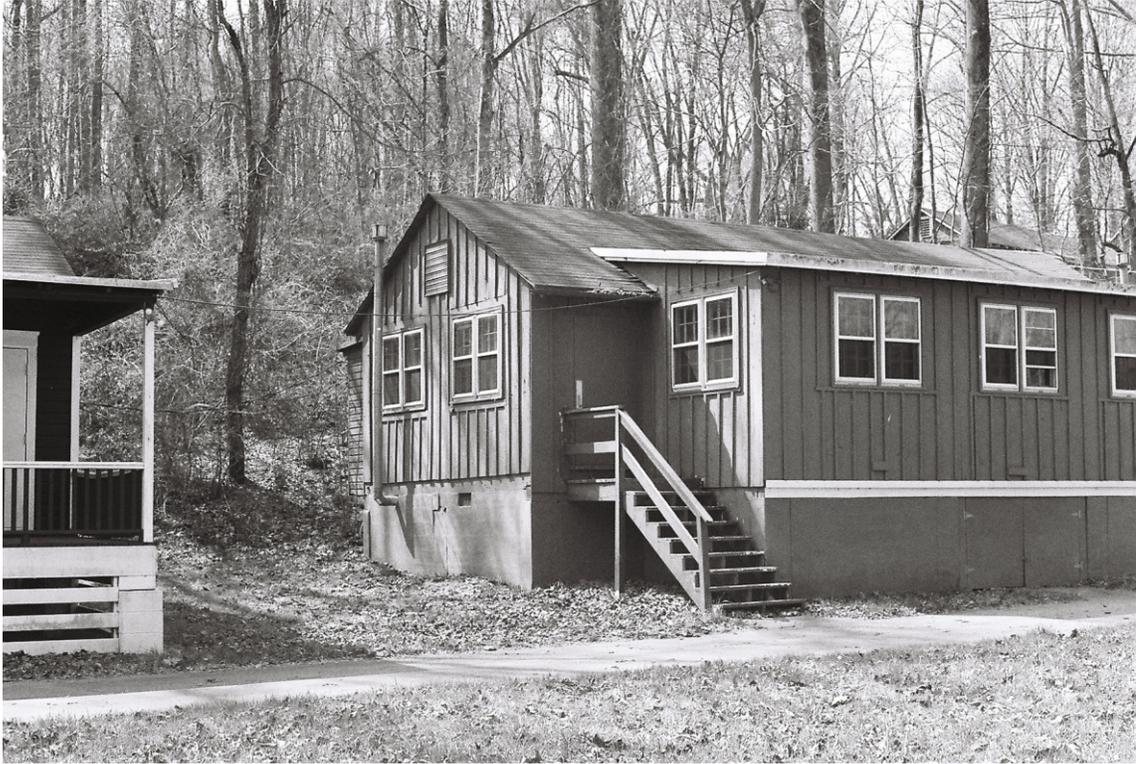
Plate 02: View looking northwest at the south side elevation.

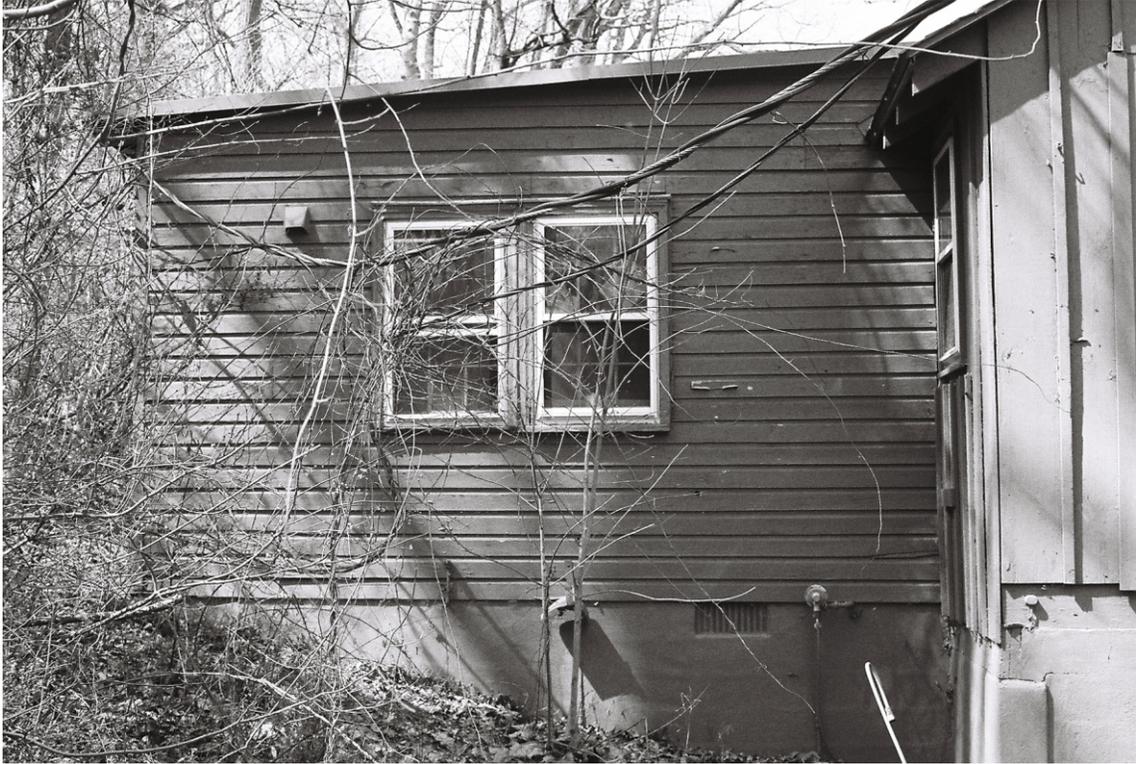
Plate 03: View looking north at the south side elevation.

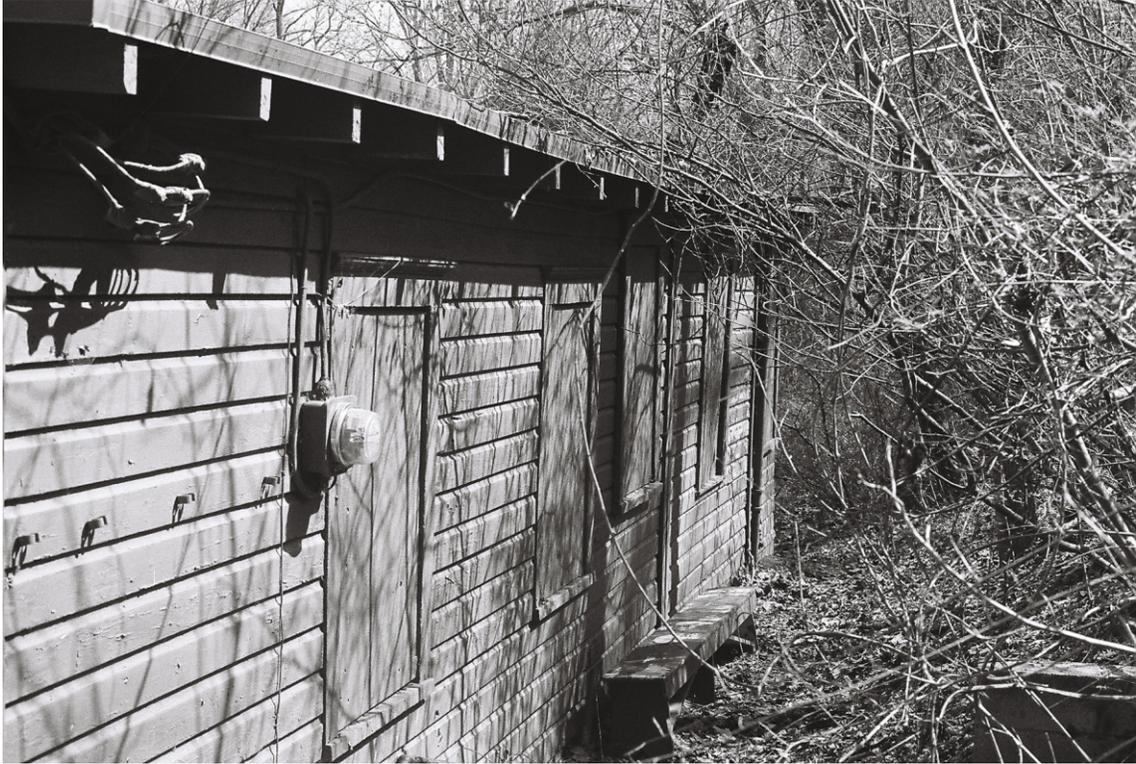
Plate 04: View looking southeast at the west rear elevation.

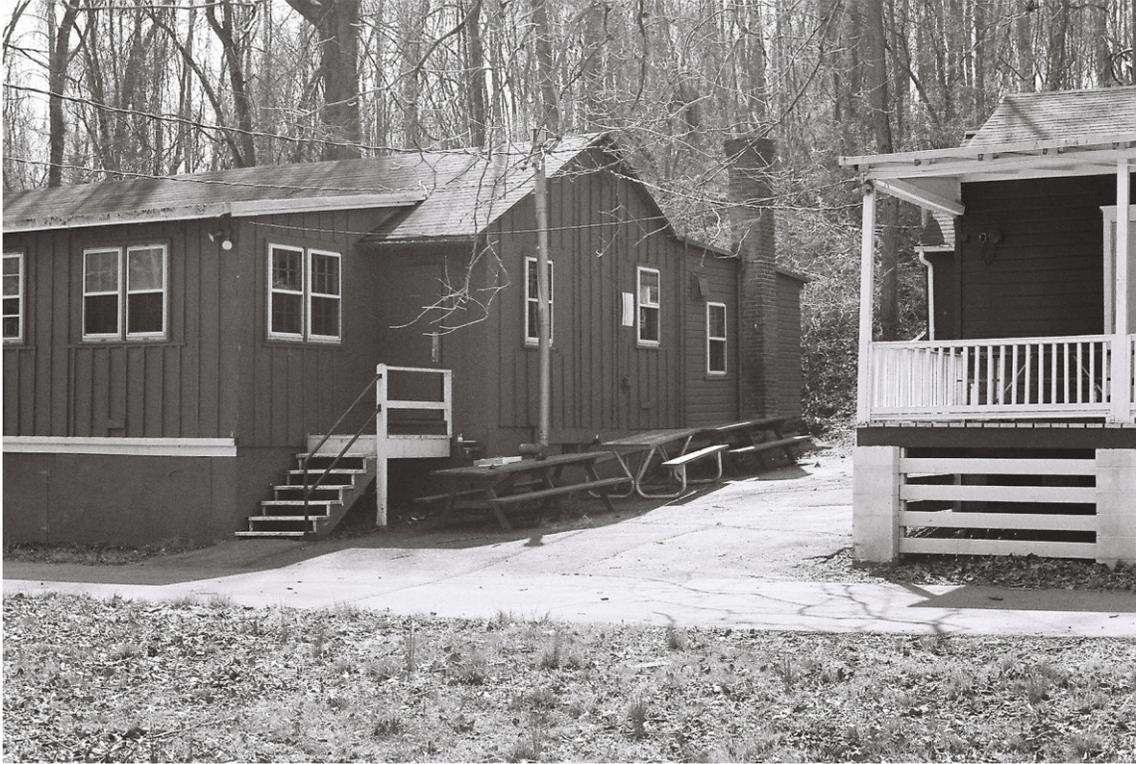
Plate 05: View looking southwest at the north side elevation.

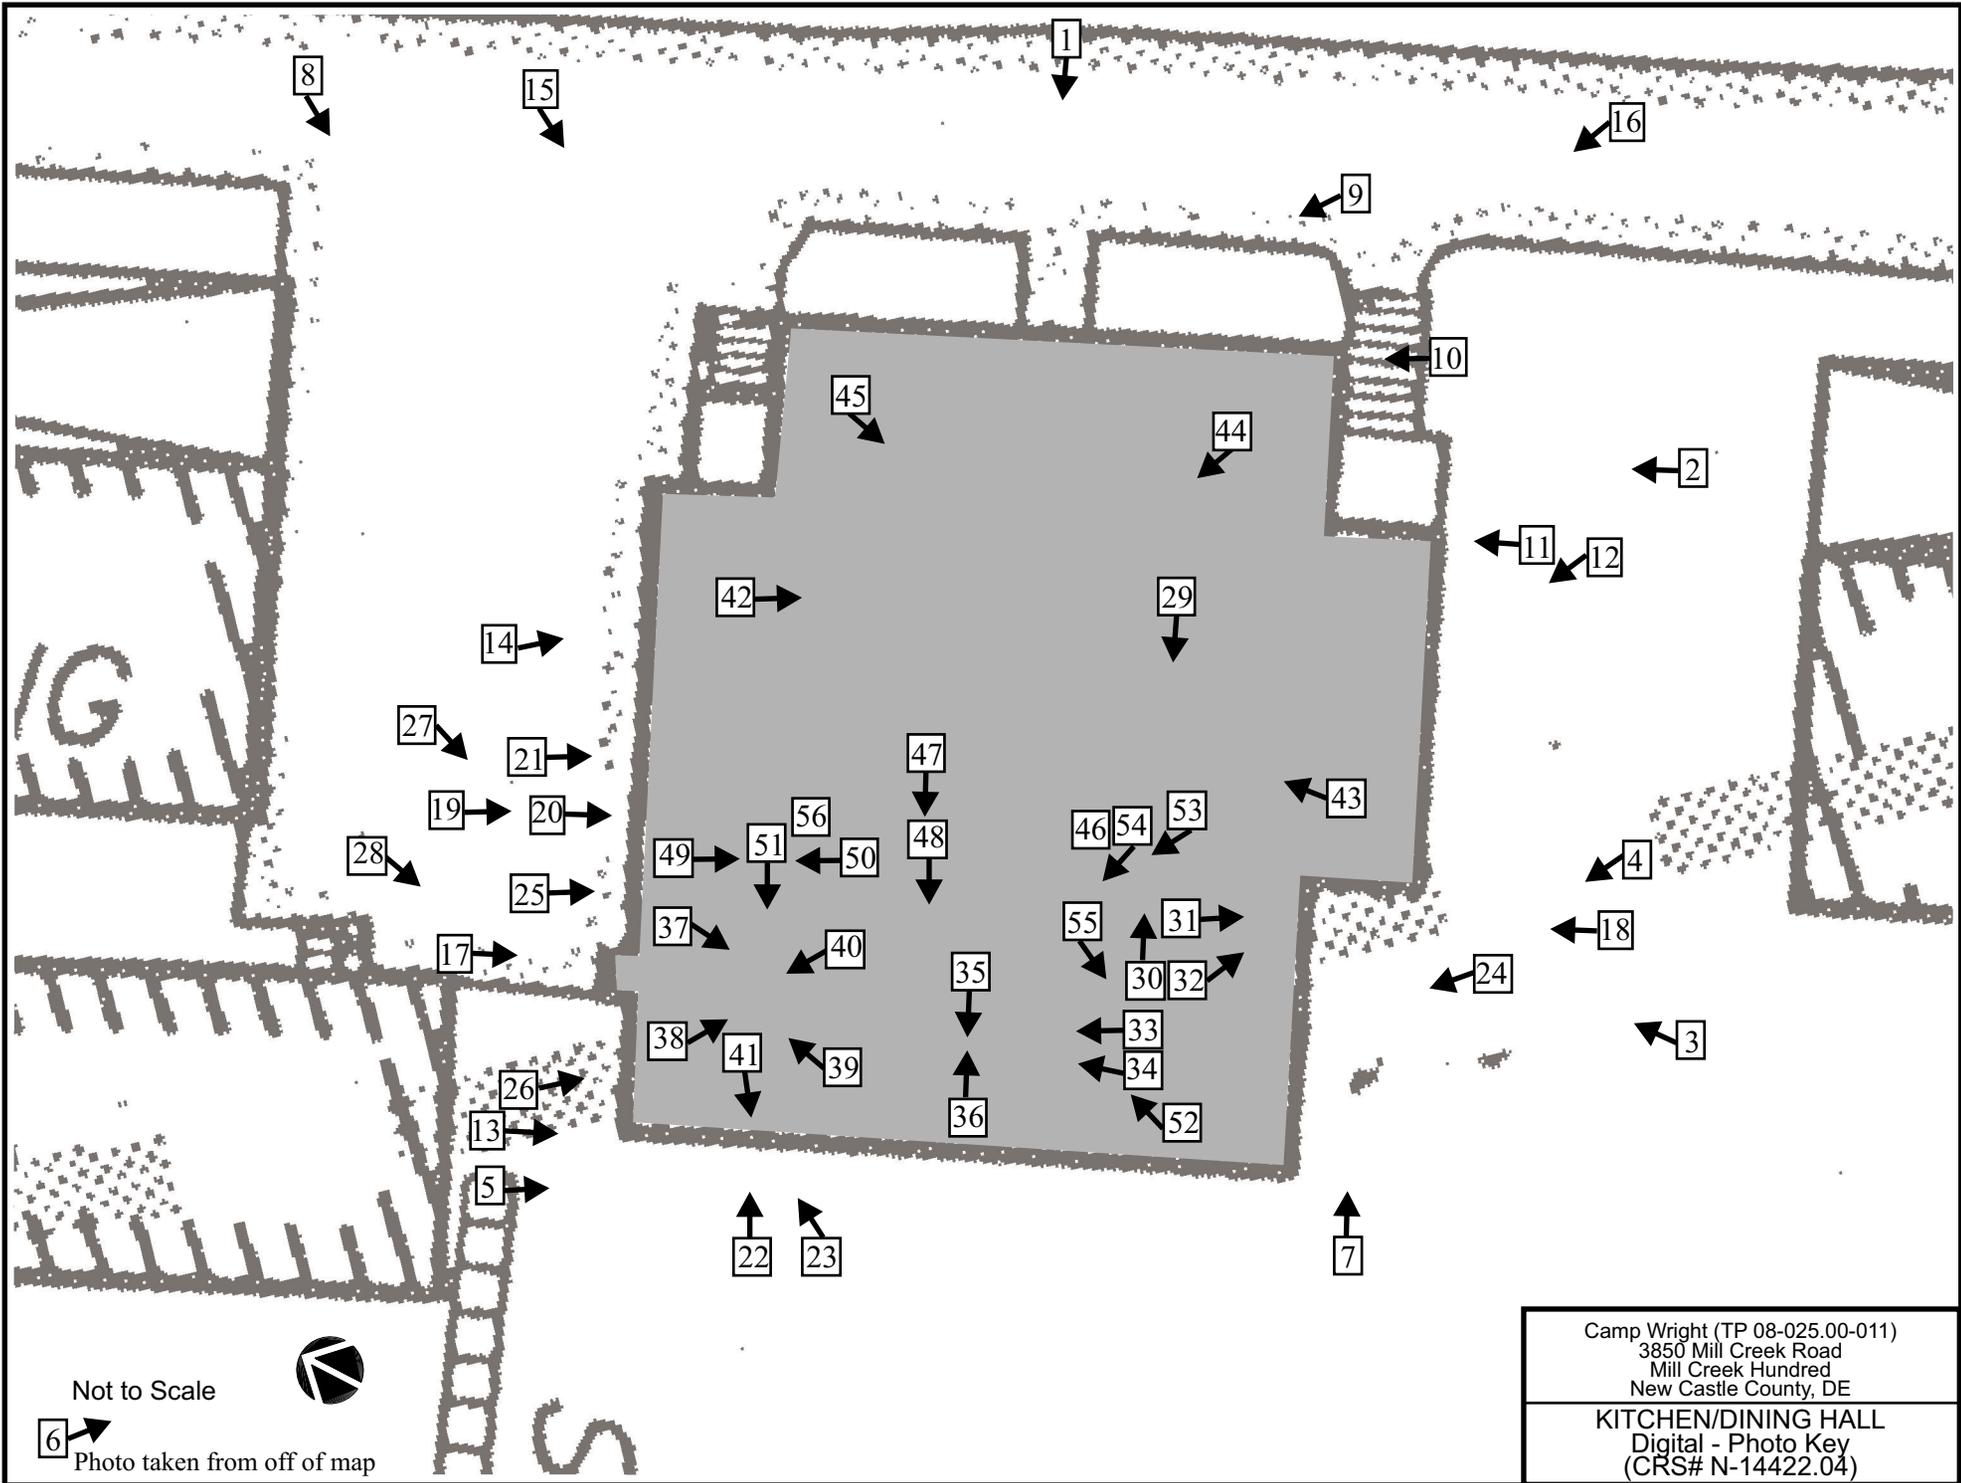
KITCHEN/DINING HALL
Digital - Photo Key
(CRS# N-14422.04)

- Plate 01: View looking west at the east elevation.
Plate 02: View looking northwest at the south elevation.
Plate 03: View looking northeast at the south elevation.
Plate 04: View looking north at the south elevation.
Plate 05: View looking southeast at the west elevation.
Plate 06: View looking southeast from Bunk House #2. Note the kitchen addition of the Kitchen/Dining Hall is below the grey shed roof in the center of the photo.
Plate 07: Looking east at the west elevation of the main block of the building.
Plate 08: View looking southwest at the north elevation.
Plate 09: Detail of the foundation of the east elevation. Note the access doors to the crawl space and the three cleats attached to the vertical siding.
Plate 10: Detail of the foundation at the southeast corner. Note the treads for the south stairs at photo left.
Plate 11: Detail of foundation of main block at the south stairs. Note the porch for the south stairs at photo right.

Plate 12: View of the foundation of the south elevation.
Plate 13: Detail of the foundation at the northwest corner.
Plate 14: Detail of the foundation of the north elevation.
Plate 15: View looking southwest at the north stairs.
Plate 16: View looking northwest at the south stairs.
Plate 17: Detail of the step for the kitchen door along the north elevation.
Plate 18: Detail of the junction of the main block and the kitchen addition along the south elevation.
Plate 19: Detail of the junction of the main block and the kitchen addition along the north elevation.
Plate 20: Detail of the junction of the main block and the kitchen addition along the north elevation.
Plate 21: Detail of the window replacement. Note the patch on both sides and below the window.
Plate 22: Detail of in-filled window along west elevation. Kitchen cabinets are located along the interior of this wall.
Plate 23: Detail of window cornice.

Plate 24: Detail of double window.
Plate 25: Detail of the exhaust vent for the kitchen.
Plate 26: Detail of door cornice.
Plate 27: Detail of the chimney stack.
Plate 28: View looking southwest at a concrete block wall and pad behind the kitchen.
Plate 29: View looking west at Room 1 from Room 4.
Plate 30: Detail of the floors between Room 1 and Room 4. Note Room 1 is in the foreground.

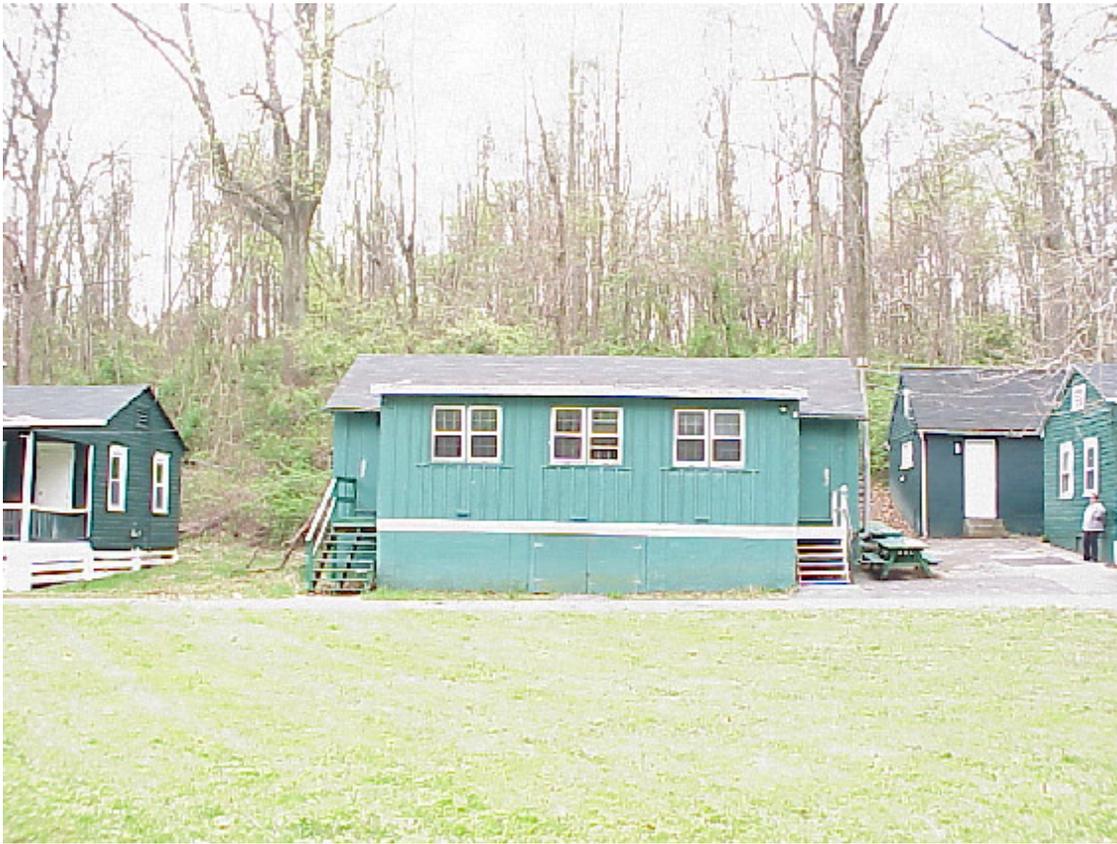
Plate 01: View looking west at the east elevation.

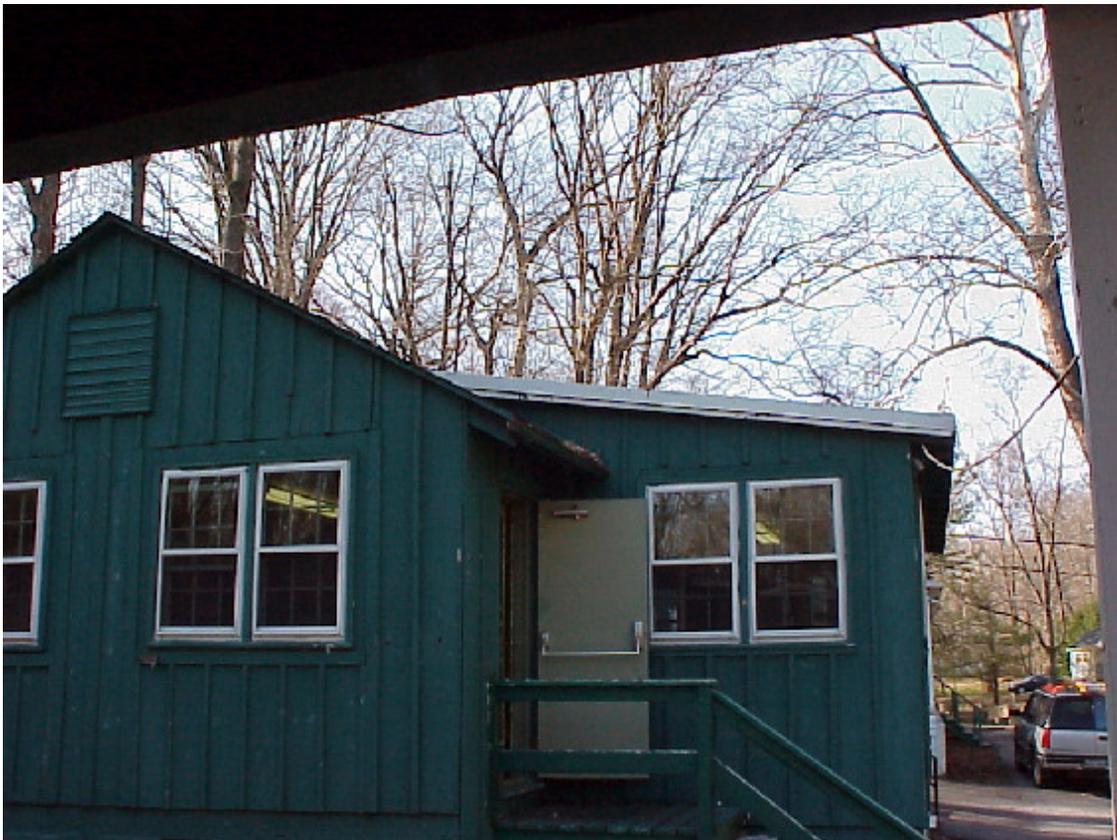
Plate 02: View looking northwest at the south elevation.

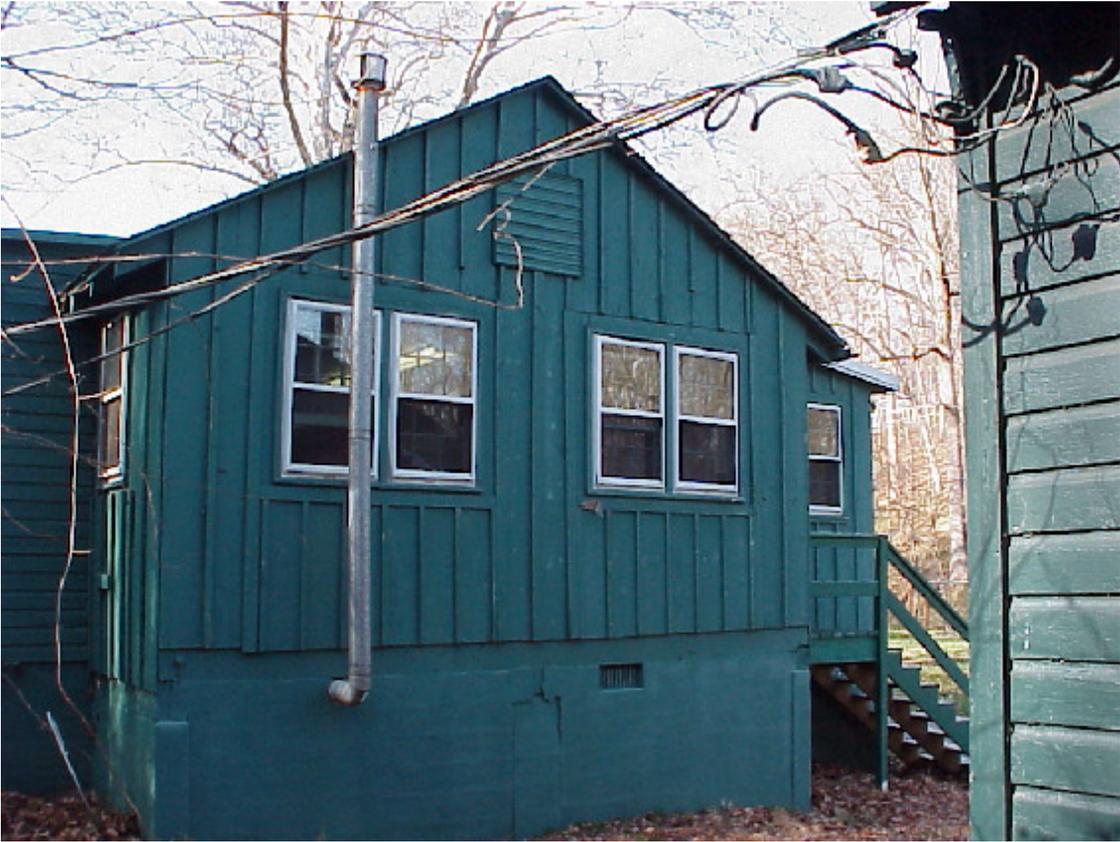
Plate 03: View looking northeast at the south elevation.

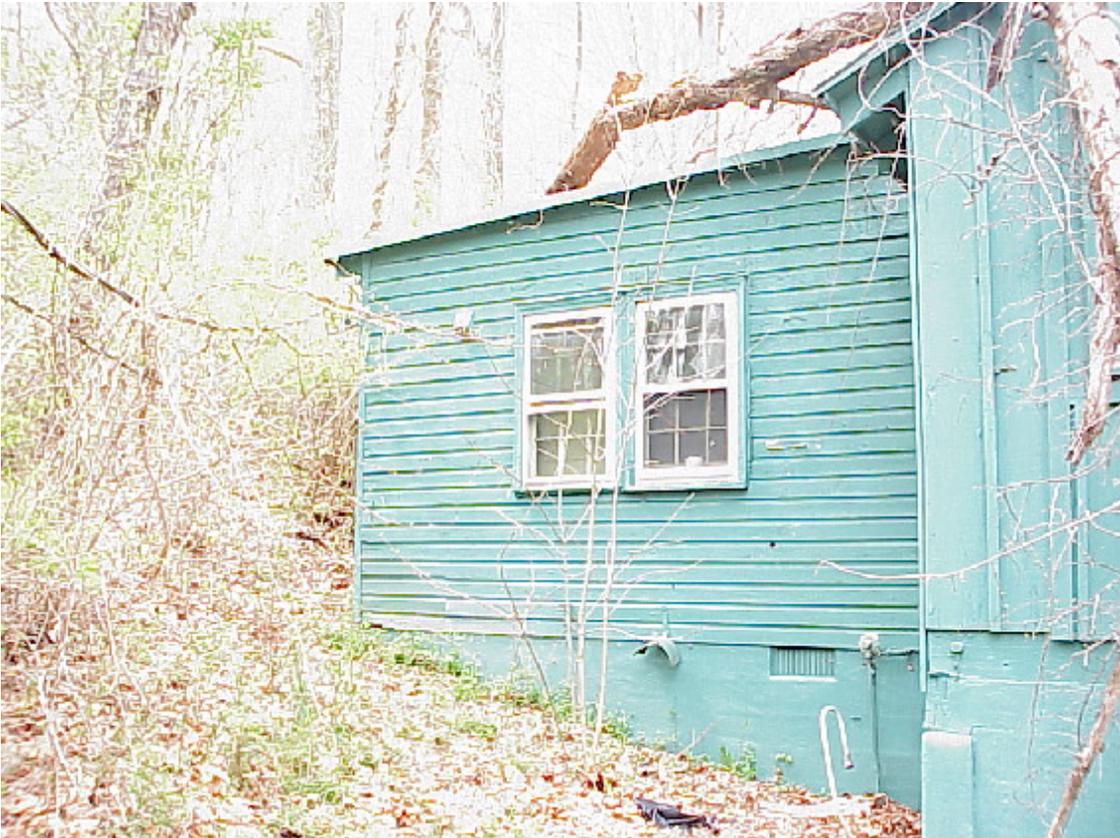
Plate 04: View looking north at the south elevation.

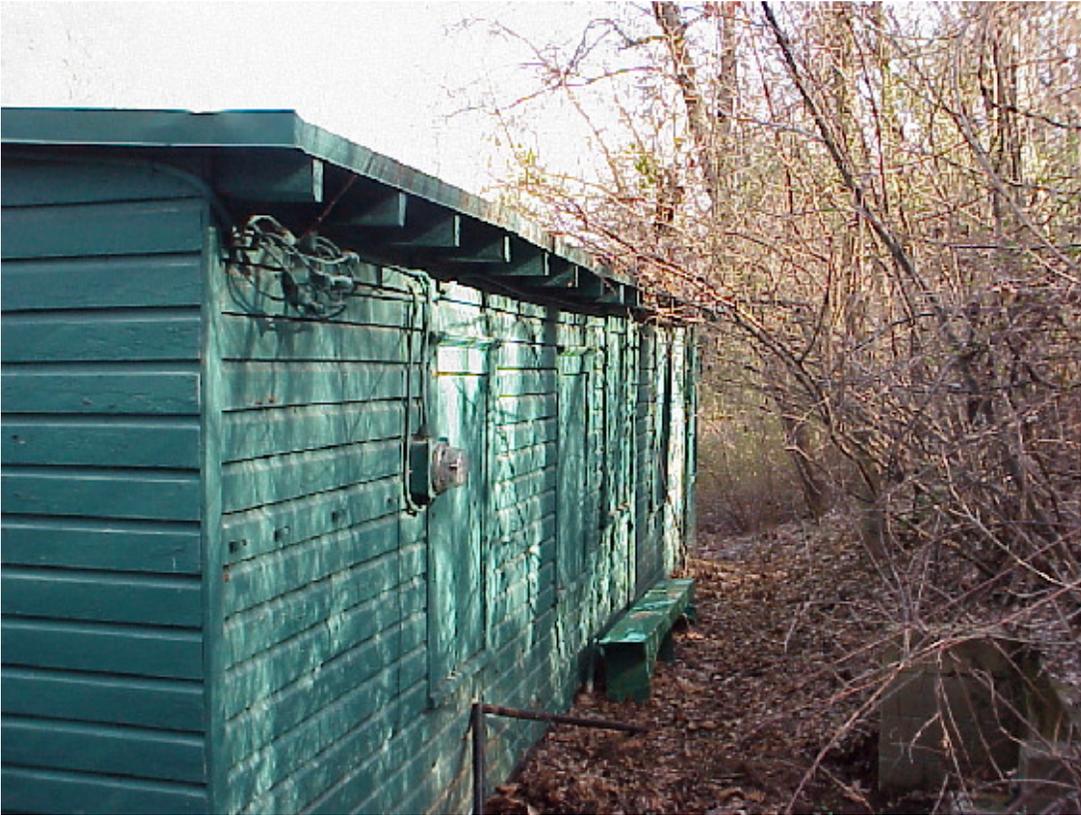
Plate 05: View looking southeast at the west elevation.

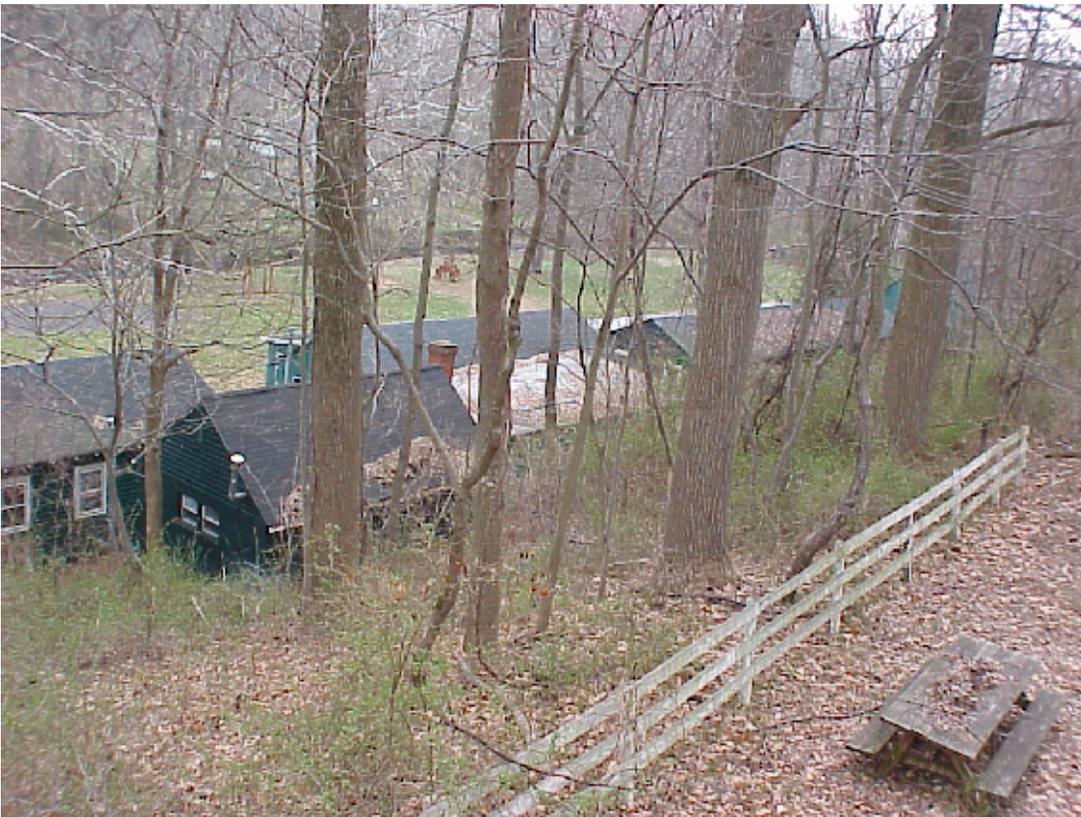
Plate 06: View looking southeast from Bunk House #2. Note the kitchen addition of the Kitchen/Dining Hall is below the grey shed roof in the center of the photo.

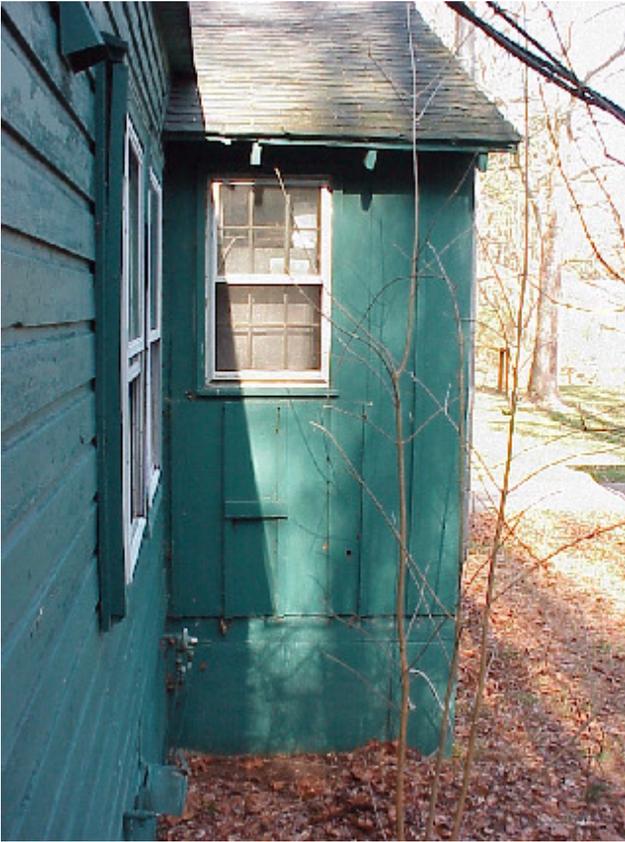
Plate 07: Looking east at the west elevation of the main block of the building.

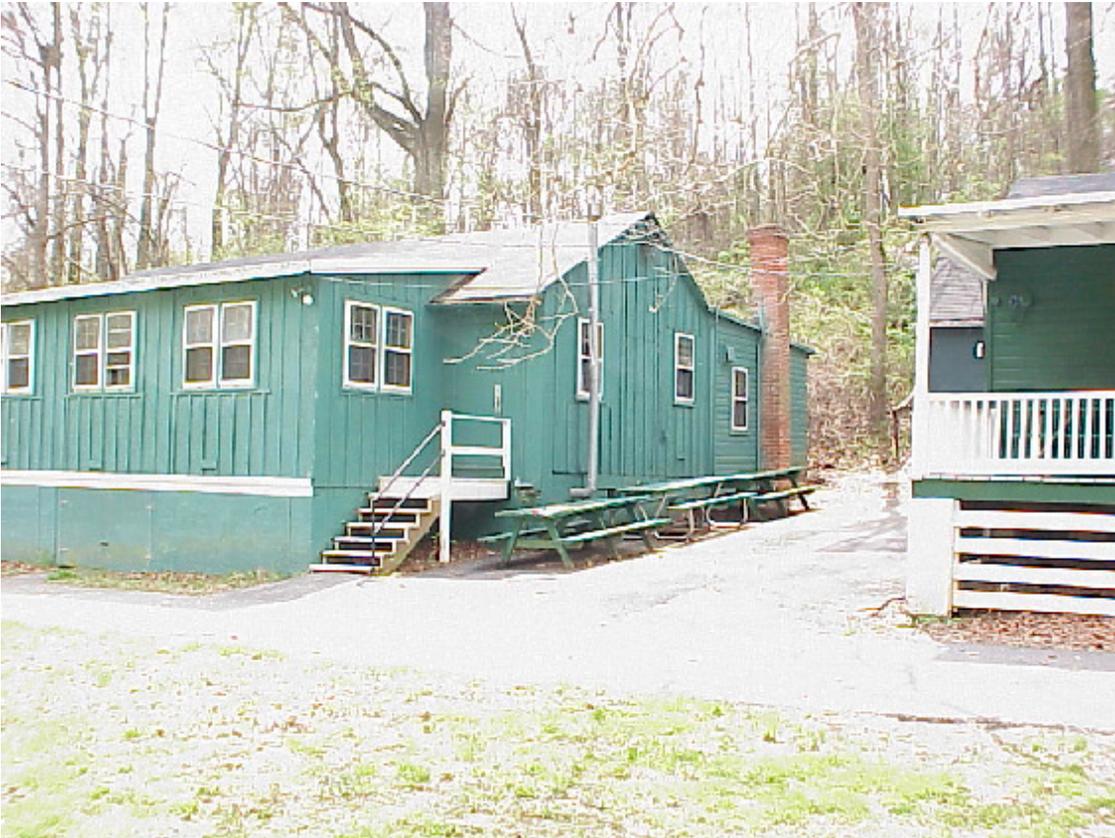
Plate 08: View looking southwest at the north elevation.

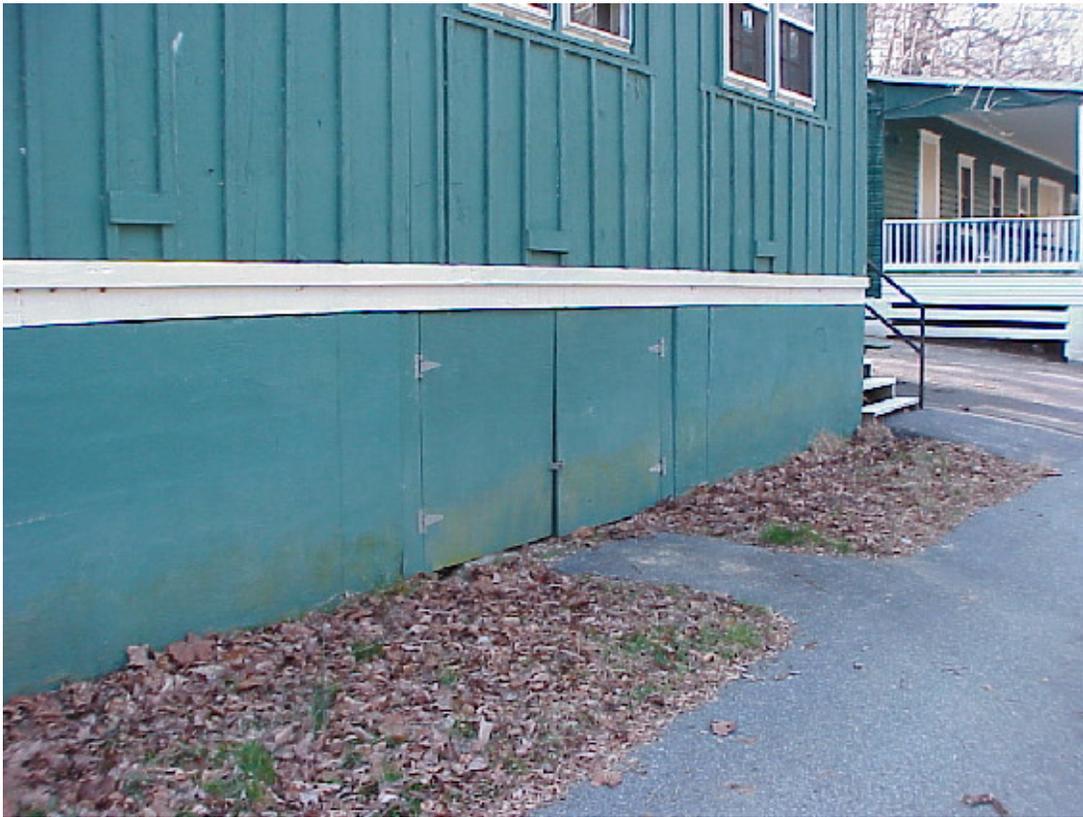
Plate 09: Detail of the foundation of the east elevation. Note the access doors to the crawl space and the three cleats attached to the vertical siding.

- There is a stainless steel water fountain next to the north steps.
- The water fountain has flexible PVC drainpipe and woven nylon feeder hose.
- The center bay of the east addition foundation is covered with a pair of plywood doors.

- The plywood doors allow access to the crawl space.

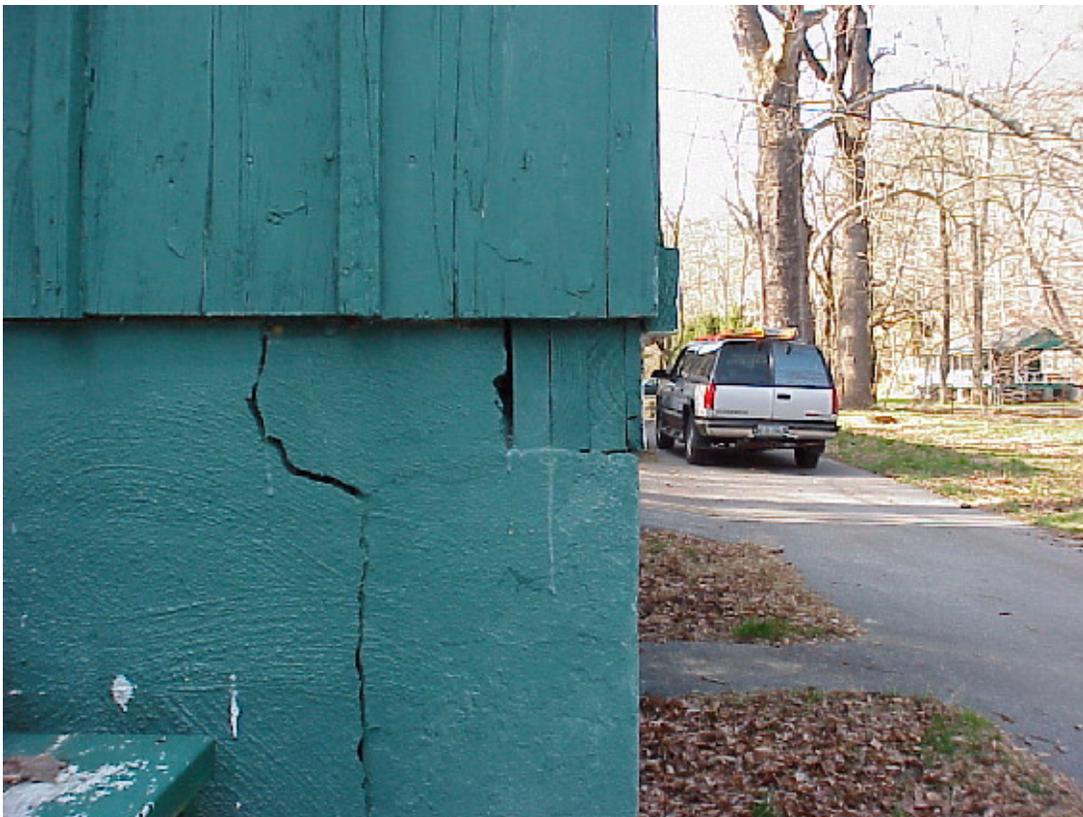
Plate 10: Detail of the foundation at the southeast corner. Note the treads for the south stairs at photo left.

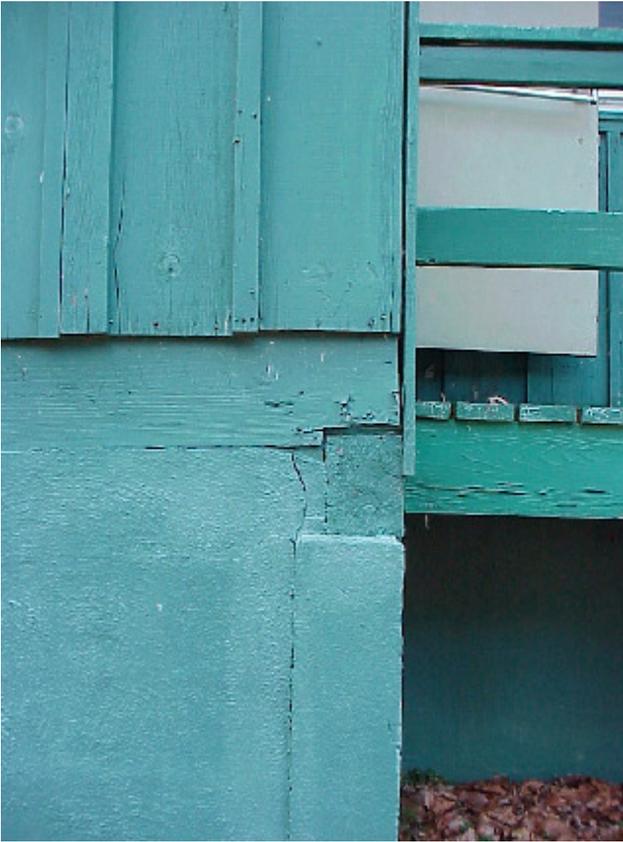
Plate 11: Detail of foundation of main block at the south stairs. Note the porch for the south stairs at photo right.

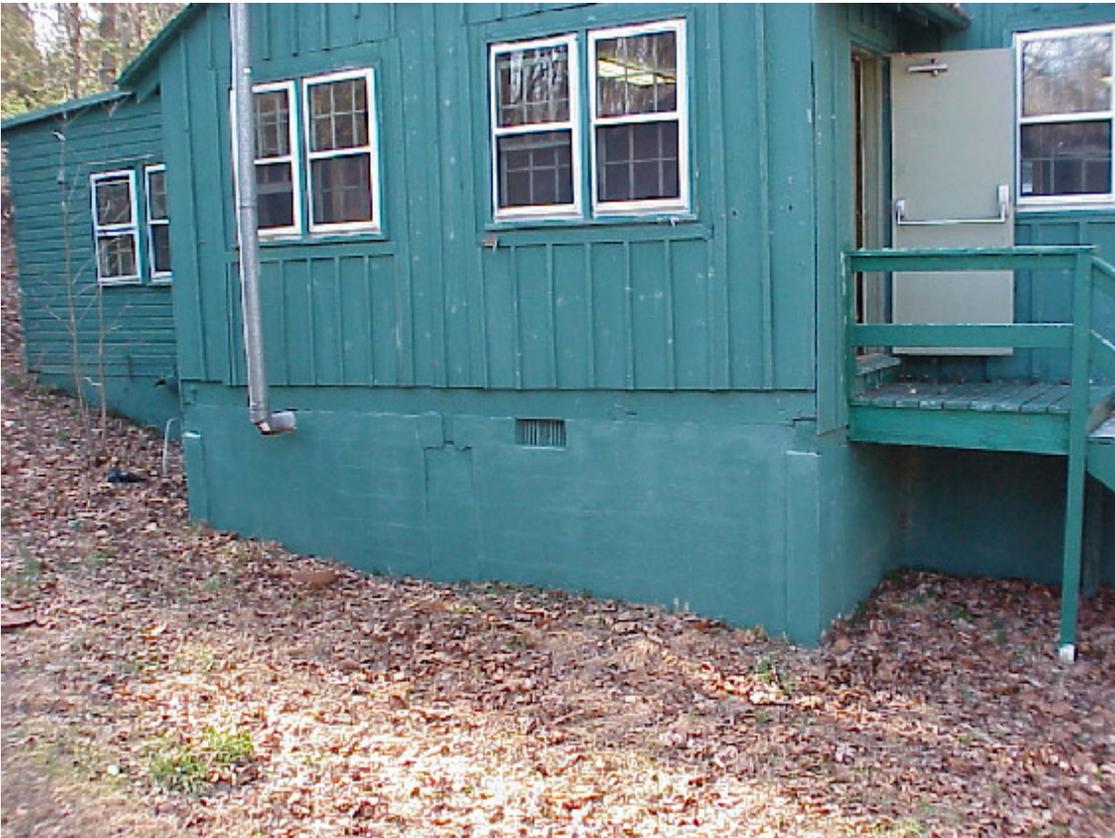
Plate 12: View of the foundation of the south elevation.
