**Kitchen/Dining Hall
(CRS # N-14422.04)**

KITCHEN/DINING HALL

CRS # N-14422.04

Detailed Building Description

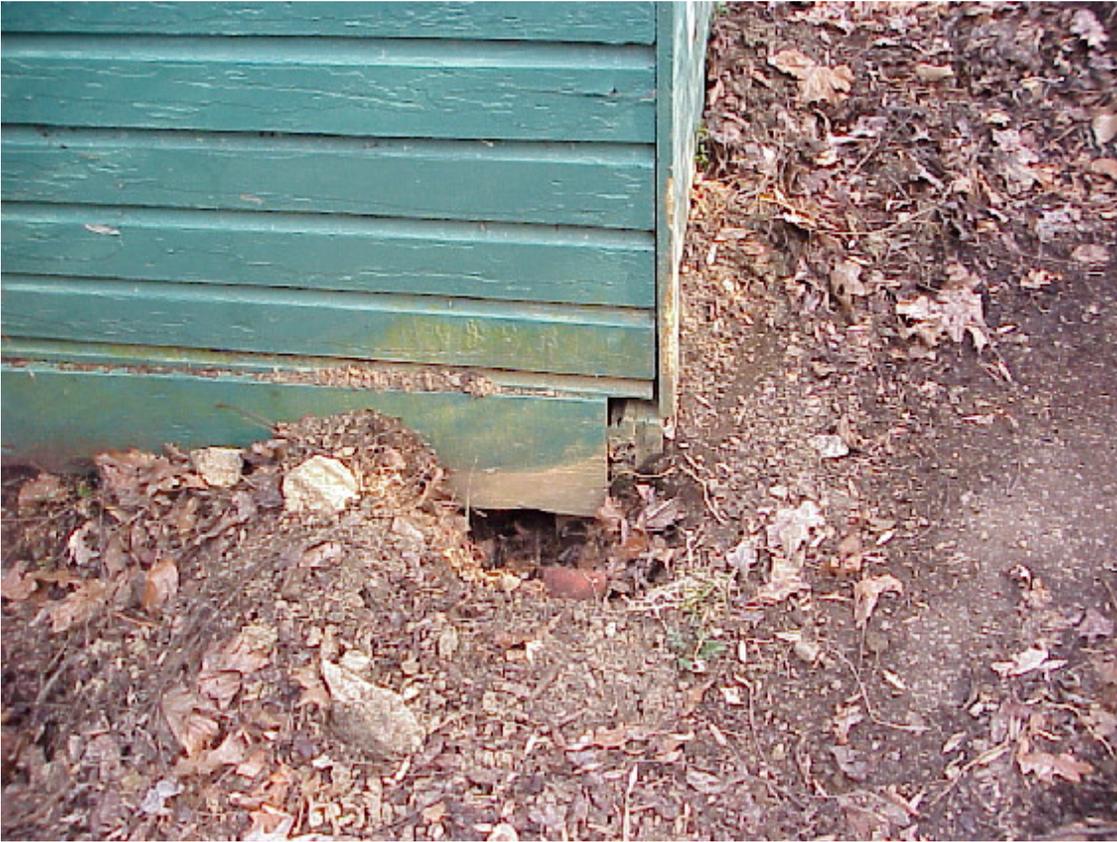
Plate 13: Detail of the foundation at the northwest corner.

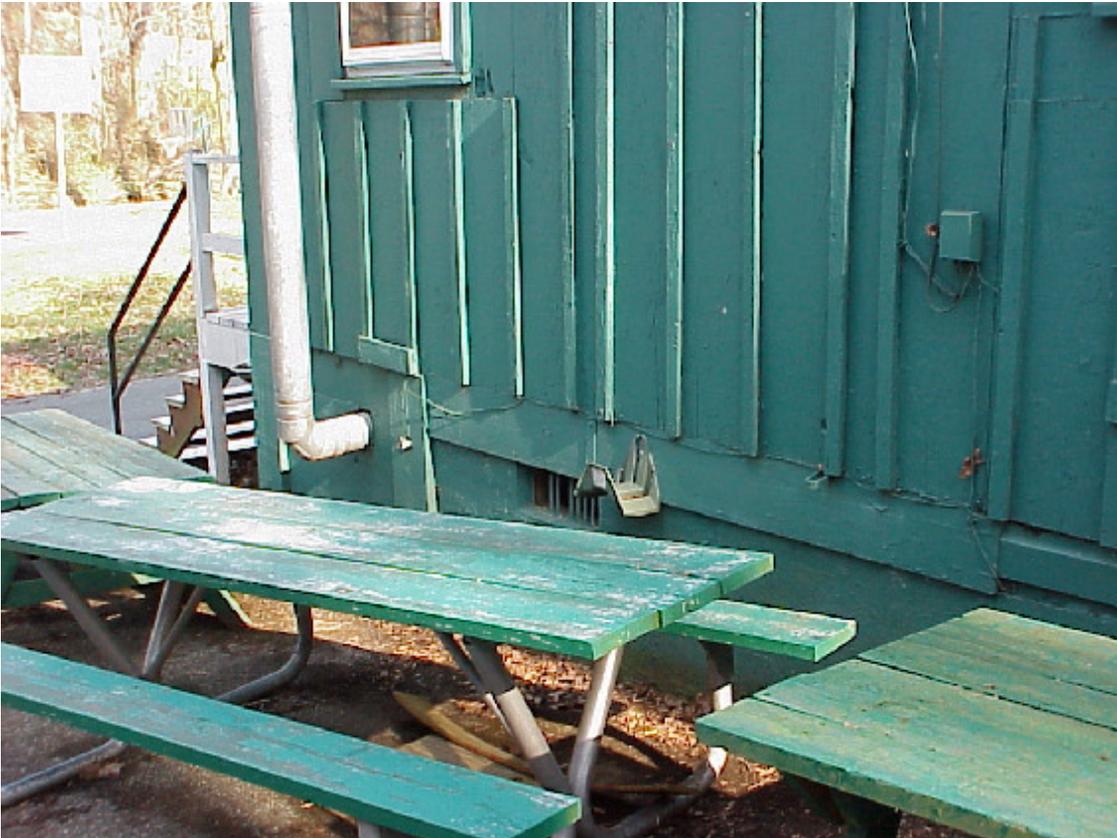
Plate 14: Detail of the foundation of the north elevation.

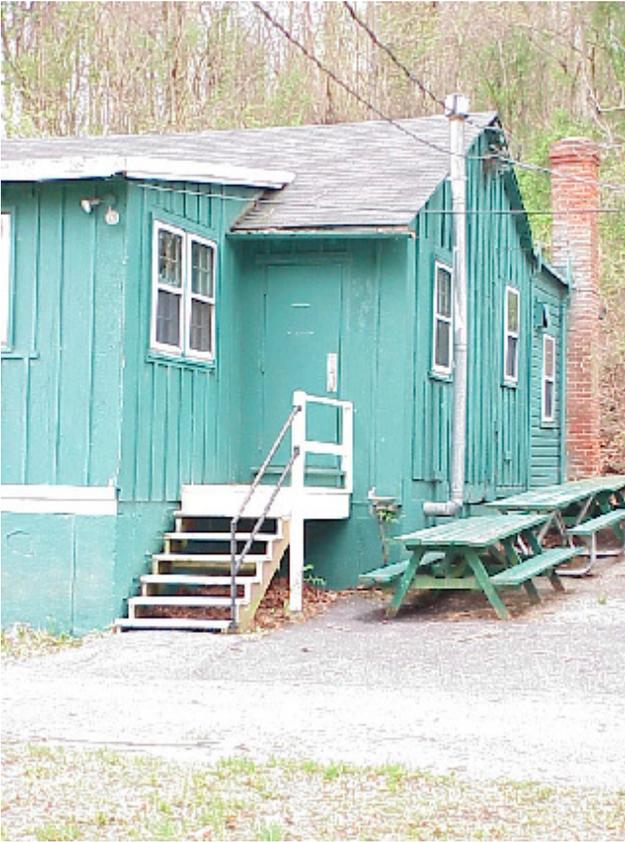
Plate 15: View looking southwest at the north stairs.

- The present steps are replacements. Impressions of earlier stairs are visible in the cement skim coat on the substructure of the east addition.
- The north steps are set in cement. The cement is inscribed "MELA 70".

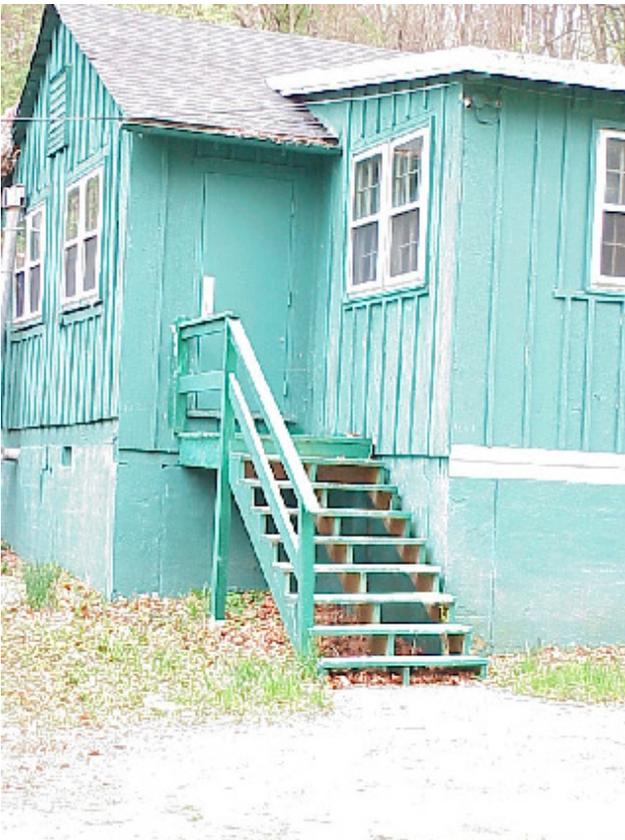
Plate 16: View looking northwest at the south stairs.

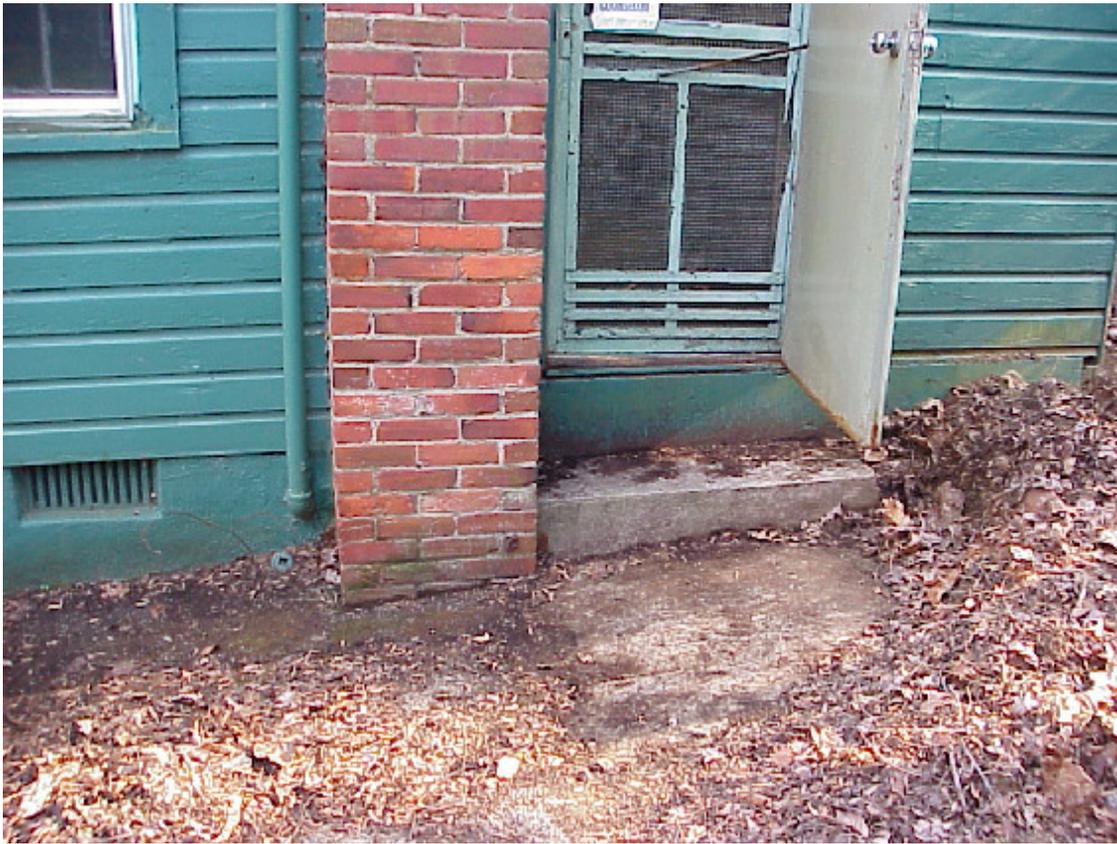
Plate 17: Detail of the step for the kitchen door along the north elevation.

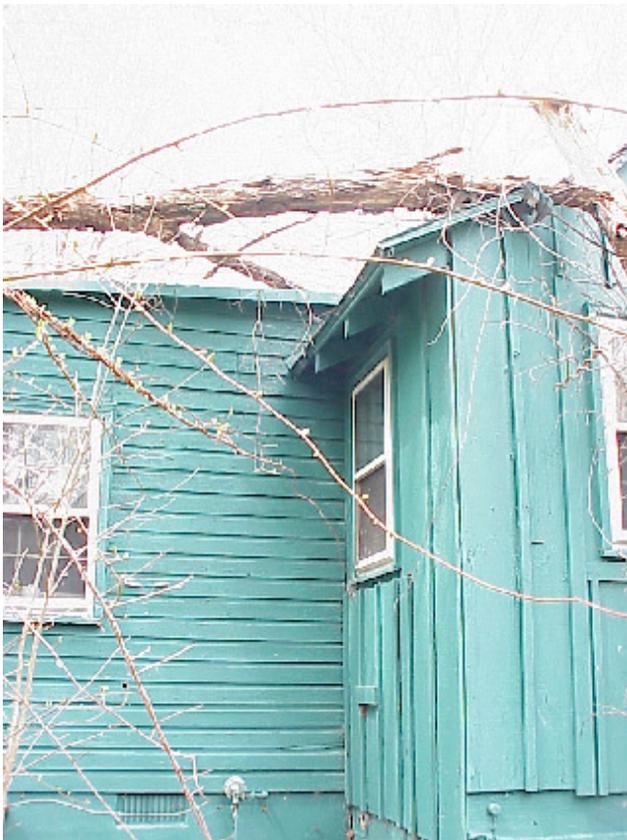
Plate 18: Detail of the junction of the main block and the kitchen addition along the south elevation.

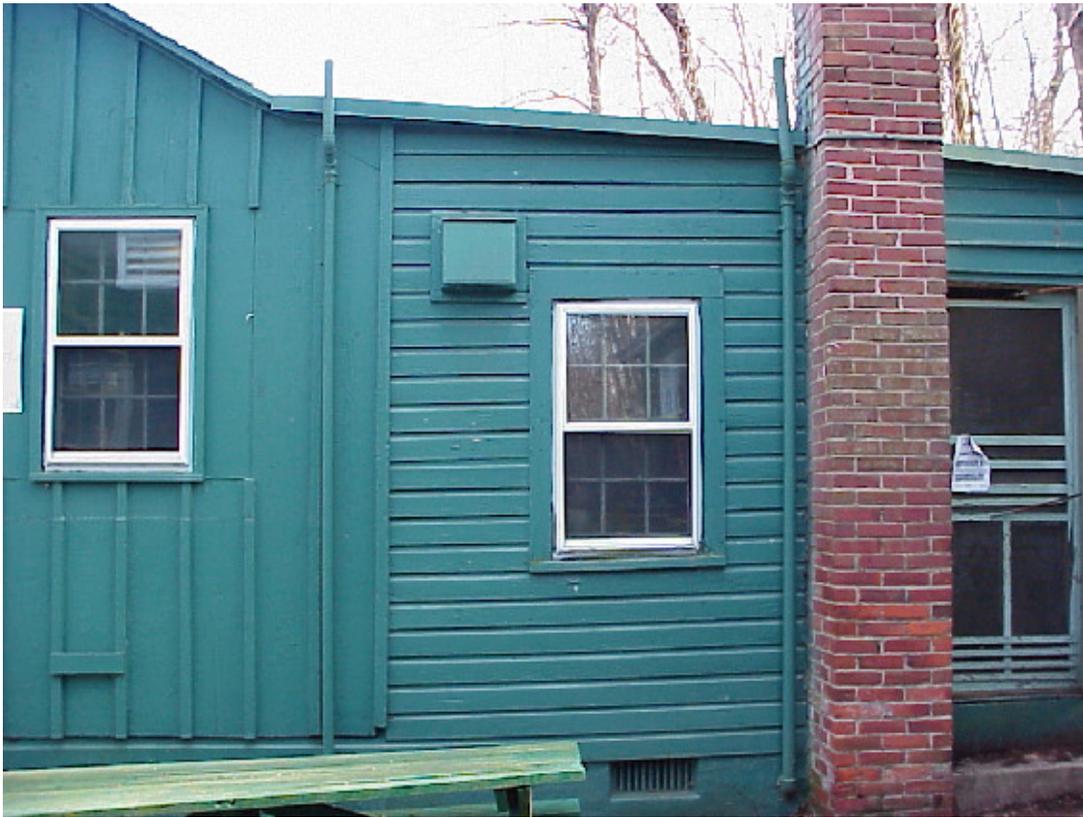
Plate 19: Detail of the junction of the main block and the kitchen addition along the north elevation.

- There is a 2-inch diameter steel vent pipe at the junction of the main block and the kitchen addition.
- There is a 21.5-inch square brick chimney located exteriorly between the window and door in the kitchen addition.
- The chimney is 17.25 feet tall.
- There is a stove vent above and to the left of the kitchen addition window.
- There are two 7.5x15 inch metal grilled vents set in the concrete block foundation. One of the metal grilled vents is located in the foundation of the main block and one of the vents is located in the foundation of the kitchen addition.
- The area between Kitchen/Dining Hall and Arts and Crafts/Bunk House is paved with asphalt.

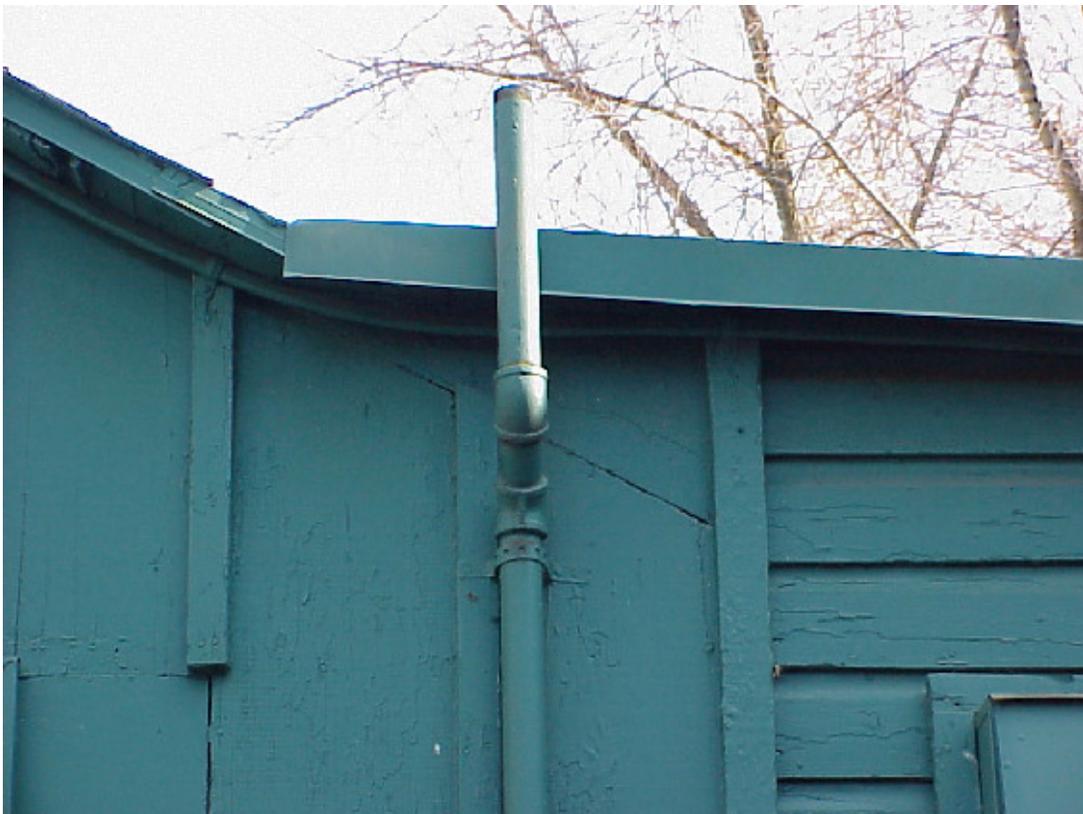
Plate 20: Detail of the junction of the main block and the kitchen addition along the north elevation.

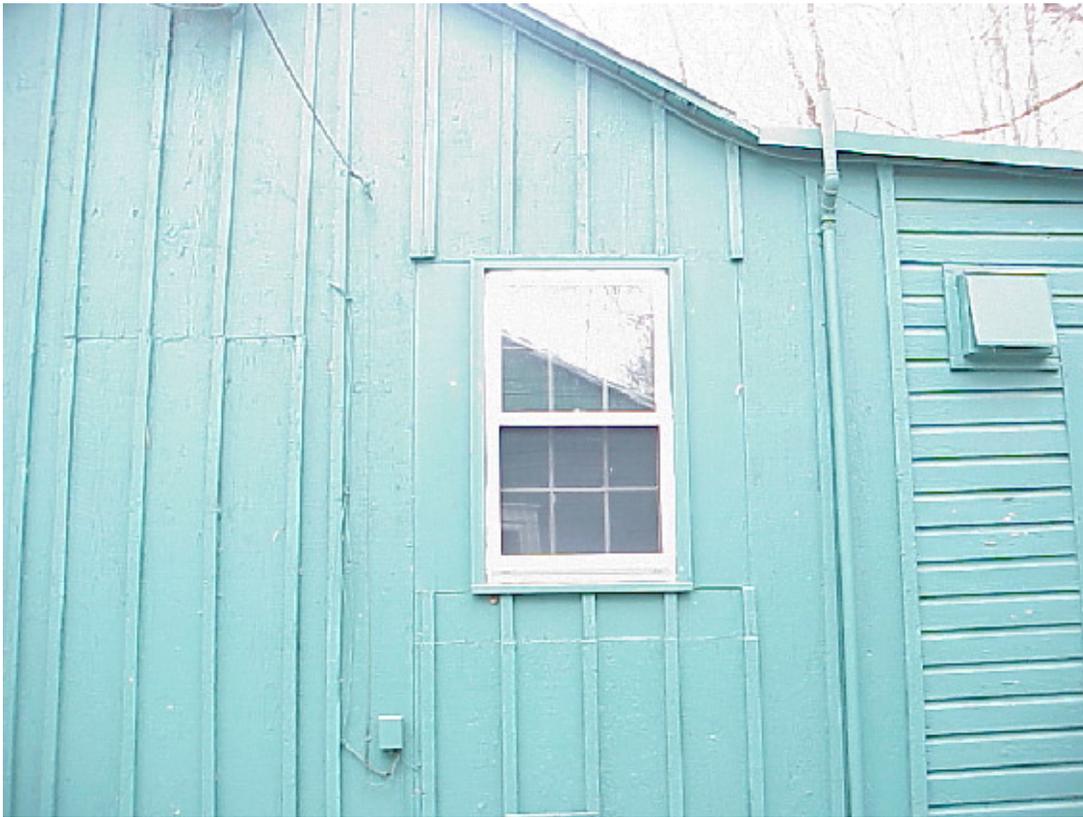
Plate 21: Detail of the window replacement. Note the patch on both sides and below the window.

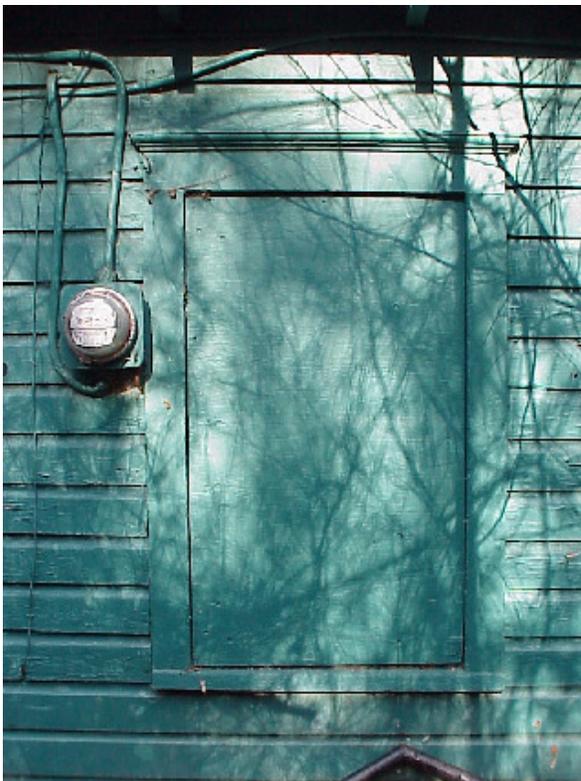
Plate 22: Detail of in-filled window along west elevation. Kitchen cabinets are located along the interior of this wall.

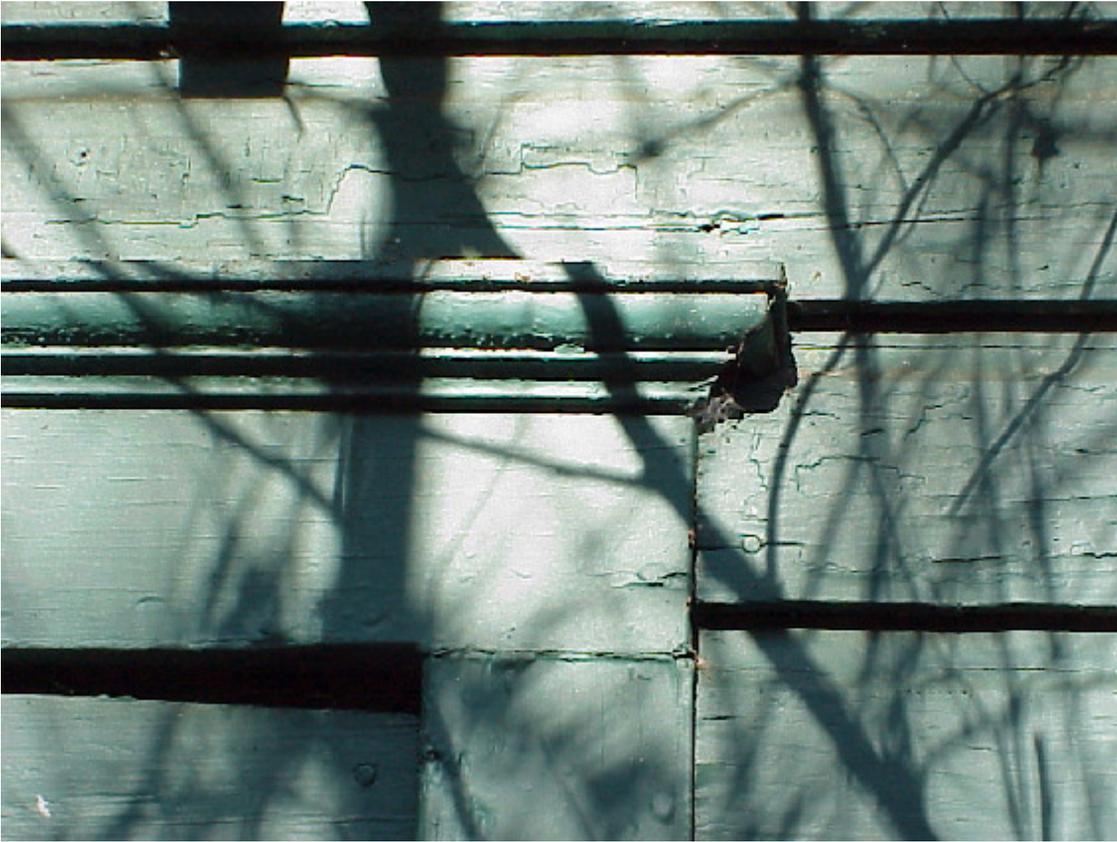
Plate 23: Detail of window cornice.

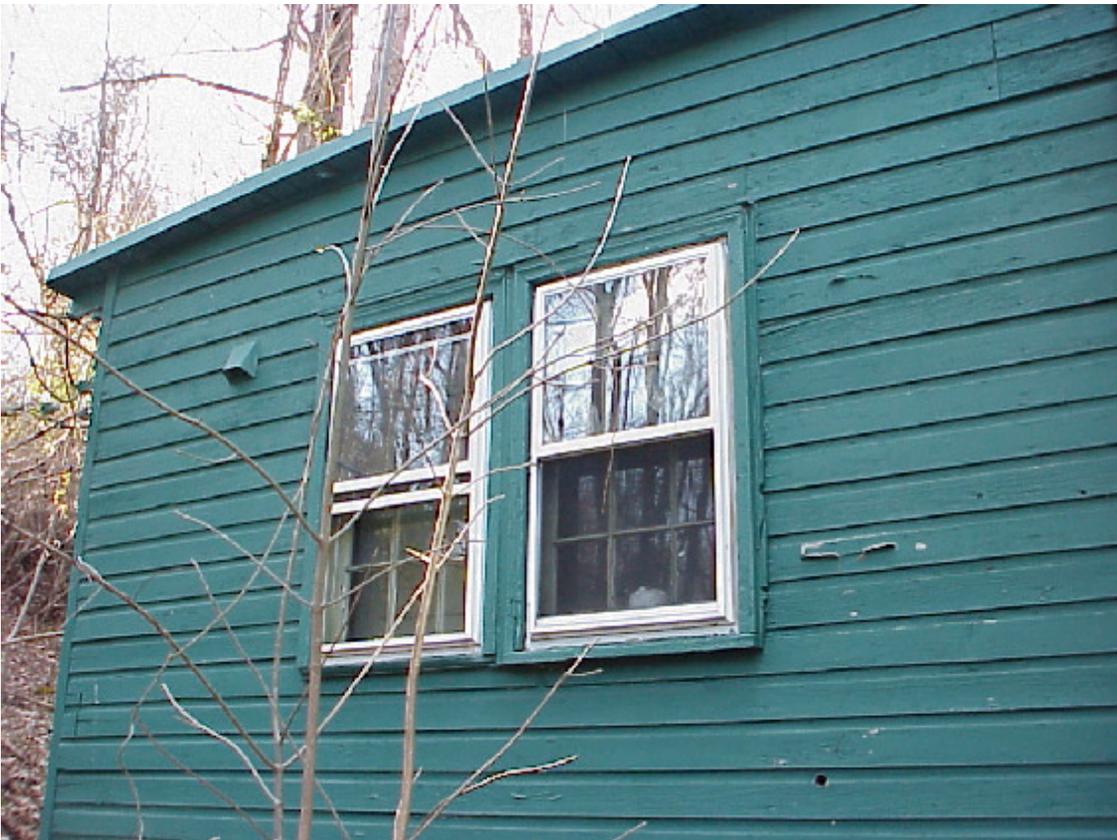
Plate 24: Detail of double window.

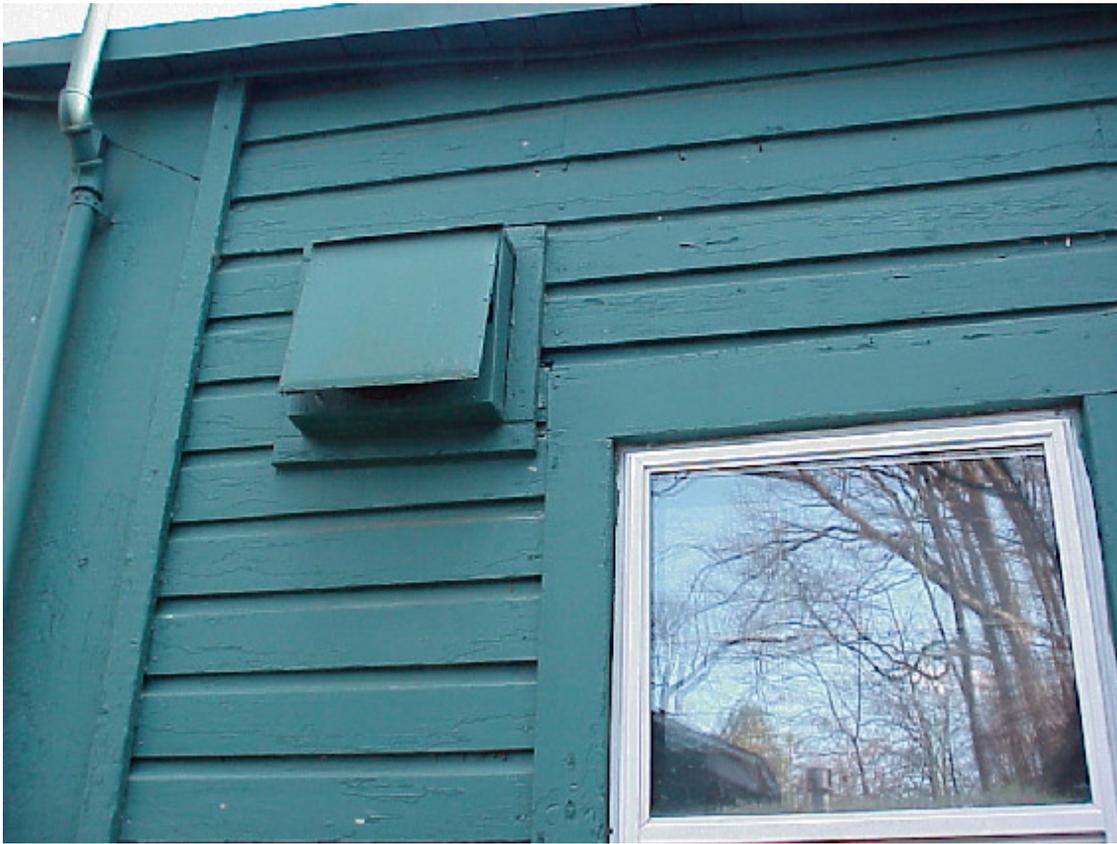
Plate 25: Detail of the exhaust vent for the kitchen.

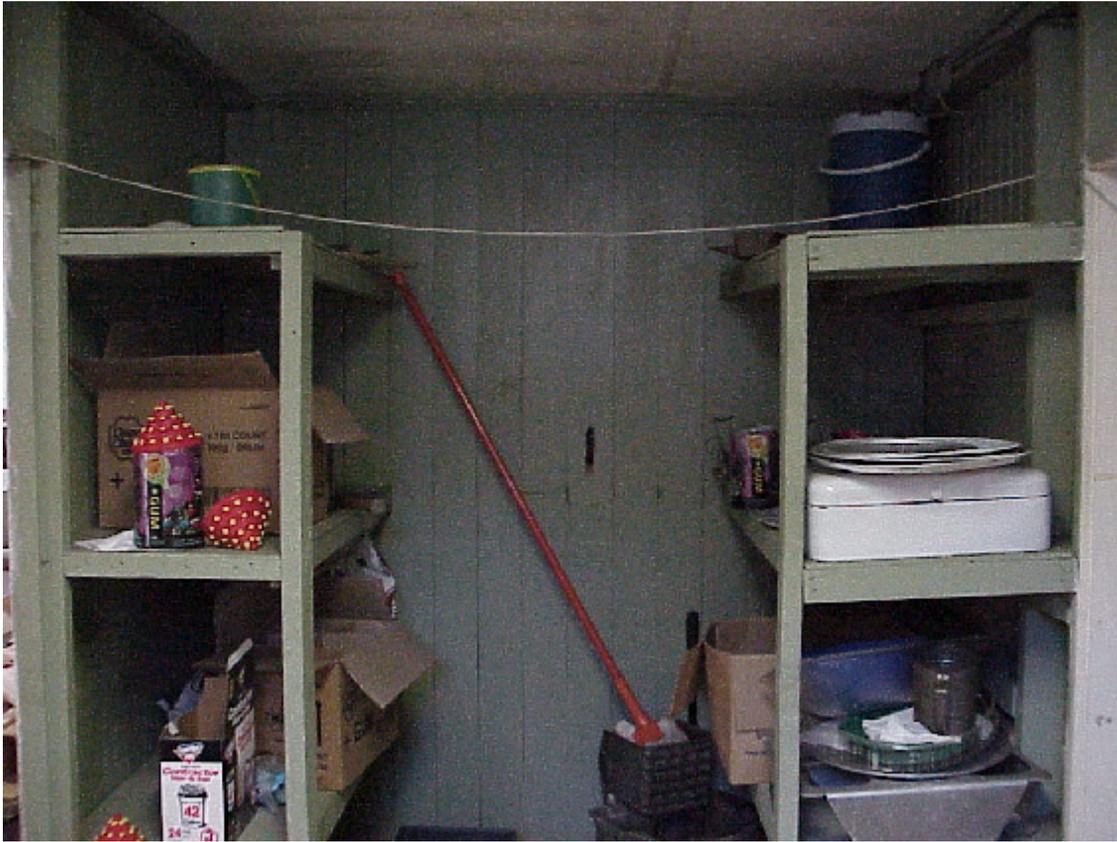
Plate 48: Detail of west wall within Room 5. Note the exposed framing of the walls and ceiling.

- Plate 46: Detail of floor vent and heater within Room 4.
- Plate 47: View looking west at Room 5 (Closet) from Room 4. Note hand made door.
- Plate 48: Detail of west wall within Room 5. Note the exposed framing of the walls and ceiling.

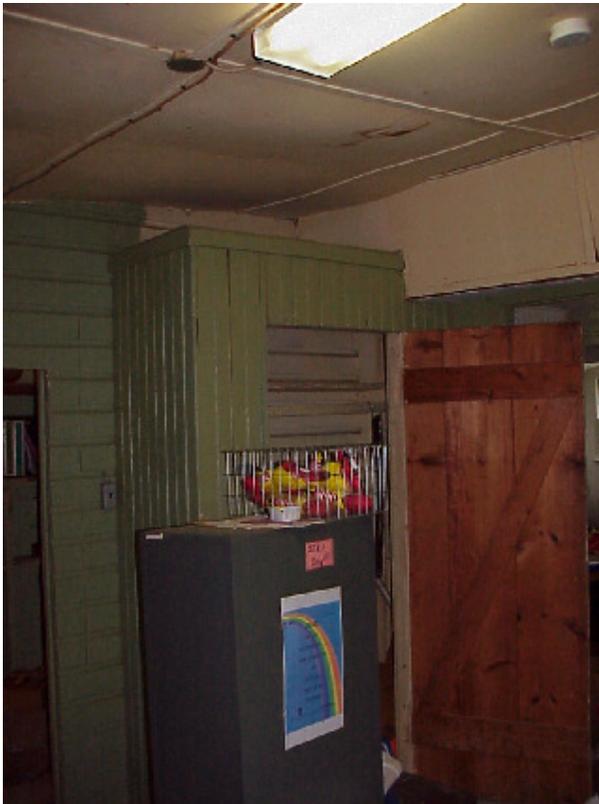
Plate 51: Detail of the exposed framing of Room 6. Note the modification to the width of the doorway, wiring, shelving, and fire suppression system.

- Plate 49: View looking south within Room 6.
- Plate 50: View looking north within Room 6.
- Plate 51: Detail of the exposed framing of Room 6. Note the modification to the width of the doorway, wiring, shelving, and fire suppression system.

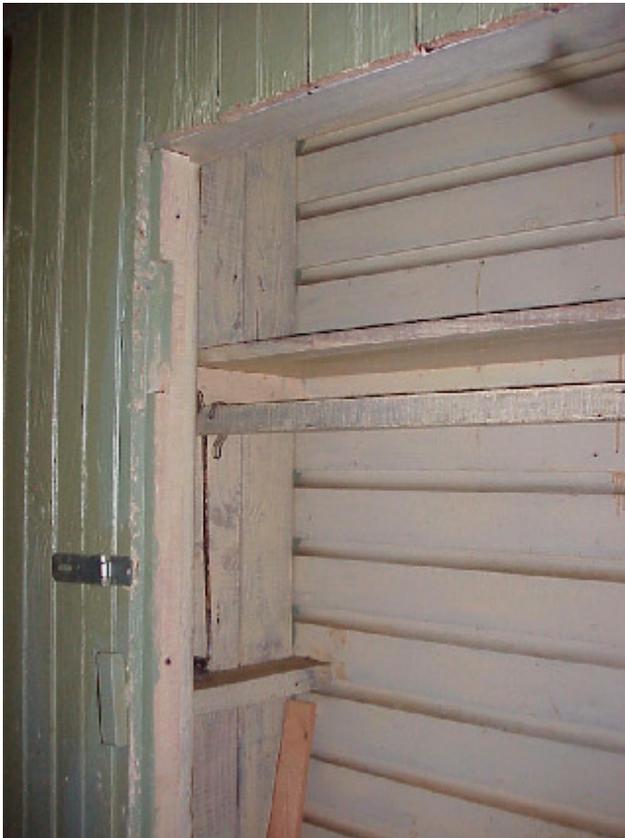
Plate 53: Detail of Room 7 (closet). Note simple drop siding in the back of the closet.

- Plate 52: View looking north at Room 7 (closet) from Room 1. Note that the top of Room 7 does not reach the ceiling in Room 1.
- Plate 53: Detail of Room 7 (closet). Note simple drop siding in the back of the closet.

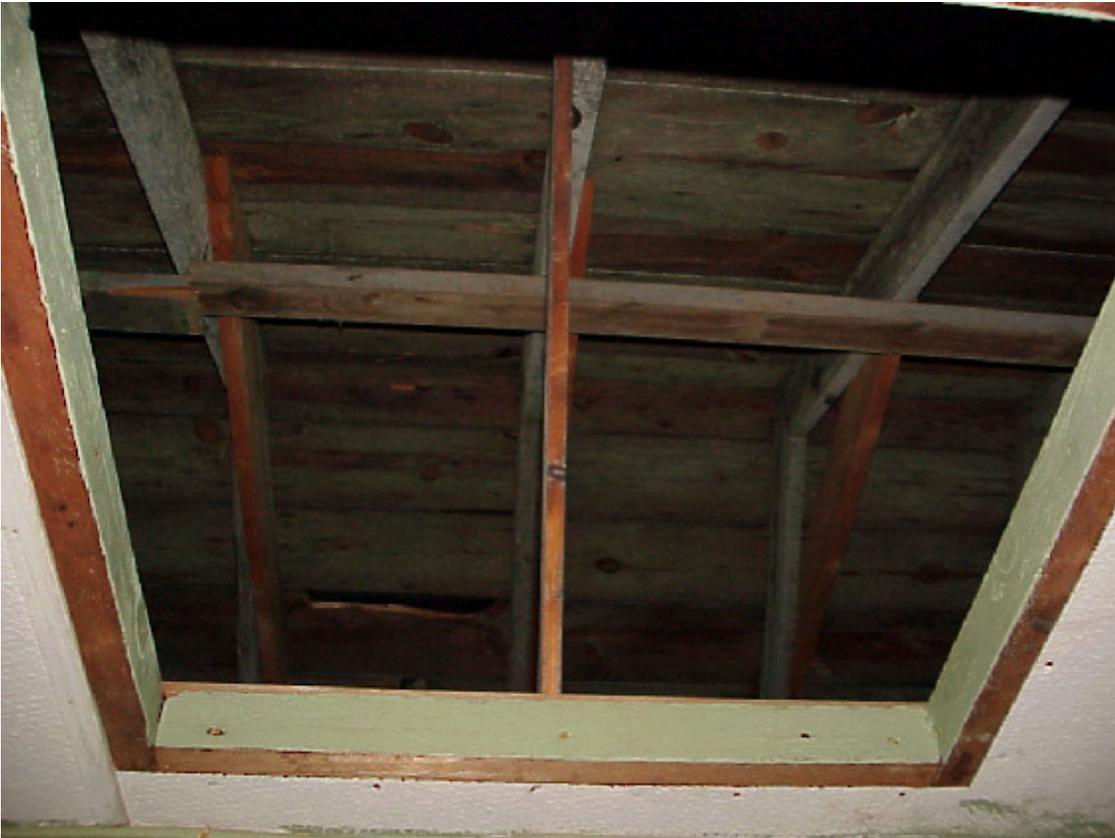
Plate 56: Detail of the roof and joists through an access hatch in Room 6.

- Plate 54: Detail of Room 7 (closet).
- Plate 55: View looking southwest at Room 8 from Room 1.
- Plate 56: Detail of the roof and joists through an access hatch in Room 6.

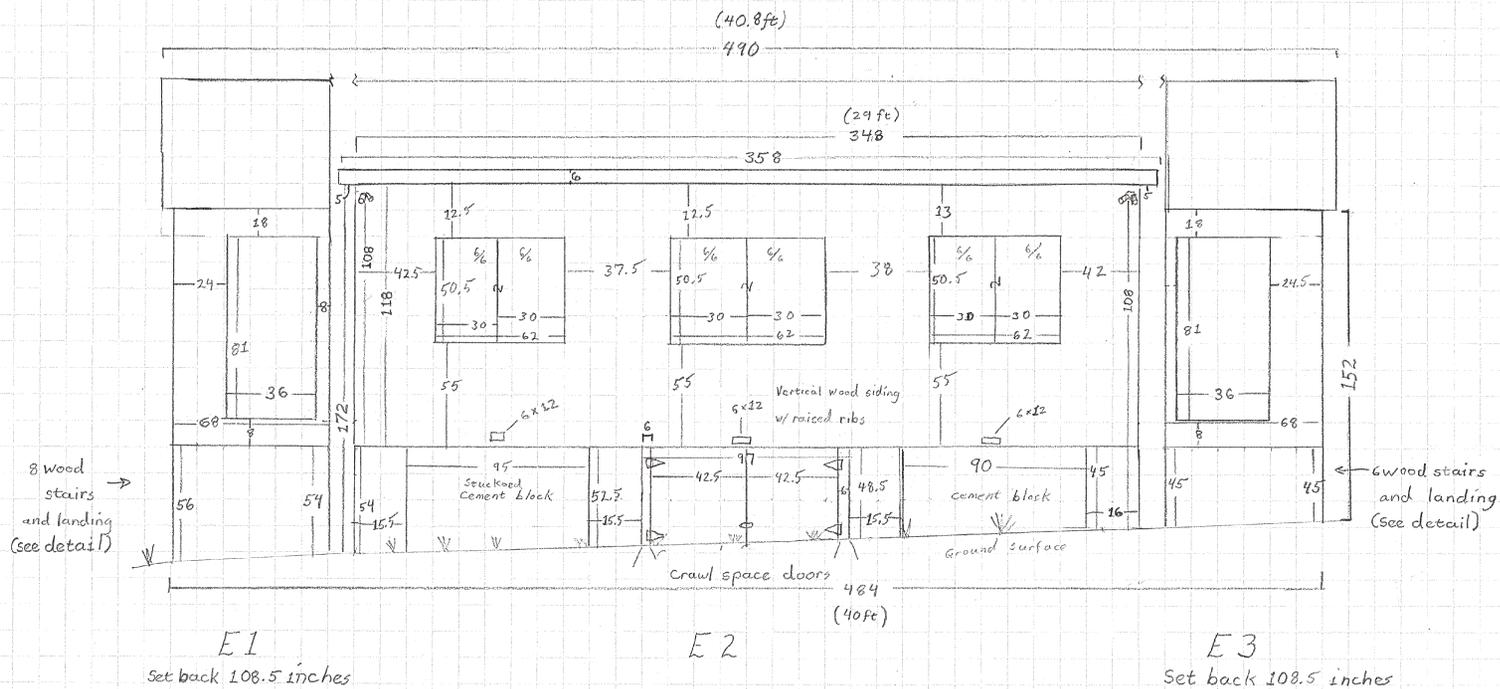
East Elevation

Notes: Crawl space doors are plywood.
 Doors
 All measurements in inches
 Not to scale

Camp Wright (TP 08-025.00-011)
 3850 Mill Creek Road
 Mill Creek Hundred
 New Castle County, DE
 Kitchen/Dining Hall
 Facade (east) - Elevation
 (CRS# N-14422.04)

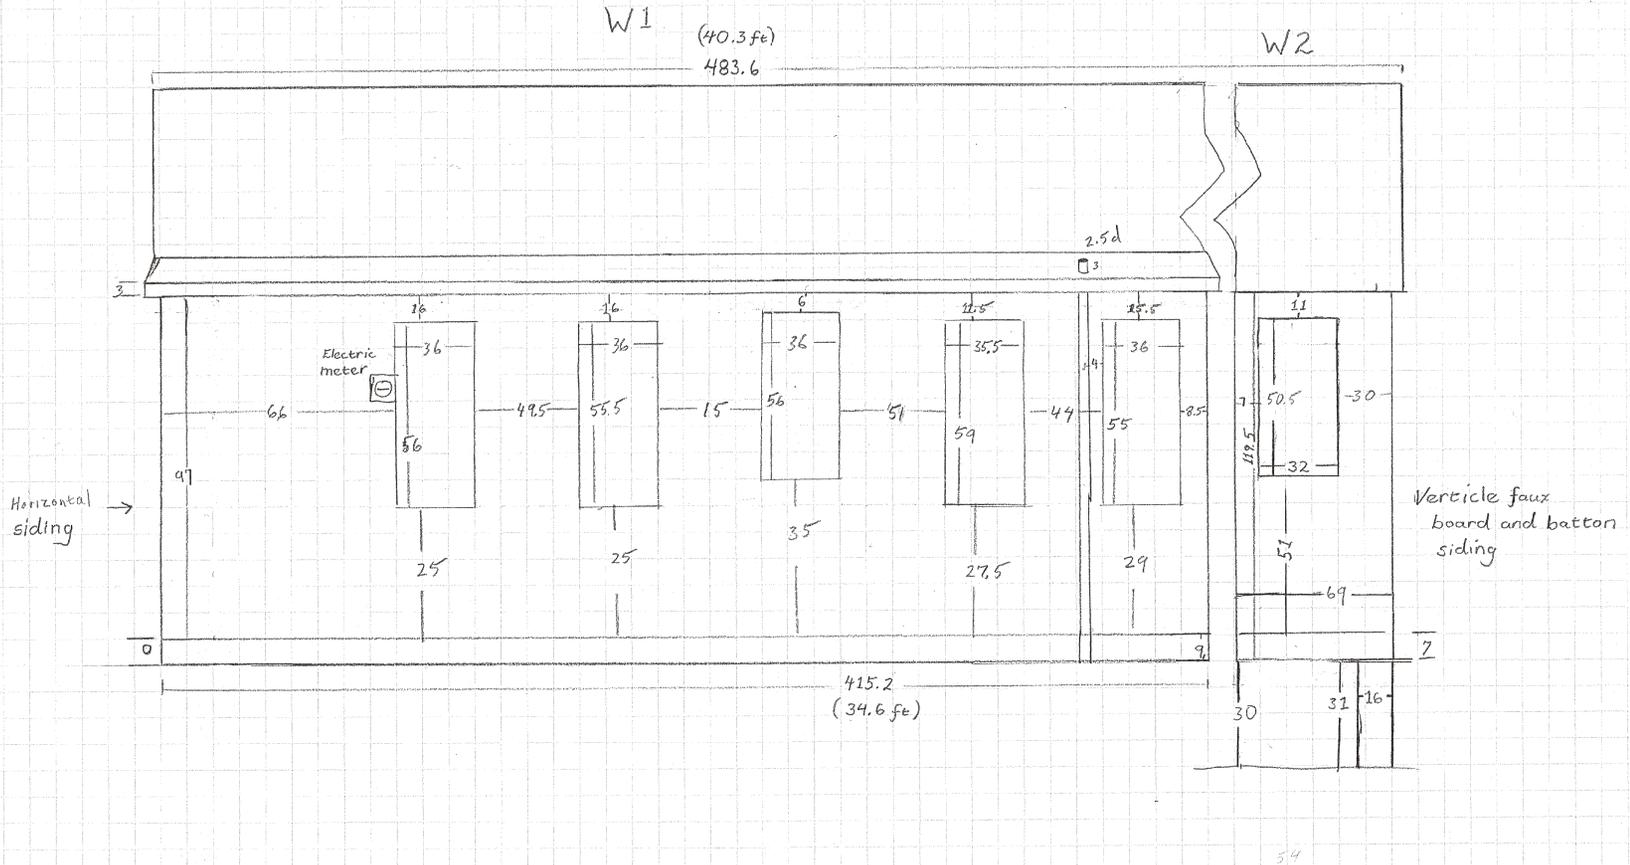
West Elevations

All windows on W1 Boarded up + painted
Not to Scale
All measurements in inches.
W2, Main Block is set back 180 inches

<p>Camp Wright (TP 08-025.00-011) 3850 Mill Creek Road Mill Creek Hundred New Castle County, DE</p>
<p>Kitchen/Dining Hall Rear (west) - Elevation (CRS# N-14422.04)</p>

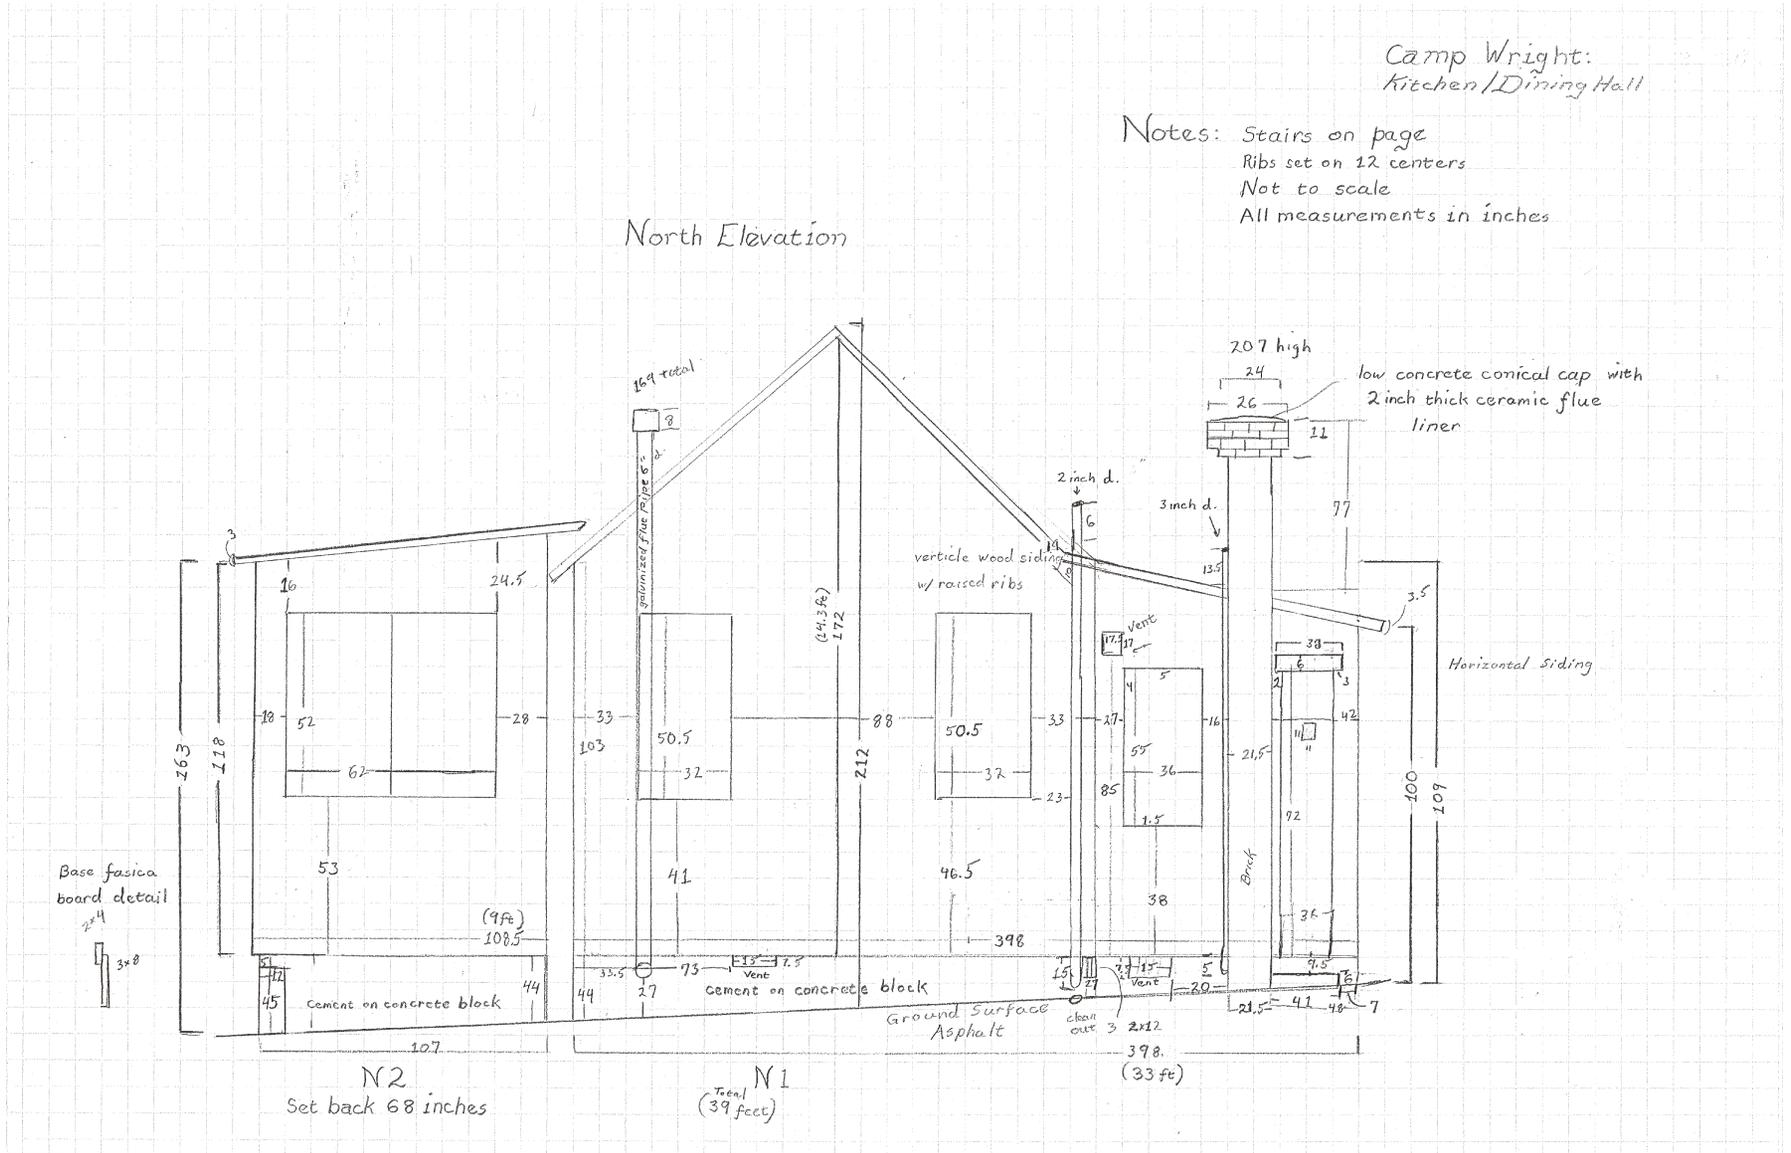
North Elevation

Notes: Stairs on page
Ribs set on 12 centers
Not to scale
All measurements in inches

<p>Camp Wright (TP 08-025.00-011) 3850 Mill Creek Road Mill Creek Hundred New Castle County, DE</p>
<p>Kitchen/Dining Hall Side (north) - Elevation (CRS# N-14422.04)</p>

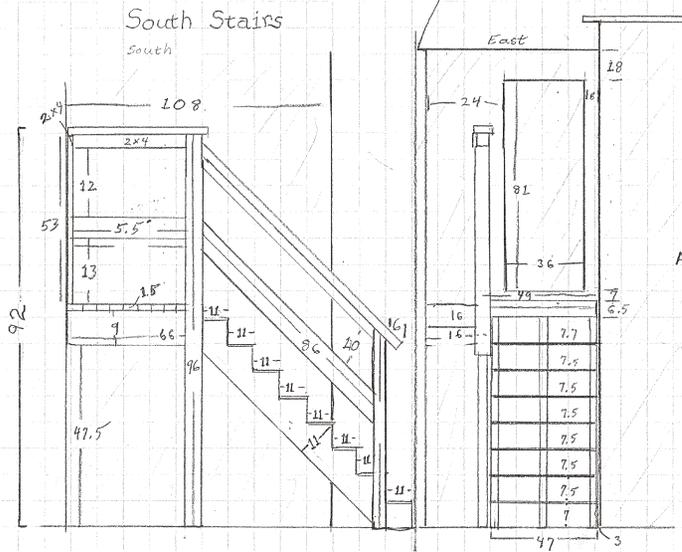
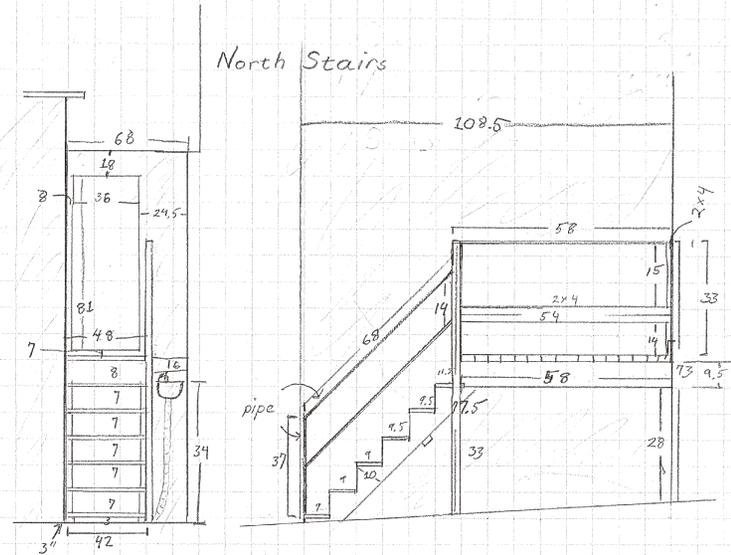
Stair Details

All measurements in inches

Notes: Wood stairs: overall length: 85"
treads: W 11 ; T 1.5 ; L 47 ; # 8
risers: H mostly 7.5
Columns: 4 x 4
Hand rail: 2 x 4
Stretcher: 2 x 6
Hunter green

Landing: overall L 58.5 ; W 49 ; T 1.5
planks: 1.5 x 5.5
support: 1.5 x 9 (2x10)
