*5.0 DESCRIPTION OF  
ARCHITECTURAL RESOURCES*

### 5.1 Wix/Robbins Property (CRS #K-6740 )

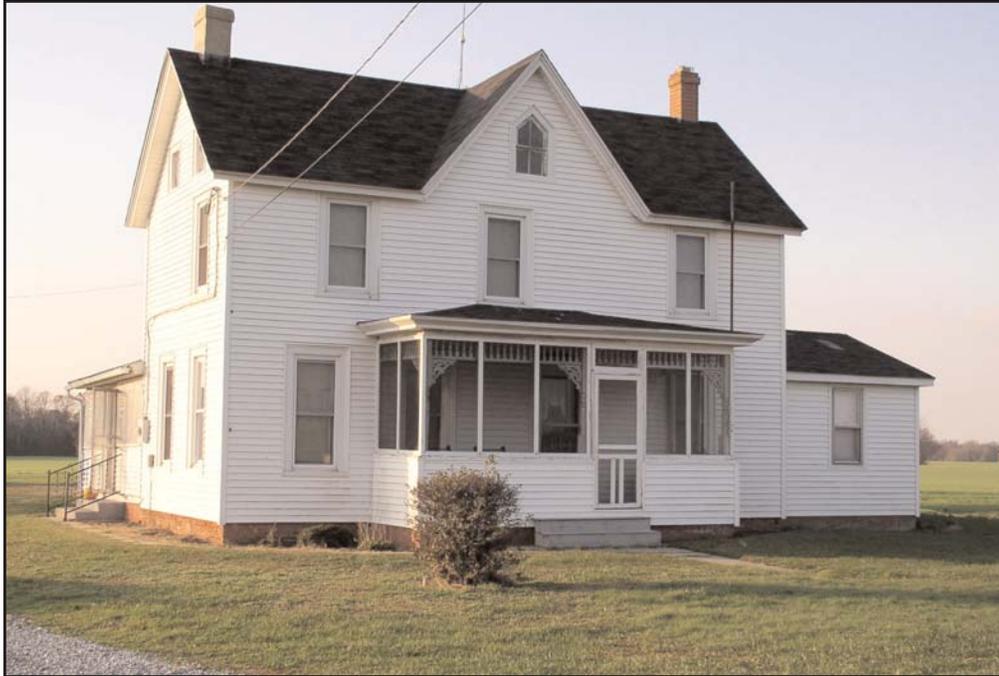
**Photograph 3:** Wix/Robbins Property. Façade, view to west (April 2004).

*Dwelling.* The dwelling is a two-and-one-half-story wood frame vernacular dwelling with a gable ell roof form (Photographs 3, 4 and 6). It rests upon a brick foundation. The entire exterior of the dwelling is clad in vinyl siding. Window openings in the dwelling contain replacement, vinyl, one-over-one, double-hung sash windows and wood four-light casement windows (in the half story). A gable wall dormer is centered in the façade, forming a small cross gable with the main roof. The roof is covered with asphalt shingles. A small brick chimney protrudes from the north interior gable end, and parged chimneys protrude from the south and east interior gable ends. Enclosed porch additions are attached to the façade (east elevation), south elevation, and north elevation. Small, single-story additions are also attached to the north and west elevations.

The façade (east elevation) of the dwelling consists of four bays, including one entrance and three window openings in the first story, and three window openings in the second story. The entrance is located in the second bay from the north end of the wall, and contains a single-leaf door. The window openings contain single windows. The window openings in the second story are not vertically aligned with those in the first story. An additional window opening is centered in the gable wall dormer. A single-story, wood frame, screened-in porch with a hipped roof obscures the first story of the façade. Two concrete steps allow access to the porch entrance, which has a screen door. The dwelling's original open wood porch, with turned posts, scroll-sawn brackets, and spindles, is intact and visible within the screened-in porch.

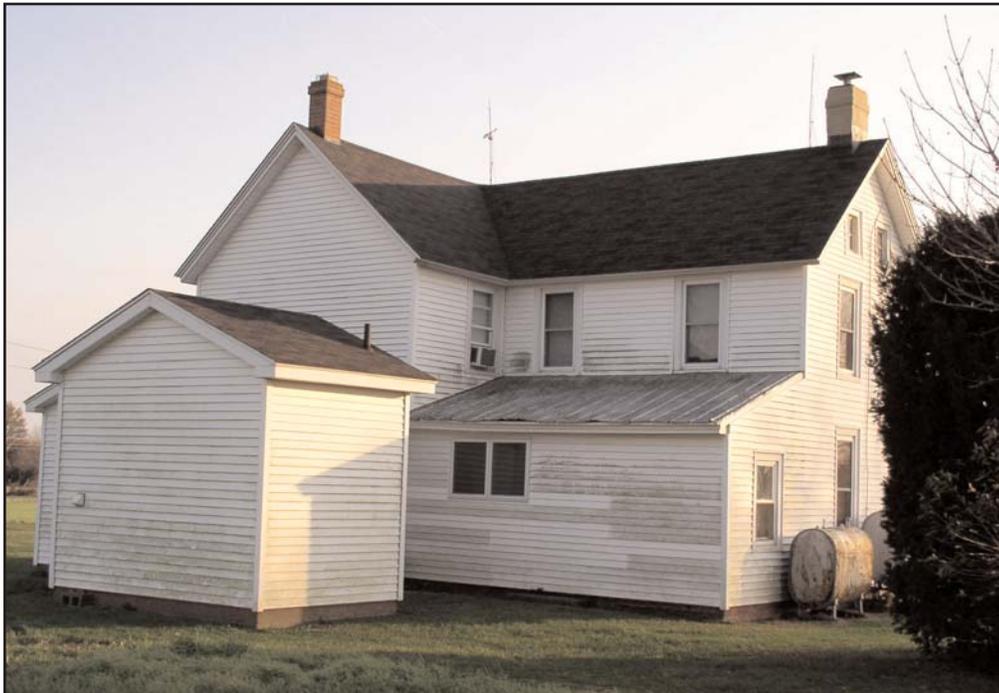
**Photograph 4:** Wix/Robbins Property - overview of side and rear of house; small wing in foreground is attached to main building. View to the southeast (April 2004).

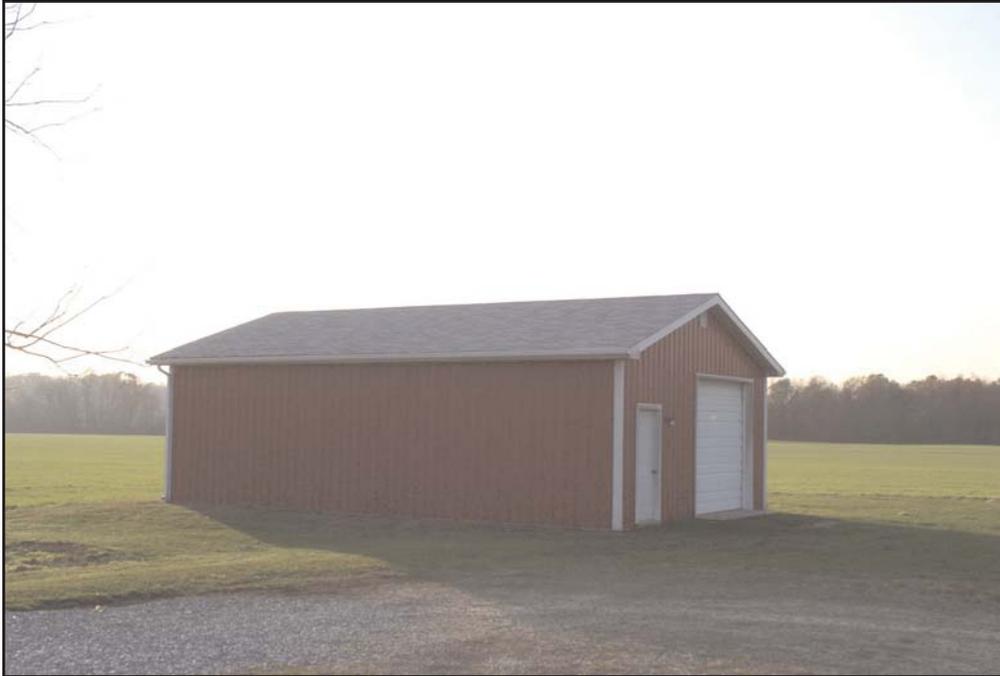
**Photograph 5:** Garage/shed at Wix/Robbins Property, view to the southwest (April 2004).

Garage/Shed. A single-story, modern garage/shed is located southwest of the dwelling (Photograph 5). The building is one story tall and is clad with vinyl siding. There are two bays in the façade (north elevation), including a pedestrian entrance and a garage opening.

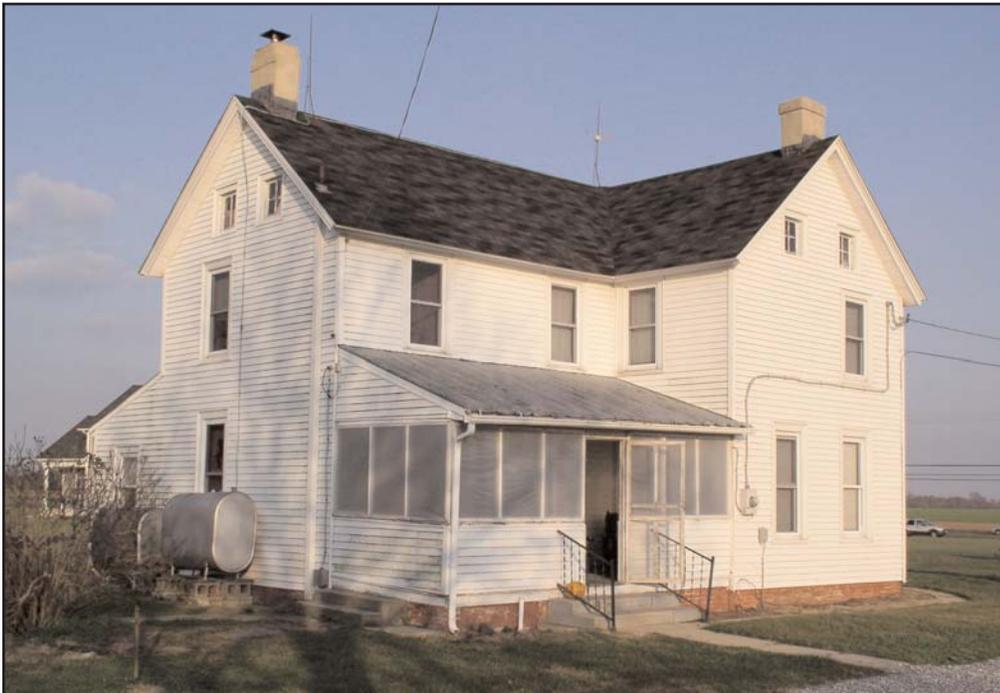
**Photograph 6:** Wix/Robbins Property showing side and rear of house, view to the northwest (April 2004).

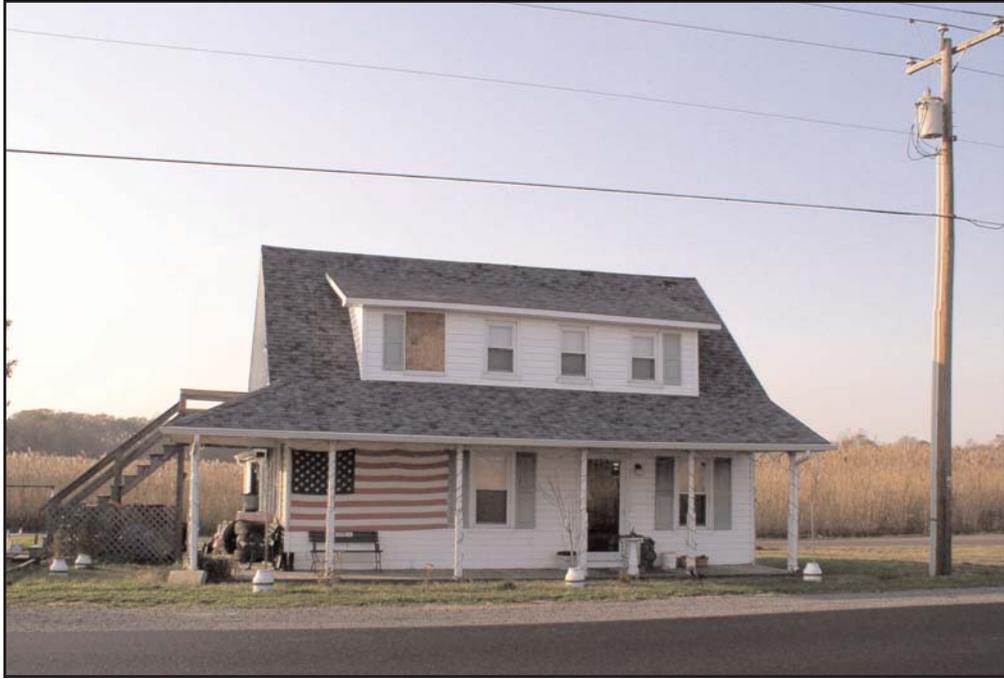
**Photograph 7:** Langrell Property, overview of façade, view to west (April 2004).

*Dwelling:* The dwelling is a one-and-one-half-story, light frame, vernacular building with a cross gable roof (Photographs 7 and 8). The rear ell that forms the cross gable appears to be a late-twentieth-century addition. The building rests on a concrete foundation. Its exterior walls are clad with vinyl siding. Window openings throughout the dwelling contain single and paired replacement, vinyl, one-over-one, double-hung sash windows. The roof is covered with asphalt

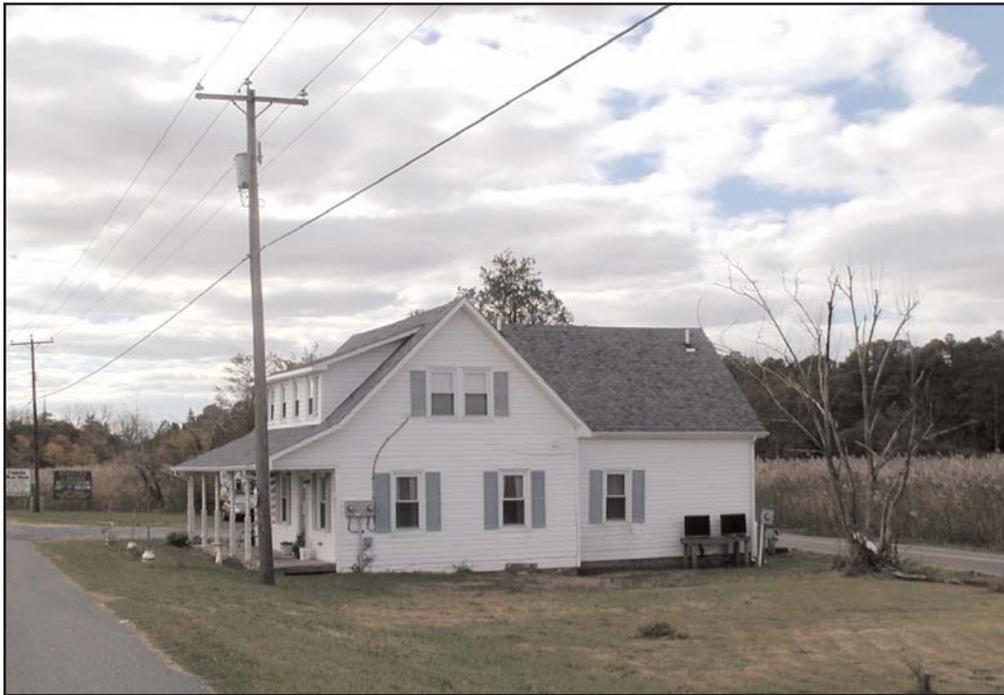
**Photograph 8:** Langrell Property, overview of north elevation, view to south (April 2004).

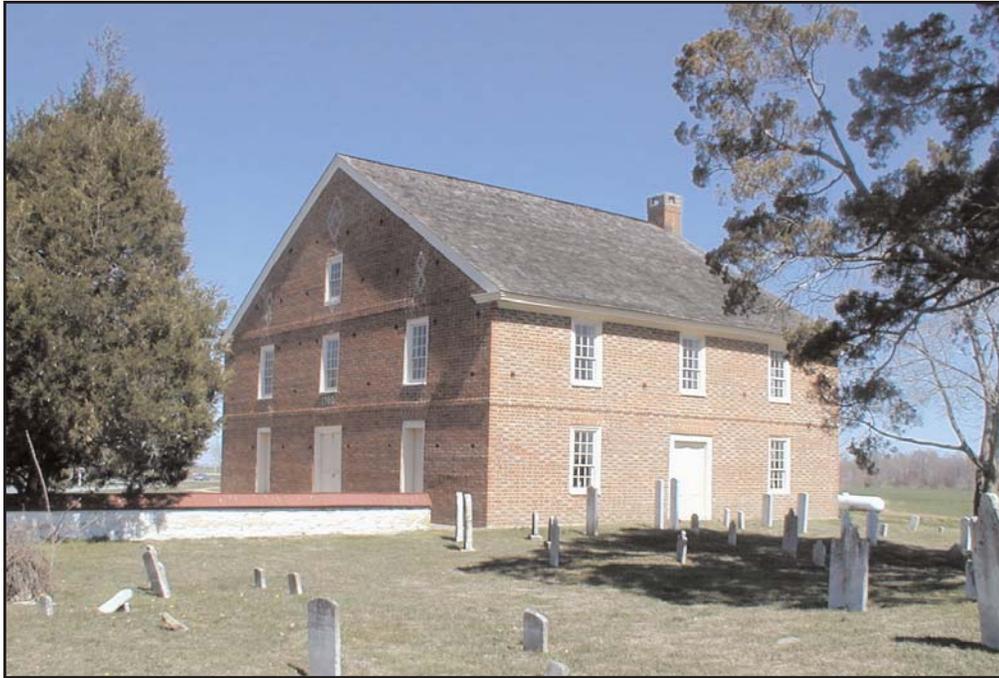
**Photograph 9:** Barratt's Chapel, view to northeast, showing west and south elevations (April 2004).

General Description. Barratt's Chapel lies on a large, triangular piece of land abutting the east side of SR 1 (Photograph 9). Although there have been recent land acquisition(s) to the Barratt's Chapel property, the main, historically older, parcel which contains the standing buildings and most of the cemetery is approximately triangular in shape and comprises 24.6 acres. The complex of buildings at this site is at the northwestern corner of the property, near SR 1, and it now includes a small parking lot and several paved driveways. The cemetery however, occupies most of the large expanse of land at this site (Photographs 10 and 11), and the cemetery has been expanding to the east. The cemetery features a variety of headstones, ranging from simple flat (vertical) stone slabs to obelisks and other, larger features and structures, including at least one mausoleum and an (elevated) tomb. There are also a variety of markers, including tall granite shafts. The cemetery grounds feature low-cut grass and several walkways. Trees are sparse, and a brick wall encloses part of the cemetery (Photograph 11). Although the brick wall is not actually a part of the chapel, it abuts the building at two ends. Similar to other Delaware churches of this period, Barratt's Chapel has a central-entry meetinghouse form. These other examples of late-eighteenth-century brick churches in Delaware include Old Drawyer's Presbyterian church (ca. 1773) near Odessa, and St. Anne's church (ca. 1765) near Middletown

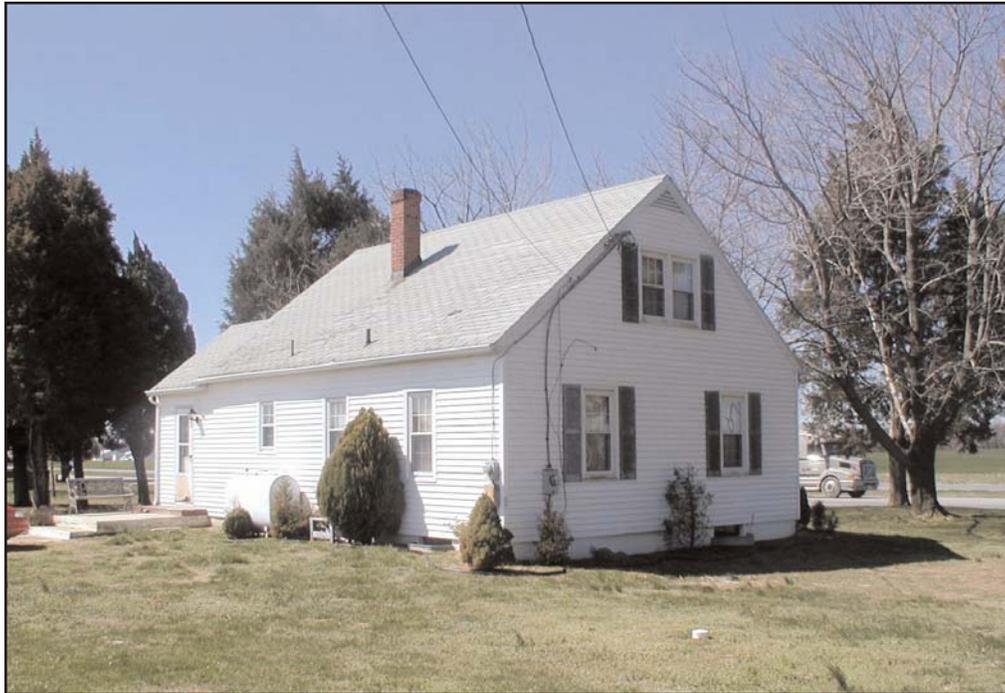
**Photograph 12:** Caretaker's house, view to southwest, showing SR 1 in background (April 2004).

*Description of Caretaker's House (CRS # K-103.001).* The caretaker's house (ca. 1941) for Barratt's Chapel is located on the front of the Barratt's Chapel lot immediately along SR 1 (Photographs 12 and 13). The one-and-one-half-story, three-bay Cape Cod/Colonial Revival dwelling is located southeast of the chapel and is surrounded by yard space and mature trees. Overall, the property is in good condition.

The main block of the house has a contemporary one-story addition to the north elevation that is set back from the facade. The walls of the dwelling and addition are clad in vinyl siding and rest on a concrete block foundation. The façade (west elevation) features a central entrance, which is sheltered by a gable front portico and accessed via concrete stairs. Eight-over-eight, double-hung wooden sash windows flank the door. Gable front dormers are located above the window openings in the façade. Six-over-six, double-hung sash wooden windows provide light in through the dormers. Like the windows of the façade and most of the windows in the gable ends, vinyl shutters flank the dormer windows. The roofs of the dwelling and the two gable front dormers are clad in asphalt shingles.

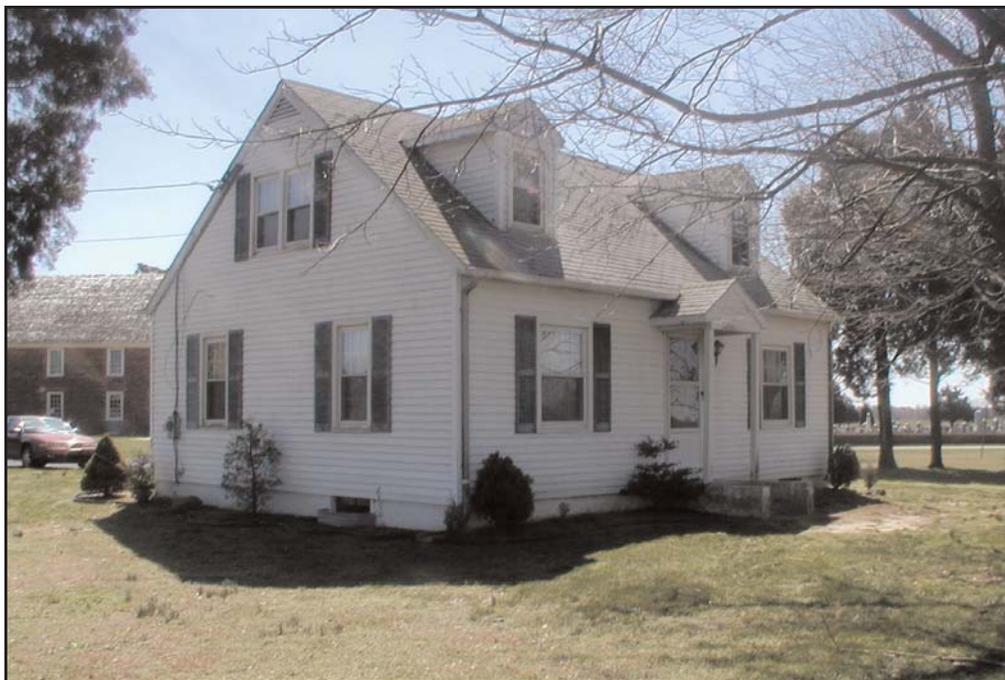
**Photograph 13:** Caretaker's house, view to southeast with chapel and cemetery in background (April 2004).

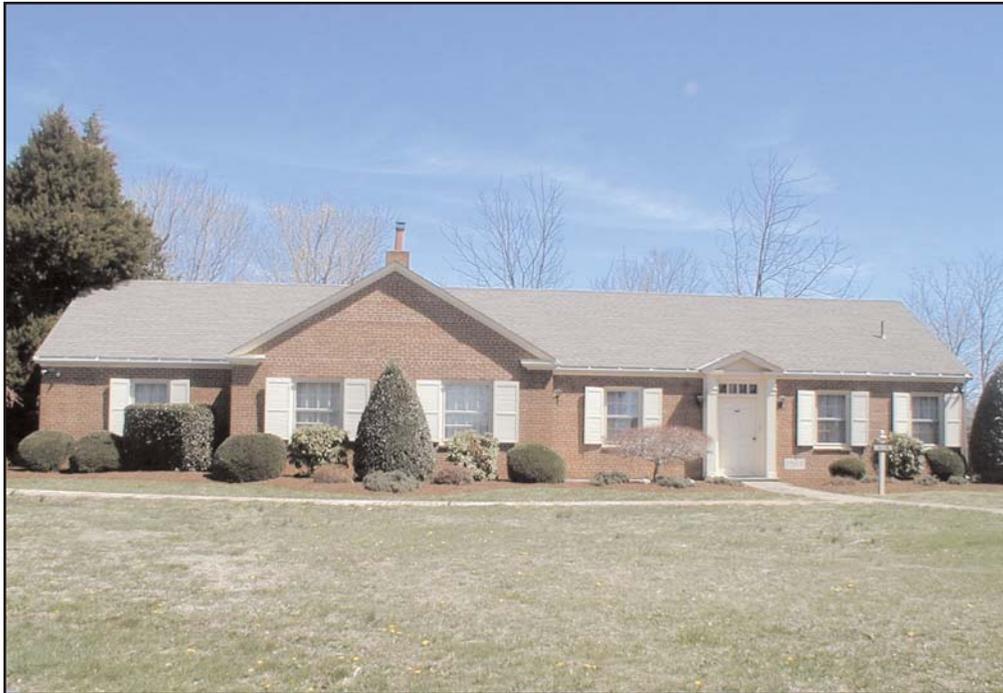
**Photograph 14:** Museum, showing façade (west elevation), looking east/southeast (April 2004).

*Description of Museum (CRS # K-103.002).* The museum is a one-story brick building resembling a Ranch-style house (ca. 1963-1965; Photograph 14). The primary gable is oriented away from the road (side gable), and there is a shallow ell extending from the northeast corner of the building. The façade is pierced by a cross gable that has two eight-over-eight, double-hung sash windows. The remainder of this elevation features a total of four six-over-six, double-hung sash windows. There is an off-center door on the façade, toward the south end, that features pilaster surrounds capped by a broken pediment. This door also features a transom panel with four lights. There are no windows on the north elevation, and there are two on the south elevation. There are two exterior doors on the rear of the building: the one on the east wall features 12-light glazing and the door on the ell is a solid, single-leaf, paneled door.

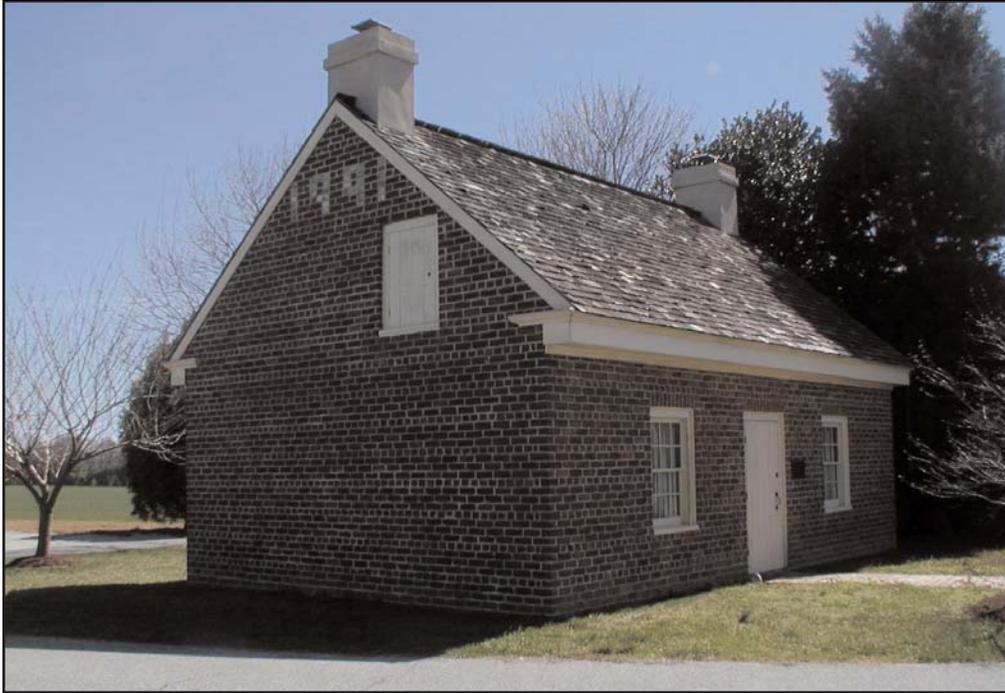
**Photograph 15:** Vestry, showing north and west elevations; view to southeast (April 2004).

Description of Vestry (CRS No. K-103.003). The vestry is a one-story brick building that was constructed in 1991 to resemble an eighteenth-century-style vestry (Photograph 15). The vestry is sited just north of the Barratt's Chapel Museum, and there is a paved walkway on the west side of the building that leads to one of the entrances. This rather diminutive building has stuccoed, interior brick chimneys at each gable end, and the building is generally oriented with its gable roof running north-south. There are wood box cornices with returns, and the building's roof is protected with wood shingles.

On the north end gable wall, just beneath the chimney, light-colored glazed bricks bear the lettering "1991" to indicate the year when the building was constructed. Just below and to the west of the "1991" is a small wooden door that is very similar to the vertical beaded-style door on the west and east elevations. The door apparently allows access to the roof crawl space from the outside. The south gable wall was masked by trees and was not visible for inspection.

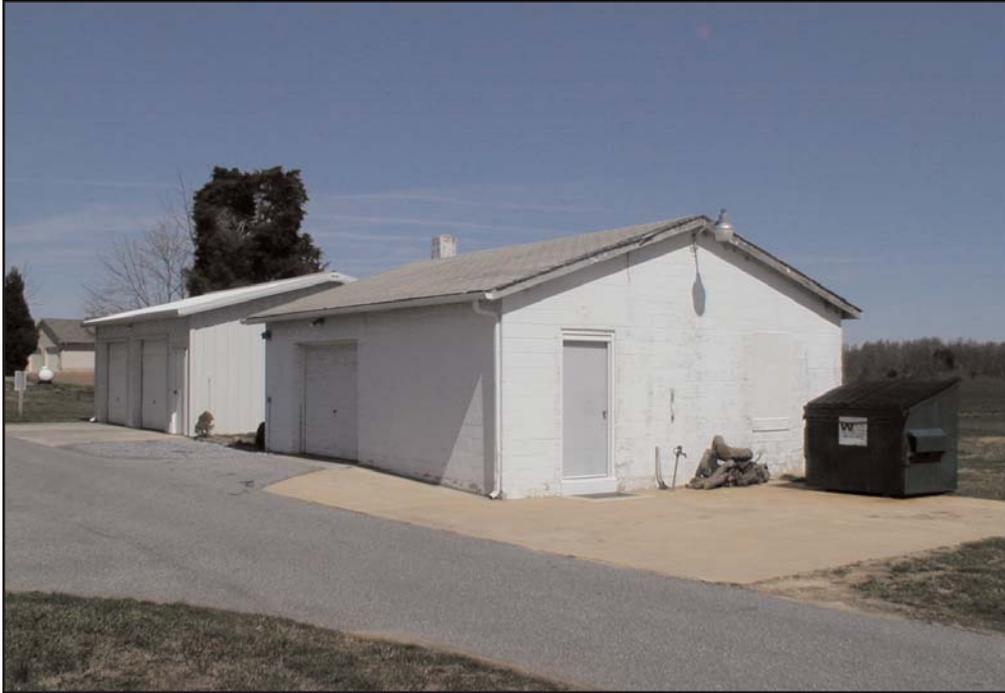
**Photograph 16:** Sheds located to southeast of Barrett's Chapel, view to north (April 2004).

*Description of Modern Garages/Sheds – (CRS # K-103.004 and K-103.005).* There are two modern garages/sheds on the Barratt's Chapel property (Photograph 16). They both stand side-by-side, each with gently pitched gable roofs. The garages/sheds rest on, and are surrounded by, concrete pads. No. K-103.005 is an aluminum shed with two overhead garage doors and a small pedestrian door on the west elevation. No. K-103.006 is constructed with concrete blocks, and it has an overhead garage door on the west wall and a pedestrian door on the south wall. Adjacent to the pedestrian door is the ghost of a filled-in window, and there are also ghosts of filled-in windows on the east wall. There is a small, stuccoed chimney on the north gable end of this building.
