4.0 RESULTS

DELAWARE DEPARTMENT OF TRANSPORTATION

S.R. 54 IMPROVEMENTS
SOUND CHURCH ROAD TO KEENWICK ROAD
BALTIMORE HUNDRED
SUSSEX COUNTY

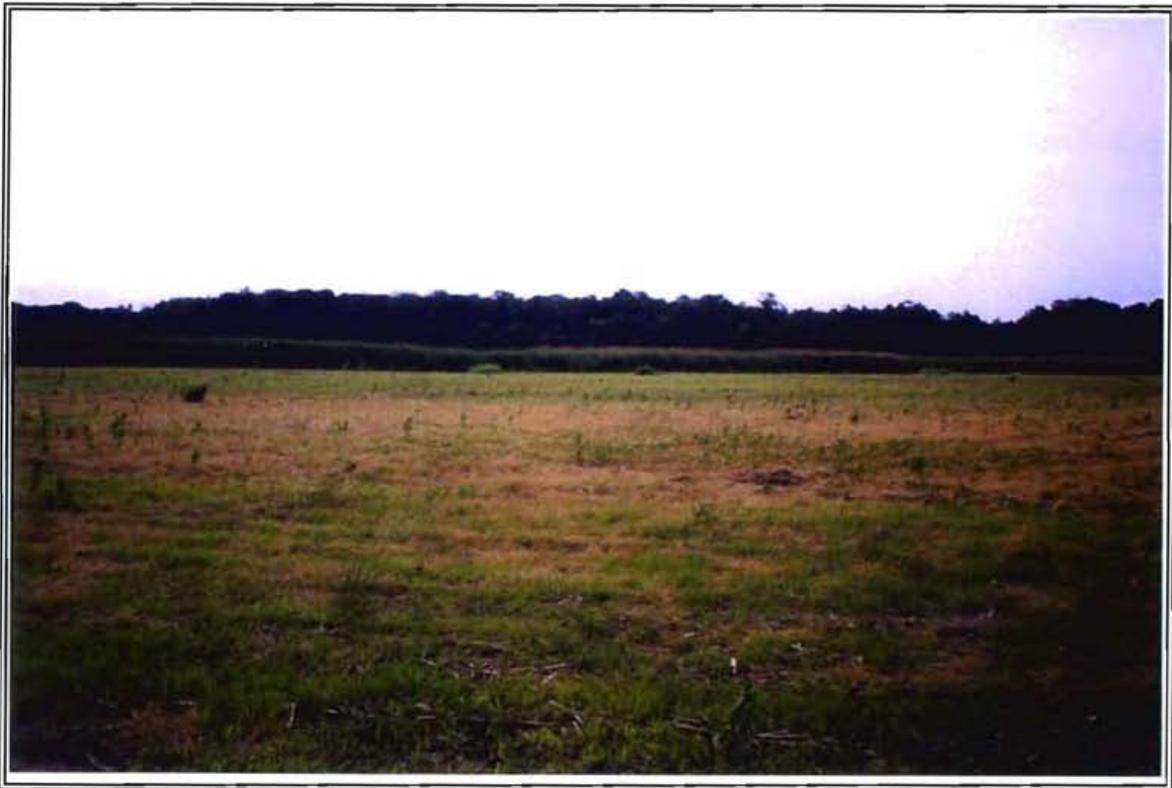
Photograph 2. Stormwater Management Area #2, facing southwest.

This stormwater management area was tested for the possible presence of archaeological resources (Photograph 2). The soils are typical of upland coastal plain sediments, with variations in the degree of internal drainage of the soil profile. Soil drainage is directly dependent on the landscape position, with the poorly drained soils in depressions or near a drainage ditch which borders the area (Photograph 3). The ditch was dug in an attempt to drain the depressions within the area and increase the ease of cultivation as well as agricultural yields.

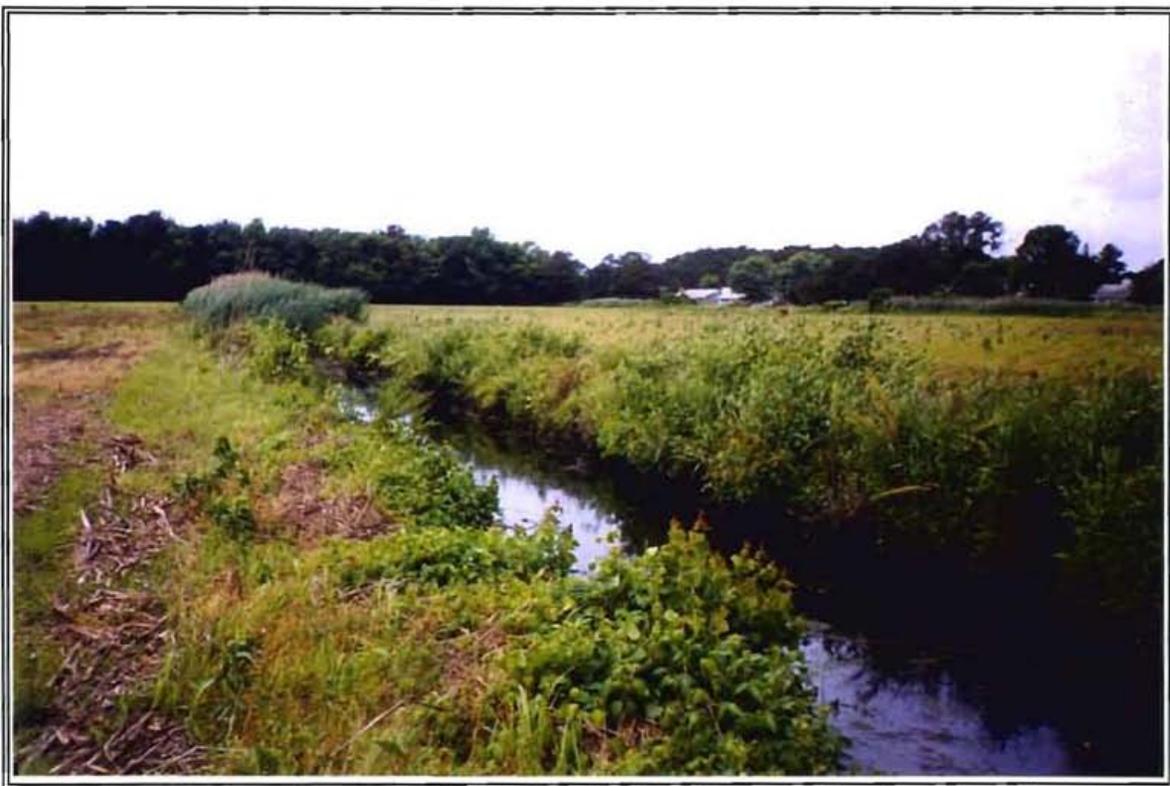
Photograph 3. Drainage ditch adjacent to Stormwater Management Area #2, facing south.

Several of the STP profiles located near the drainage ditch included additional surface horizons not encountered under natural conditions. These sandy layers are the materials dredged during the construction and maintenance of the ditch and graded over the adjacent ground. Despite the excavation of 35 STPs, no archaeological remains of any type were identified.

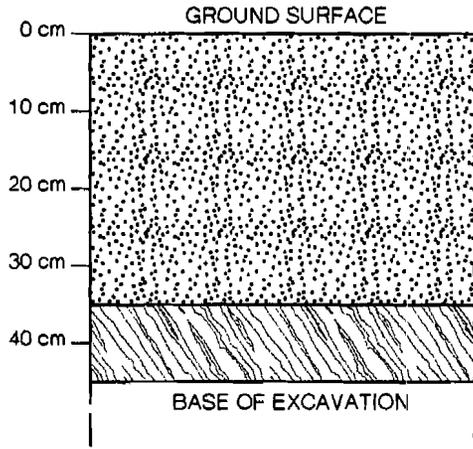
SOIL PROFILE SHOVEL TEST PIT N315 E90

Ap 10YR 4/3 Brown sandy loam.

Bw 10YR 6/2 Light brownish gray sandy loam.

The profile of STP N315 E90, excavated within the southeast corner of this stormwater management area, is comprised of a brown sandy loam plowzone (Ap horizon) underlain by a light brownish gray sandy loam subsoil (Bw horizon) (Figure 3; Appendix A). The profile of STP N345 E45, excavated within the west-central edge of the area near the ditch, is comprised of a thick, ca. 48.0 cm (18.9 in) black surface sandy loam plowzone (Ap horizon) overlying a light gray loamy sand subsoil (C horizon) (Figure 3; Appendix A). The surface is highly organic from the accumulation of decomposed plant material, and the subsoil is undeveloped and gleyed. These parameters indicate that this portion of the stormwater management area has been poorly drained, as saturation impedes soil development and results in the accumulation of organics.

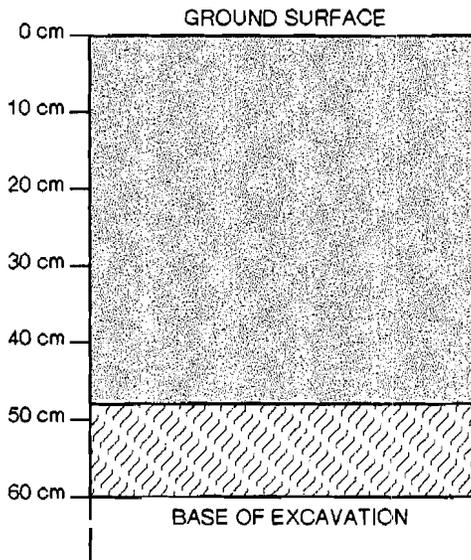
SOIL PROFILE SHOVEL TEST PIT N345 E45

Ap 10YR 2/1 Black sandy loam.

C 10YR 7/1 Light gray loamy sand.
