## HISTORIC COMPONENT RESULTS

In this discussion of the historic component of 7NC-D-100, a summary of the historic documentation related to the site will be presented followed by a description and interpretation of the historic features recorded at the site. These features include sets of posthole features which appear to be related to three structures and additional artifact-bearing features located both adjacent to and away from the postholes. Following the description and interpretation of features, the accompanying artifact assemblage and its distribution will be discussed. This analysis will provide information on the date-range of the historic occupation and data on the material culture assemblage of the historic occupants. Finally, the features and artifact assemblage will be considered in light of data from the documentary sources.

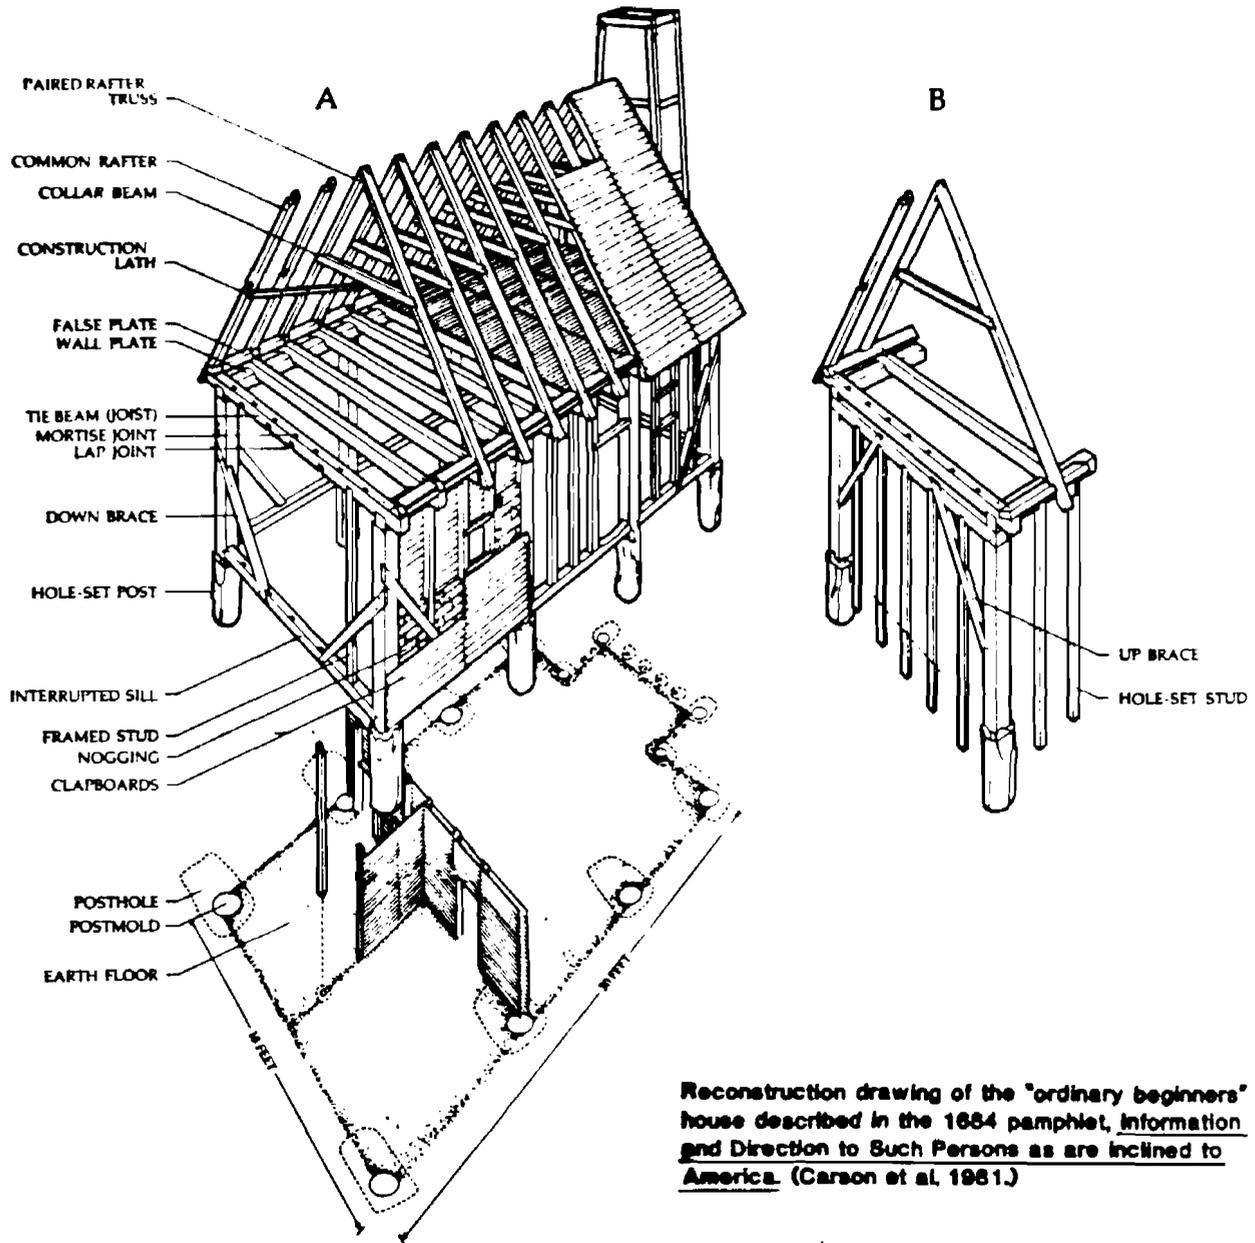
FIGURE 23

Earthfast housing is characterized by framing elements in direct contact with the ground, without intervening stone, brick, or mortar foundation elements (Figure 23). Earthfast structures are typically framed upon large, paired vertical posts set directly into excavated holes (hole-set framing) or upon wood or stone blocks (hole-set block framing). These paired vertical members were then connected by a horizontal brace called a tie-beam. Earthfast housing also includes log structures and frame buildings set directly upon the ground or upon simple wooden blocks without any vertical members inserted into excavated holes. Hole-set and tie-beam framed structures, however, are usually much sturdier and longer lasting. Hole-set blocks represent an additional improvement in structure longevity as more of the frame is not in direct contact with the ground and not as susceptible to moisture and decay. Structures identified at the Whitten Road site utilized both hole-set and hole-set block construction and there is some evidence that partial log construction or construction upon wooden blocks was used in an addition onto one of the structures (Structure I). A glossary of architectural and archaeological terms is given in Appendix IX.

Diagram of Earthfast Construction

together (Figure 23). With the postholes of oversized shape and consistent depths, these main support posts could be maneuvered into the related joinery. These holes would then be backfilled and the main support posts would be earthfast.

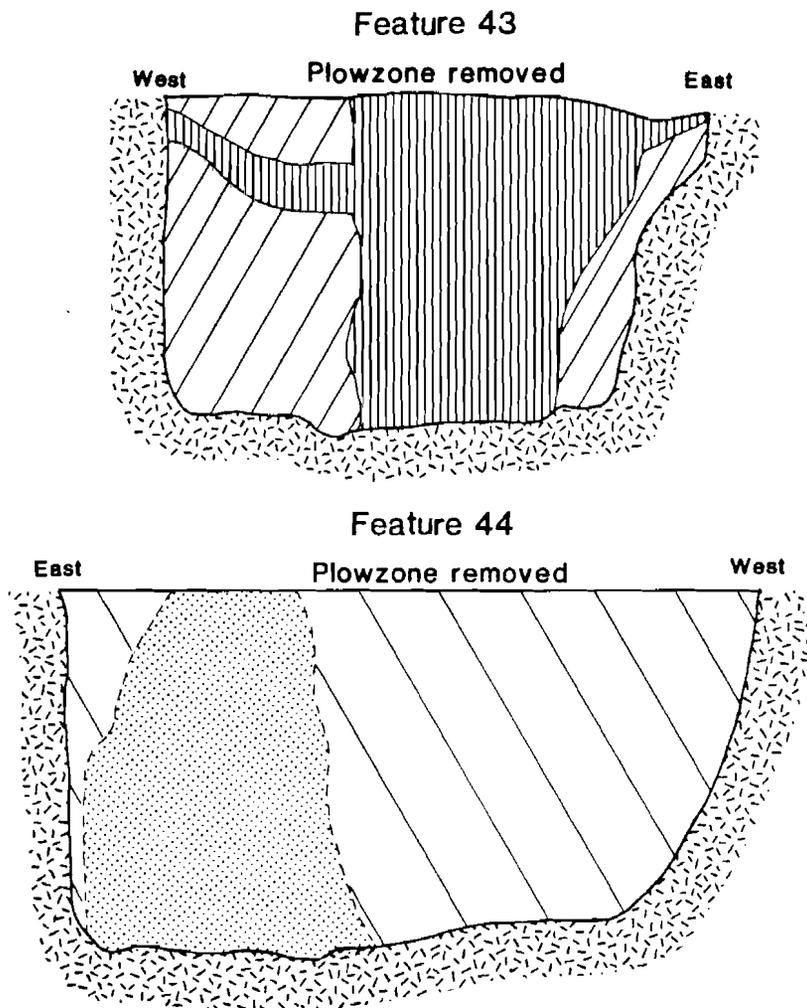
FIGURE 24  
 Profiles of Features 43 and 44  
 (Structure I)

In addition to these postmolds, oval, post-like, dark, soil discolorations were also observed within each posthole (Features 43B and 44B) at the plowzone-subsoil interface. However, excavation revealed that neither of these features was more than an inch or two deep, making it seem likely that both may be the result of non-cultural disturbance such as the burrowing of rodents or the displacement of rocks originally within the

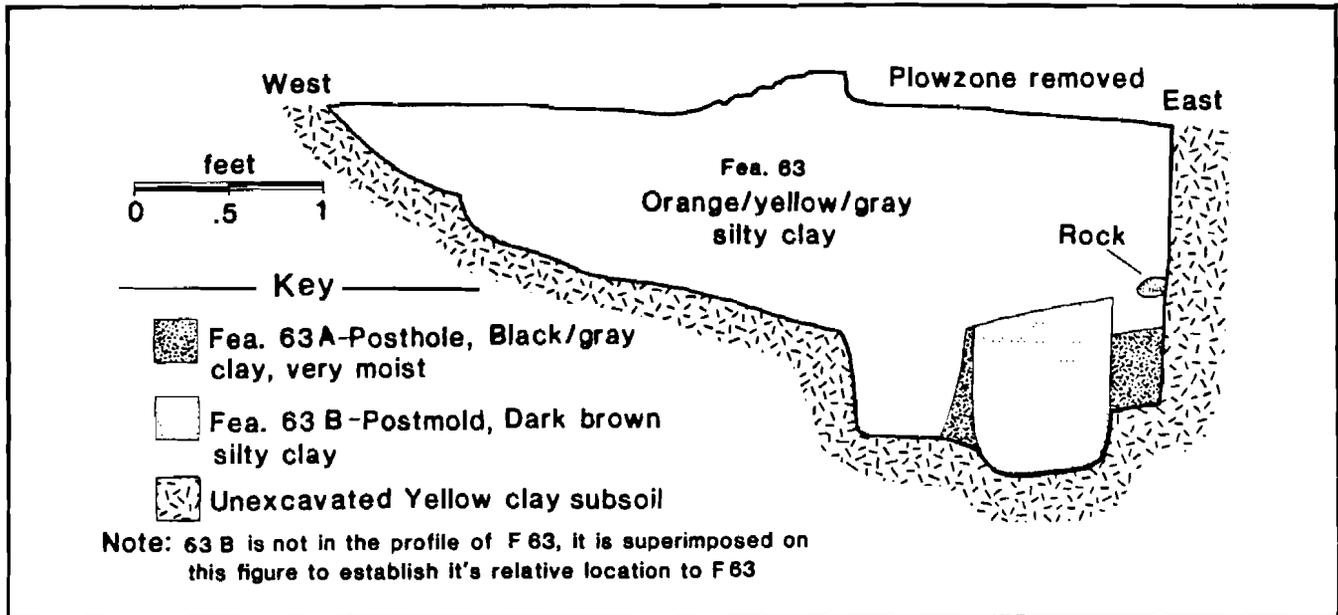
**FIGURE 25**  
**Profiles of Features 63, 63A, and 63B**  
**Structure I**

Features 63, 63A, 63B and 47, 47A form the central tie-beam pair of Structure I although this was not immediately apparent, because Features 63A and B, which formed a tie-beam pair with Features 47, 47A (Figure 20), were overlain by Feature 63, a large, uniformly dark, curvilinear-shaped feature measuring approximately 12 feet long by 3.5 to 4 feet wide. Feature 63 was basin shaped, and was quite shallow along the edges. However, in the center of the feature, the dark, organic deposit reached a depth of approximately 1 foot below the surface of the feature. Sherds of scratch blue white salt-glazed stoneware and redware, burned bone, and possible daub fragments were recovered from the surface of Feature 63 during the Phase I/II test excavations.

Upon excavation, a posthole and associated mold feature (Features 63A and B) were found centrally-located beneath the overlying fill of Feature 63. The posthole fill was a predominantly darker, mottled, loosely-packed soil mixed with gray, ashy deposits and large chunks of carbonized wood, and was different from all other postholes of Structure I, which appeared as intrusions of displaced orangish subsoil with smaller amounts of darker organic material. The posthole (Feature 63A) was approximately 2 feet square with straight sides and a flat bottom (Figure 25). Feature 63A was unlike all other postholes of Structure I in one important respect: the walls and floor of the feature appeared to be reddened as if by extreme heat.

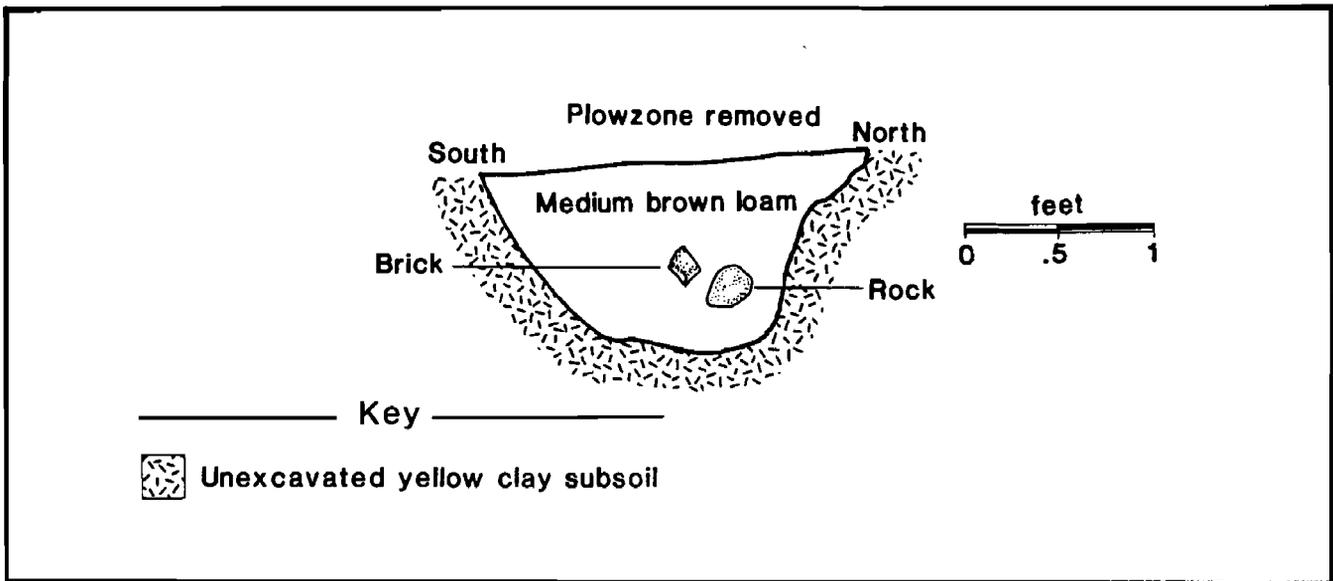
**FIGURE 26**  
**Profile of Feature 55**  
**(Structure I)**

Feature 55 had an irregular shape, measuring approximately 2.5 feet long by 2.2 feet wide. The walls of this posthole were not as straight as those of some of the other postholes, although the floor was as flat (Figure 26). Most artifacts were of the very small variety, although a mangled pewter spoon was found at the bottom of the posthole. Only a hint of a postmold (Feature 55A) was present at the surface of the posthole, suggesting that perhaps this post had been pulled from the ground. This vague evidence of a post was located in the south end of the posthole. Feature 55 was also not as deep (1') as any of the other postholes of Structure I, including its counterpart on the east side of the structure, Feature 57.

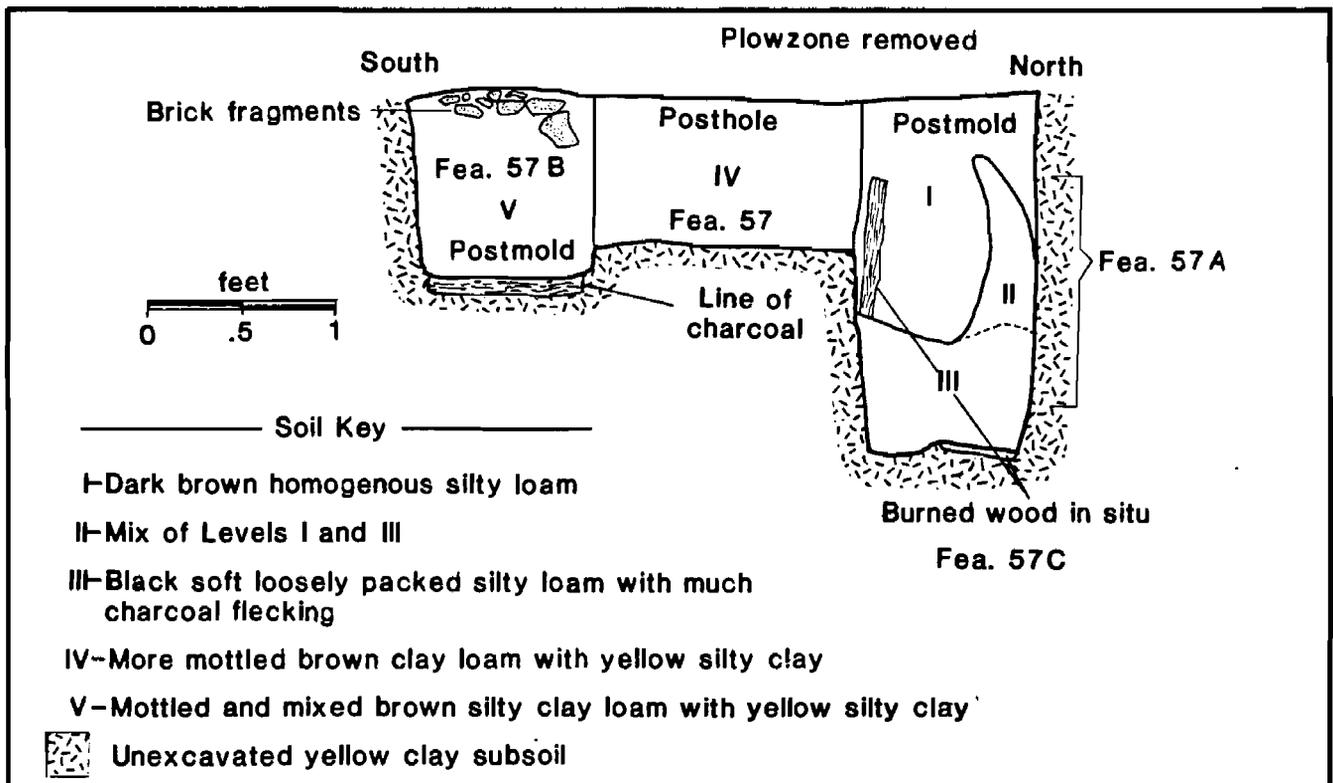
**FIGURE 27**  
**Profiles of Features 57, 57A, 57B, and 57C**  
**(Structure I)**

Feature 57 measured slightly more than 4' long by 2.4' wide with the long axis parallel to the length of the structure. The elongated nature of Feature 57 suggests that it was enlarged to accommodate a replacement post (Feature 57B), the mold of which was clearly defined in the south end of the posthole. In profile this postmold had a diameter of 1' and it was located approximately 2' south of the other postmold (Feature 57A) in this posthole. It was also located slightly outside (east) of the other postmold in this hole. Whereas an existing hole was simply enlarged to facilitate post replacement at the southeast corner of Structure I, a separate hole (Feature 31) was dug for this purpose at the southwest corner. Like Feature 57B, the postmold (Feature 31A) in this posthole was located slightly outside, or in this case, west of the original postmold at this corner (Feature 55A). This posthole was also smaller (2' long by 1.6' wide) and not as deep (1') as the postholes of the north and central tie-beam pairs, although the long axis is parallel to the length of the structure (Figure 20). This depth is comparable to that of Feature 57B, its counterpart on the east side of the replacement tie-beam pair.

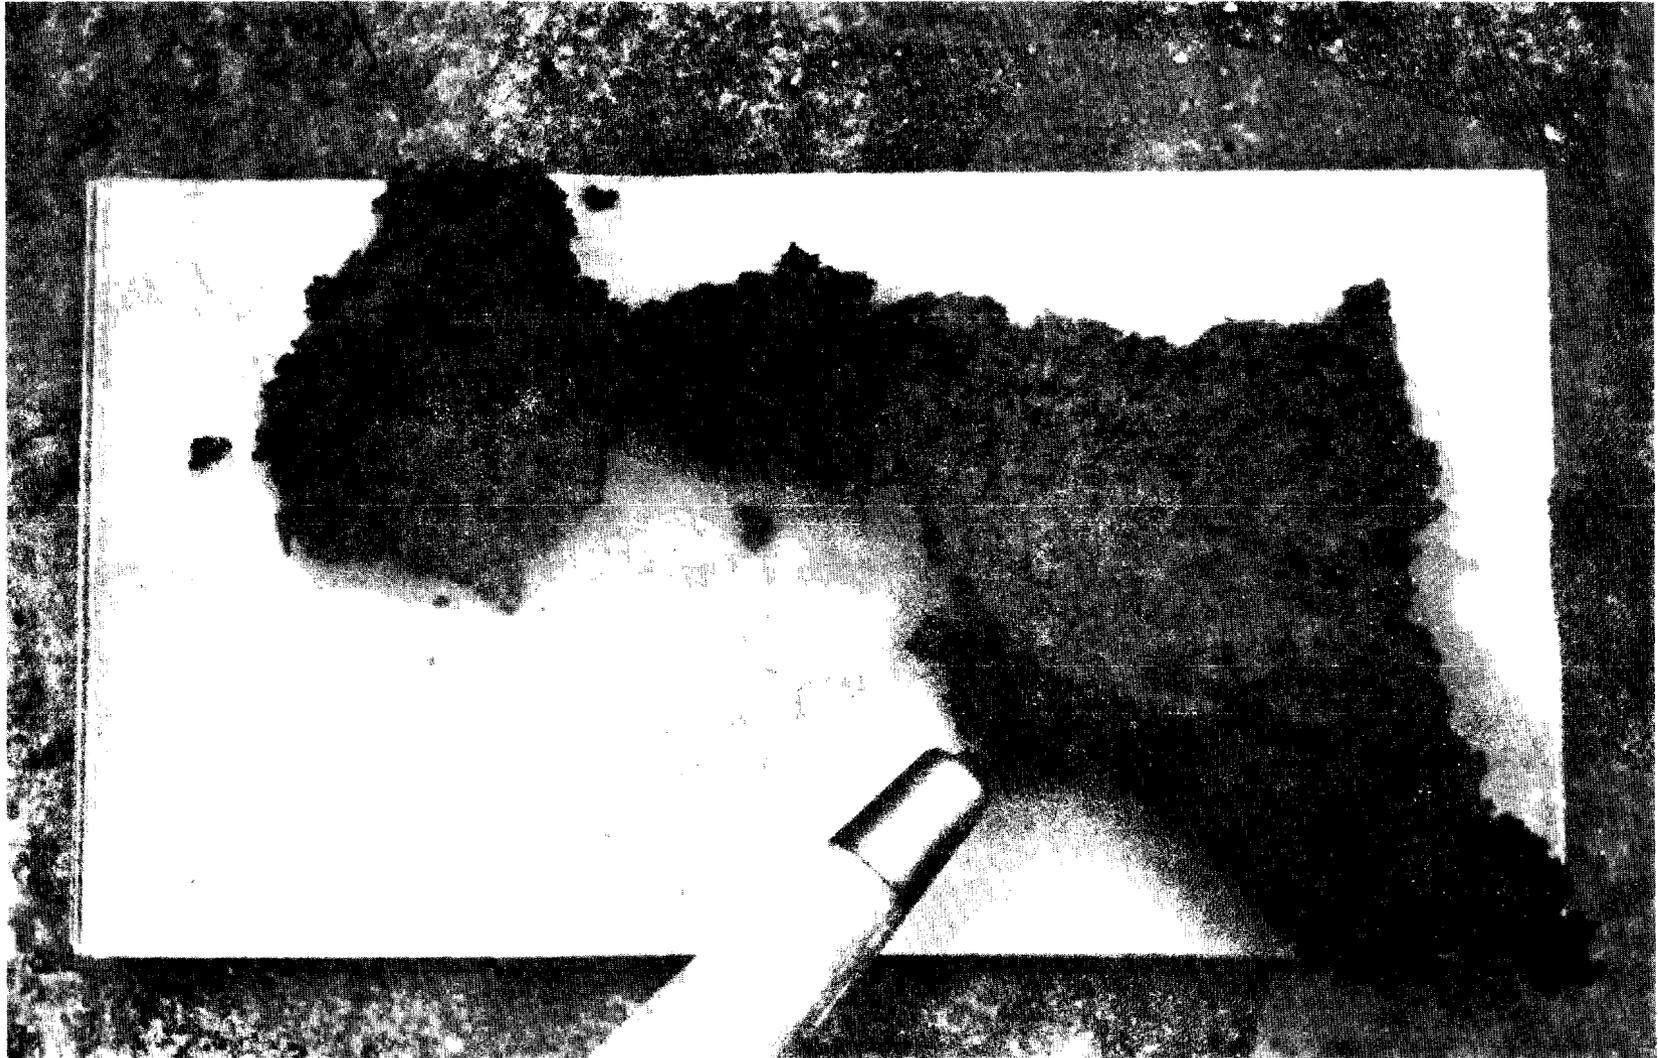
PLATE 4

Wood from Posthole, Feature 57

At a depth of approximately 1' below the top of the postmold (Feature 57C), a rectangular feature was encountered. Both the shape and soil texture suggested that it was a separate feature and this feature is thought to represent the remains of a rectangular wood block that was placed in the north end of this posthole and upon which the actual post rested. In fact, a carbonized remnant of this block was found at the base of the feature (Plate 4). This block had been apparently fire-hardened before placement in the posthole. This could account for its burned appearance. Although this portion of the posthole (Feature 57) reached a depth comparable to those observed among the postholes of the northernmost and central tie-beam pairs, the depth at which the round post mold ended and the squared off feature emerged is similar to the depth of the related posthole (Feature 55). It is unclear whether the post (Feature 55A) at this corner of the structure was set directly into a prepared hole like those of the northernmost and central tie-beam pairs, or if it rested upon a block like its counterpart at the southeast corner of the structure. Whatever the case, the lack of a well-defined postmold suggests that it had been pulled out at one time, indicating that this tie-beam pair was once disassembled and replaced. This supposition is corroborated by the locations of replacement and enlarged postholes with postmolds located south of the posts of the original tie-beam

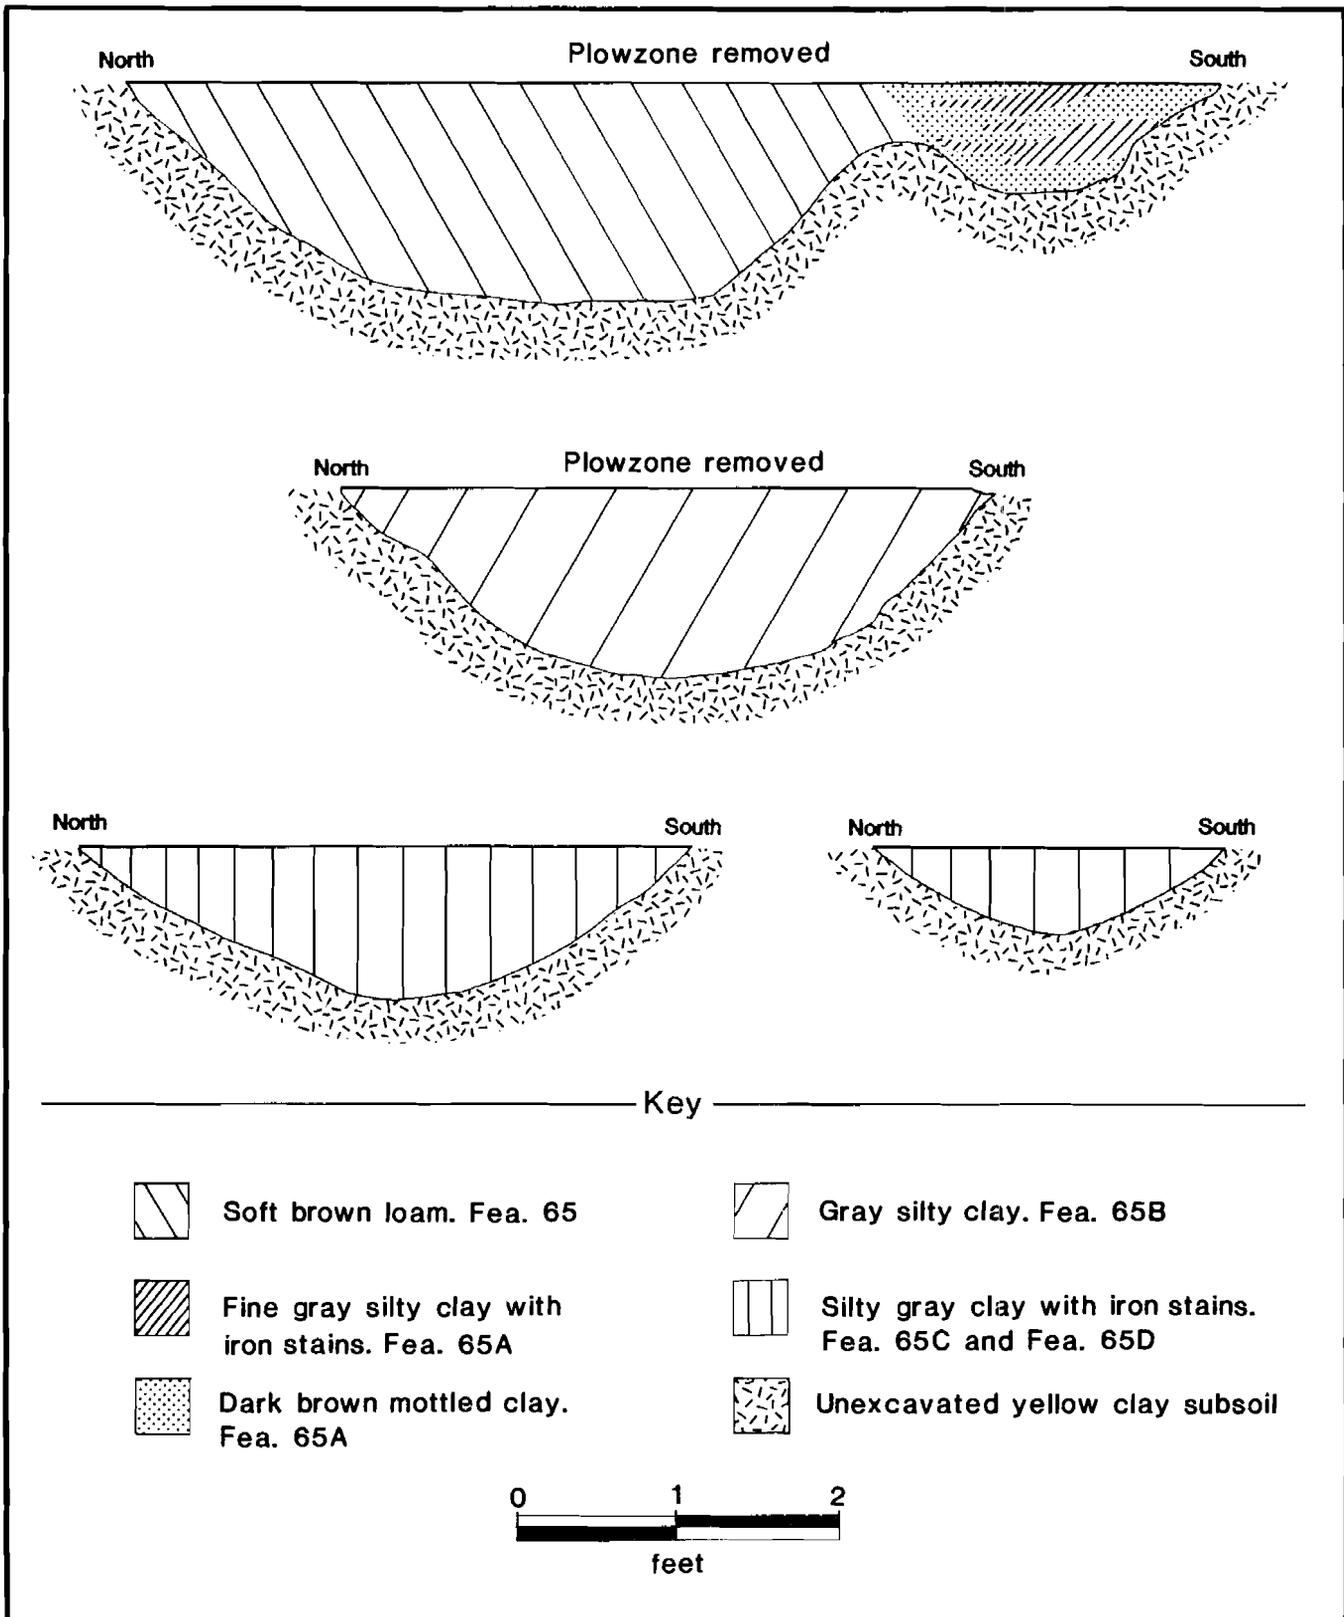
FIGURE 28

Profiles of Features 65, 65A, 65B, 65C, and 65D  
(Structure I)

Excavation of Feature 65 revealed the presence of 5 oval, basin-shaped pits ranging in depth from approximately 0.5 foot to 1.33 feet. The largest of these features consisted of an oval pit centrally located within the larger, feature area. Feature 65 had a maximum diameter of nearly 5 feet, and in profile the feature appeared to be a single deposit of dark brown silty loam which persisted to the bottom of the feature (Figure 28). The feature was approximately 2.5 feet deep before the top was truncated by post-occupation plowing and the variety of material recovered remained consistent throughout the profile. Appendix IV provides a complete inventory of artifacts from the Feature 65 complex.

In order to define the nature of this large feature, it was sectioned into east and west halves. Four inches into the excavation of the west portion of the uniformly dark brown feature fill and in the vicinity of the southwest corner of the feature area, sterile subsoil was observed below a shallow "bridge" of feature fill, clearly indicating the presence of two distinct pit features (Plate 5). This smaller feature was designated Feature 65A and was located south of the larger Feature 65 (Figure 20). The profiles of both features were found to consist of one natural level of dark brown silty loam, although the fill of Feature 65 was also characterized by ash and carbon flecking. Artifacts consisted predominantly of brick fragments, large redware sherds, nails, wine bottle fragments, and poorly preserved bone. Excavation of the east sections of these features defined the overall shapes of these disturbances with Feature 65 being a fairly circular soil discoloration with a maximum north-south diameter of approximately 7.25 feet and a maximum east-west diameter of slightly more than 7.33 feet. Feature 65A was of a more oblong shape, measuring approximately 2.5 feet north to south by approximately 3.5 feet east to west and reached a depth of slightly under 0.83 feet (Figure 28).

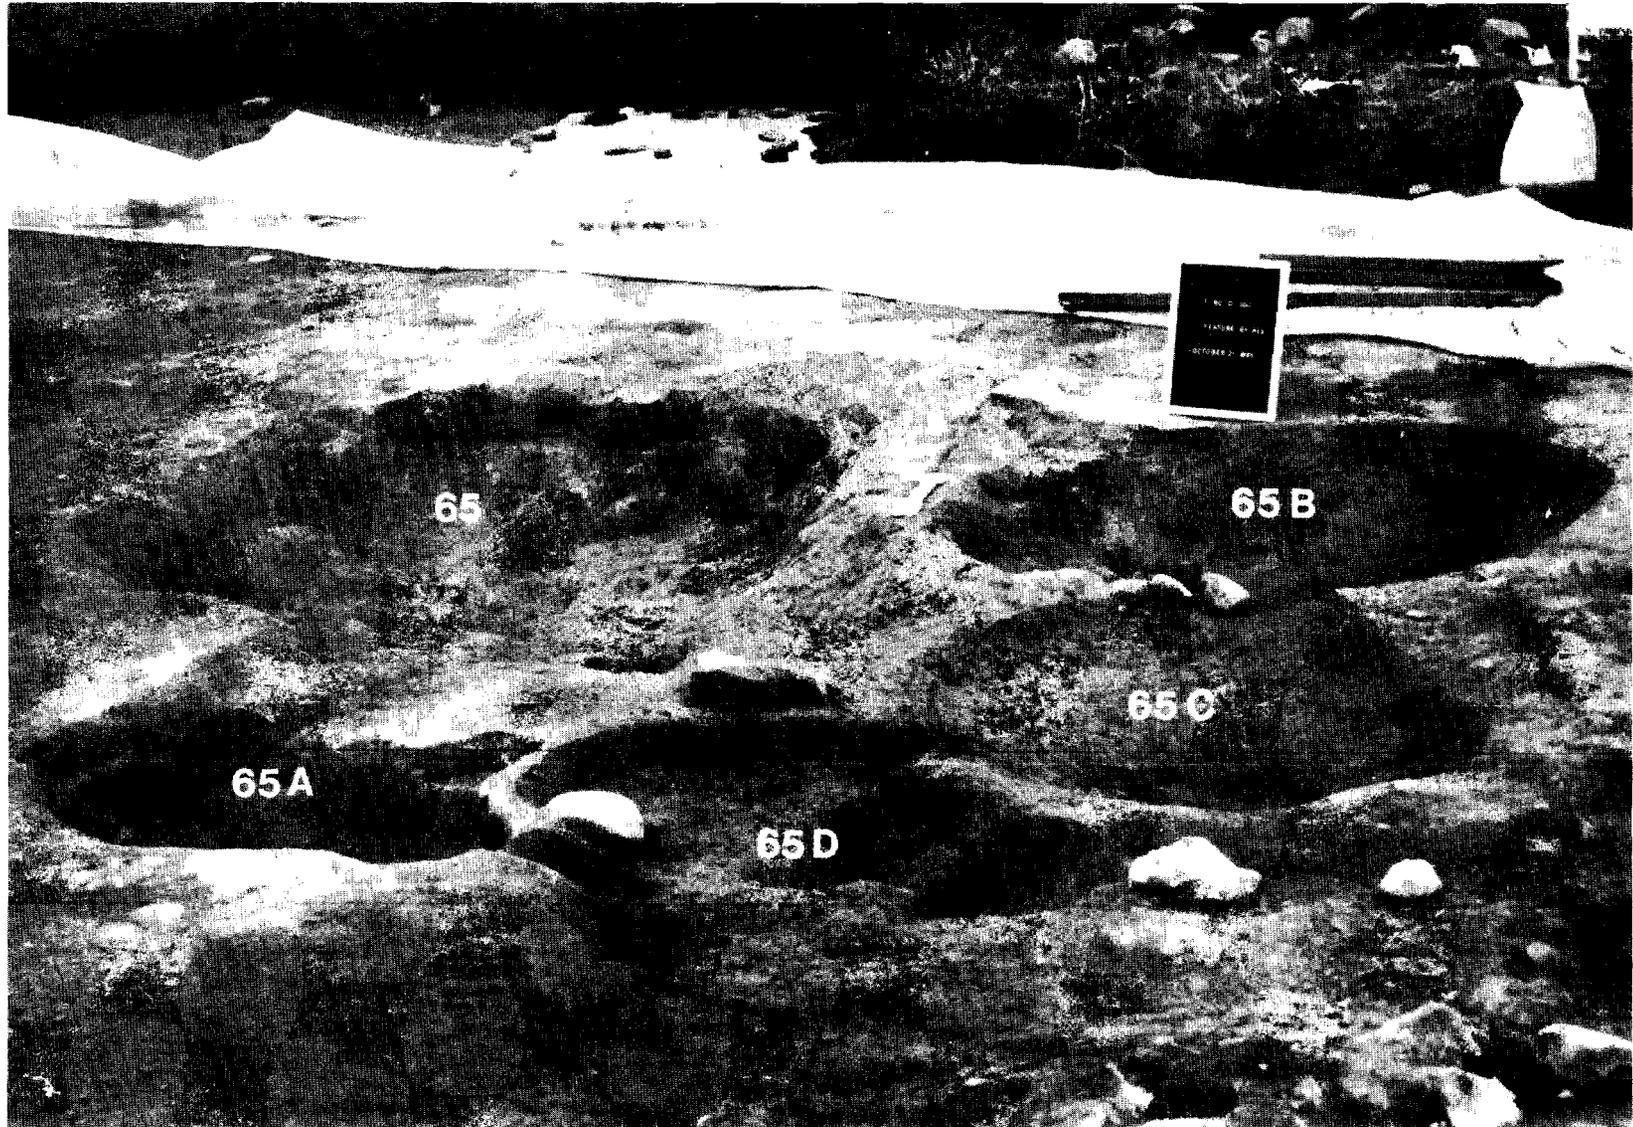
PLATE 5

Feature 65 Complex, Planview

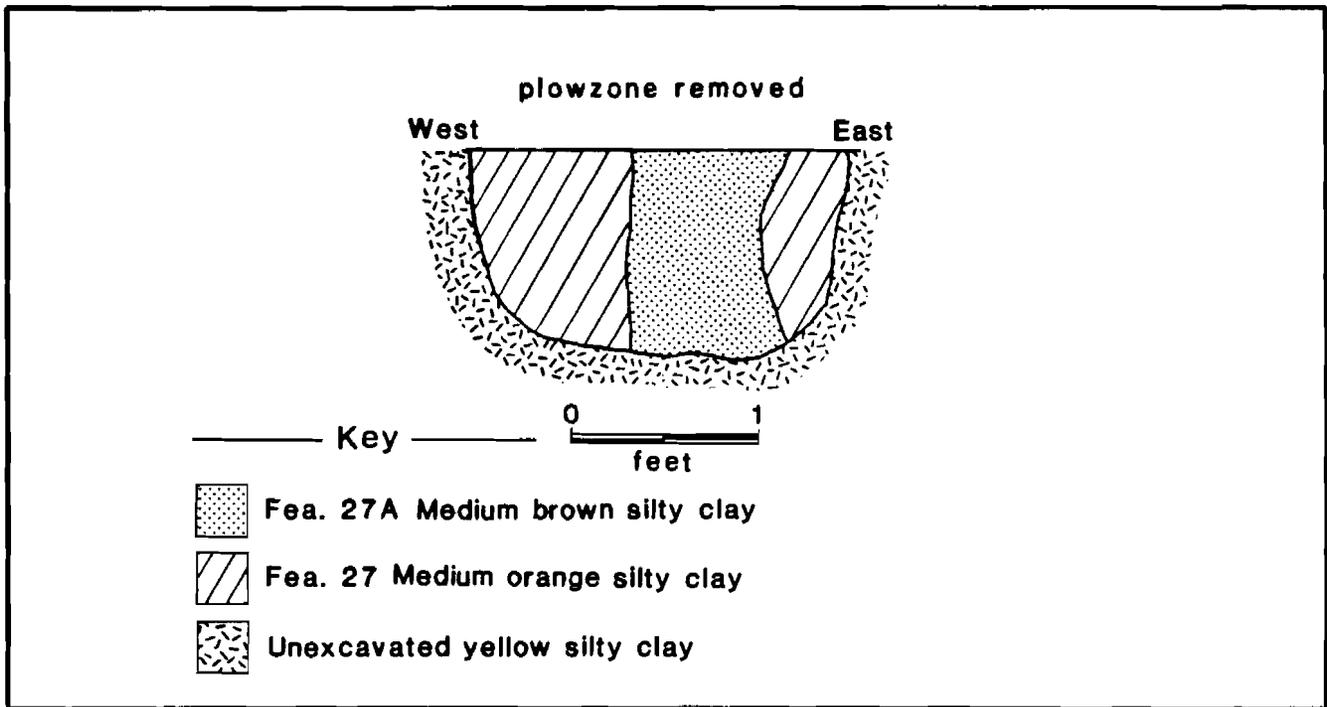
FIGURE 29

Profile of Feature 27  
(Structure II)

Upon excavation, Feature 27 was found to have a diameter of slightly under 2 feet and was found to be significantly shallower than any of the first six postholes of Structure I but of a comparable depth (slightly over 1 foot) as that observed in Features 31 and 57B. In profile, Feature 27 had straight walls and a flat bottom, and the impression of a post measuring approximately 0.75 feet in diameter was clearly evident from the top to the bottom of the hole (Figure 29). Small fragments of ceramics, bone, and glass were found in the posthole fill (Appendix IV), which was also marked by carbon and brick flecking and a mottling of subsoil with darker, organically-derived fill.

this trench-like feature. The postmold was well-defined in profile to the bottom of Feature 30, with straight sides and a flat bottom, however, the walls curved inward slightly at the base similar to Feature 27 (Figure 29). Artifacts were found in the postmold but were absent from Feature 30 (Appendix IV). Because it is located on line with the supposed west wall line of Structure II, Feature 30A could represent a trench-laid stud located slightly north of the main framing post at the northwest corner of the structure (Feature 27A) in order to provide additional support. Evidence of a similar feature contained within Feature 30 was located at the southernmost end of the trench-like disturbance and designated Feature 29 (Figure 21). This feature was also well-defined to the bottom of Feature 30 and may be evidence of another trench-laid stud at the northwest corner of Structure II.

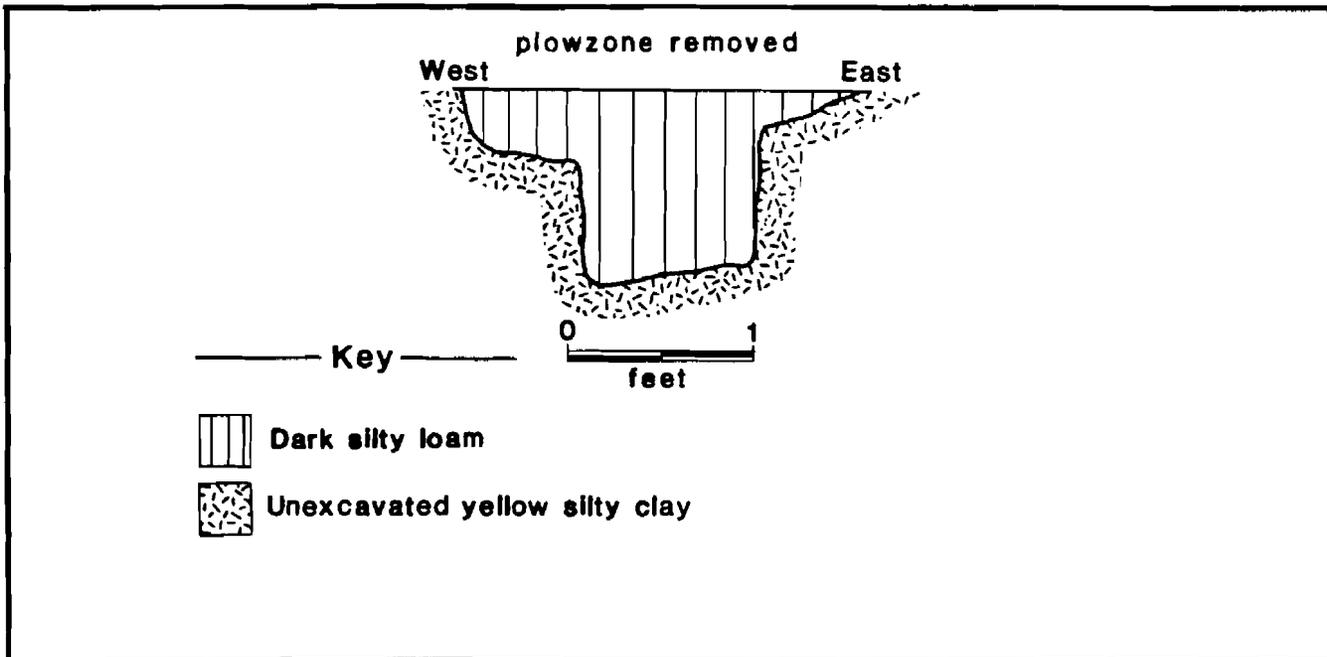
FIGURE 30

Profile of Feature 26  
(Structure II)

Several additional features were located near Feature 27 and it is unclear whether these disturbances are related to Structure II or if they are natural disturbances. Feature 26 the center of which is 2.5 feet west of the center of Feature 27 displayed a fairly oval shape and a diameter of slightly under 2 feet. The feature fill consisted of uniformly dark brown silty loam and contained artifacts (Appendix IV). This feature initially gave the appearance of a shallow, basin-shaped pit; however, the central portion of the feature assumed a rectangular shape characterized by straight walls at points approximately 1/2 foot east of the west edge and 1/2 foot west of the east wall (Figure 30). The rectangular portion was just under 1 foot in diameter and was about 1 foot deep, having a flat floor. The shape and location of this feature suggest that it is structure-related. However, the relationship between it and Feature 27 is unclear with regard to the chronology of these two features, although both are believed to be elements of the northernmost of the three tie-beam pairs of Structure II.

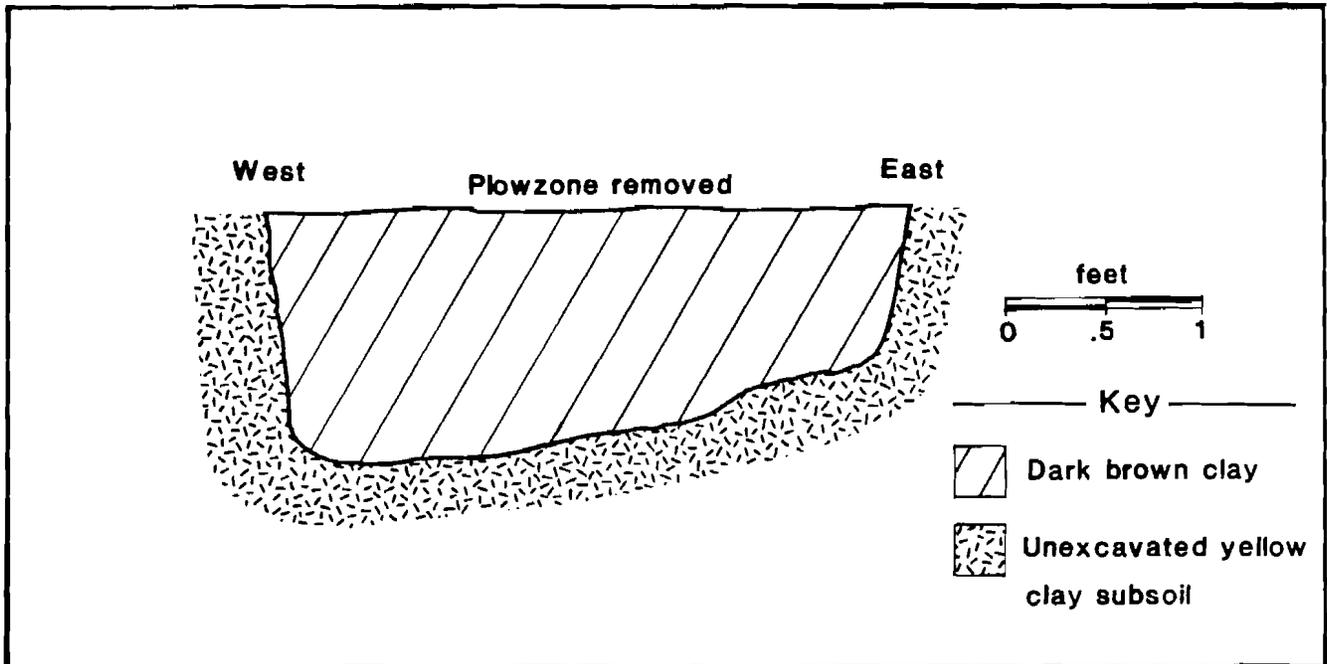
FIGURE 31  
 Profile of Feature 118  
 (Structure II)

In profile, Feature 118 ranged in depth from slightly under 6 inches at the west edge of the feature to just over 6 inches at the east edge and consisted of one natural level bearing a variety of material similar to that found in the previously-described postholes. However, the floor of this feature was not flat as were the others, and sloped slightly downward from east to west (Figure 31). The trend of horizontal patterning of postholes of comparable depths observed among the posthole/mold features of Structure I is not evident among Features 27 and 118. Consequently, this pair of features seems to represent something other than construction involving hole-set upright structural framing posts at both sides of the tie-beam pair, particularly with regard to Feature 118. Although hole-set remains are evident in the posthole at the northwest corner of the structure (Feature 27A) in addition to several other features (Features 26, 29, 30, 30A) which may be related to additional structural support in this corner, none were found in Feature 118 at the northeast corner of Structure II.

A third pair of features (Features 116 and 120) were located approximately 20 feet south of Features 27/118 and 10 feet south of Features 110/119 (Figure 21). Although Features 116 and 120 occurred at the angle established by the locations of the Features 27, 118, 110 and 119, their morphological characteristics differ. Feature 116, located parallel to and south of Feature 110, consisted of a uniformly dark brown deposit similar to that observed in Features 110, 118, and 119 (Figures 31 and 32). Feature 116 was of an oblong shape, ranging from a

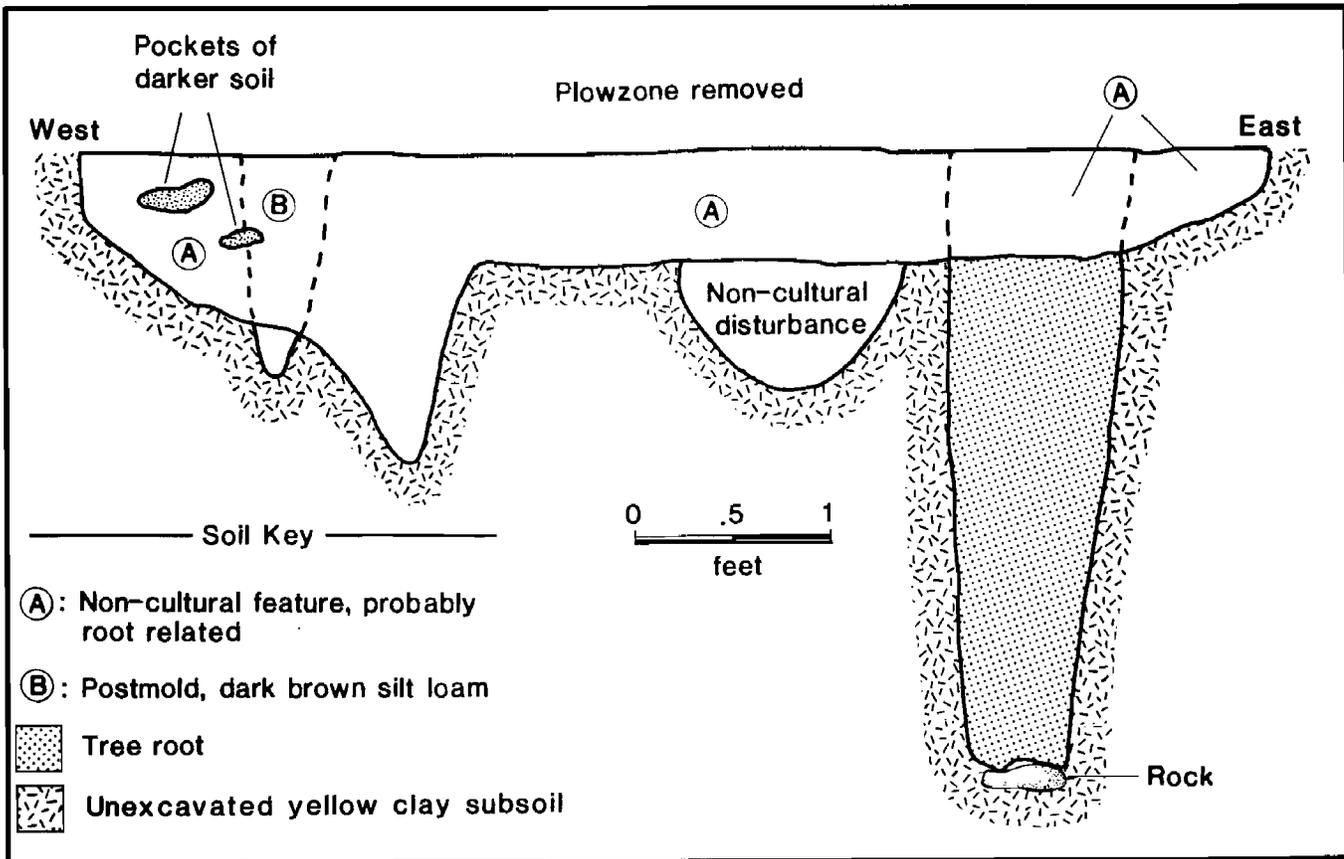
**FIGURE 34**  
**Profile of Feature 80**  
**(Structure III)**

Features 80 and 102 make up the fourth and final set of remains of hole-set upright structural members related to Structure III. The definition of Feature 80 was marred by a large, non-cultural intrusion (Figure 22); however, in the profile view the outline of a posthole (Feature 80B) was evident in the west portion of the larger intrusion and had a depth of 0.90 feet (Figure 34). Unlike the other related postholes to the north, Feature 80 itself was subjected to some sort of non-cultural disturbance as evidenced by its rounded base which at one point tapers into a virtual point.

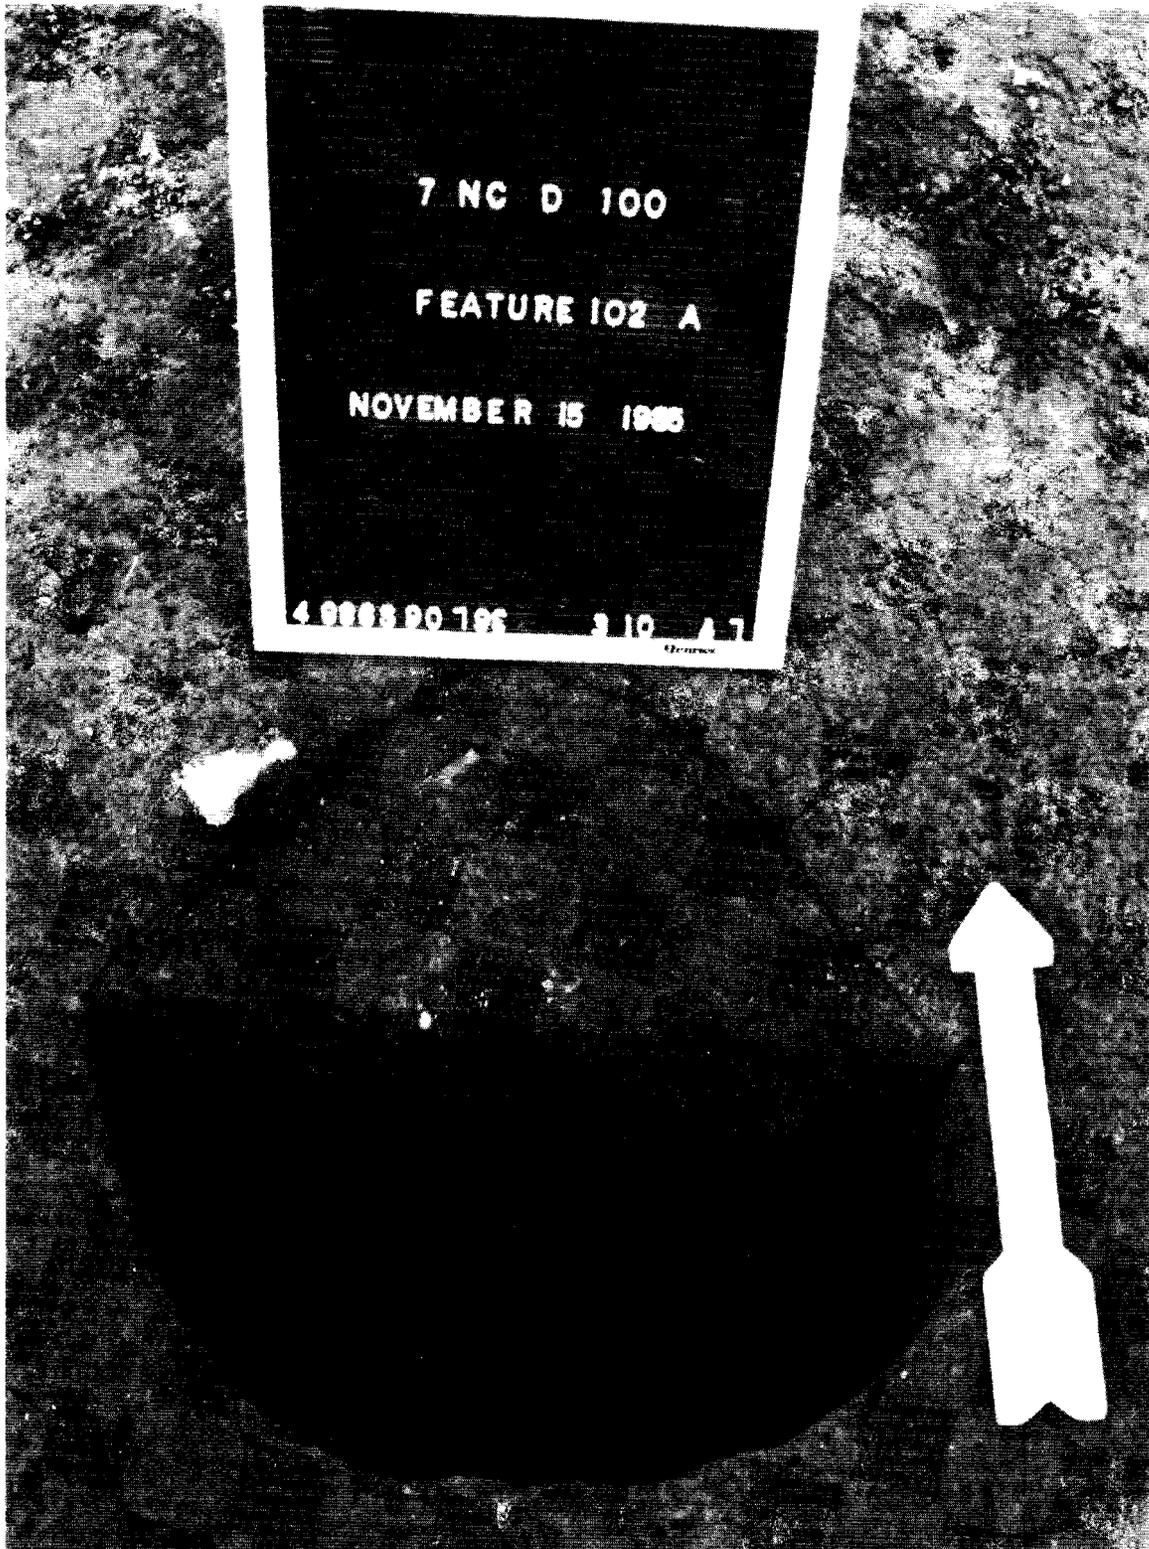
PLATE 7  
Feature 102, Profile

Feature 102, on the other hand, provided the clearest picture of a postmold within a hole of any of the features related to Structure III. This was also the only feature related to these structural remains to contain artifacts. At the surface this feature had a diameter of 1.55 feet and upon sectioning was found to have very straight walls and an essentially flat bottom at a depth of 0.88 feet (Figure 35 and Plate 7).

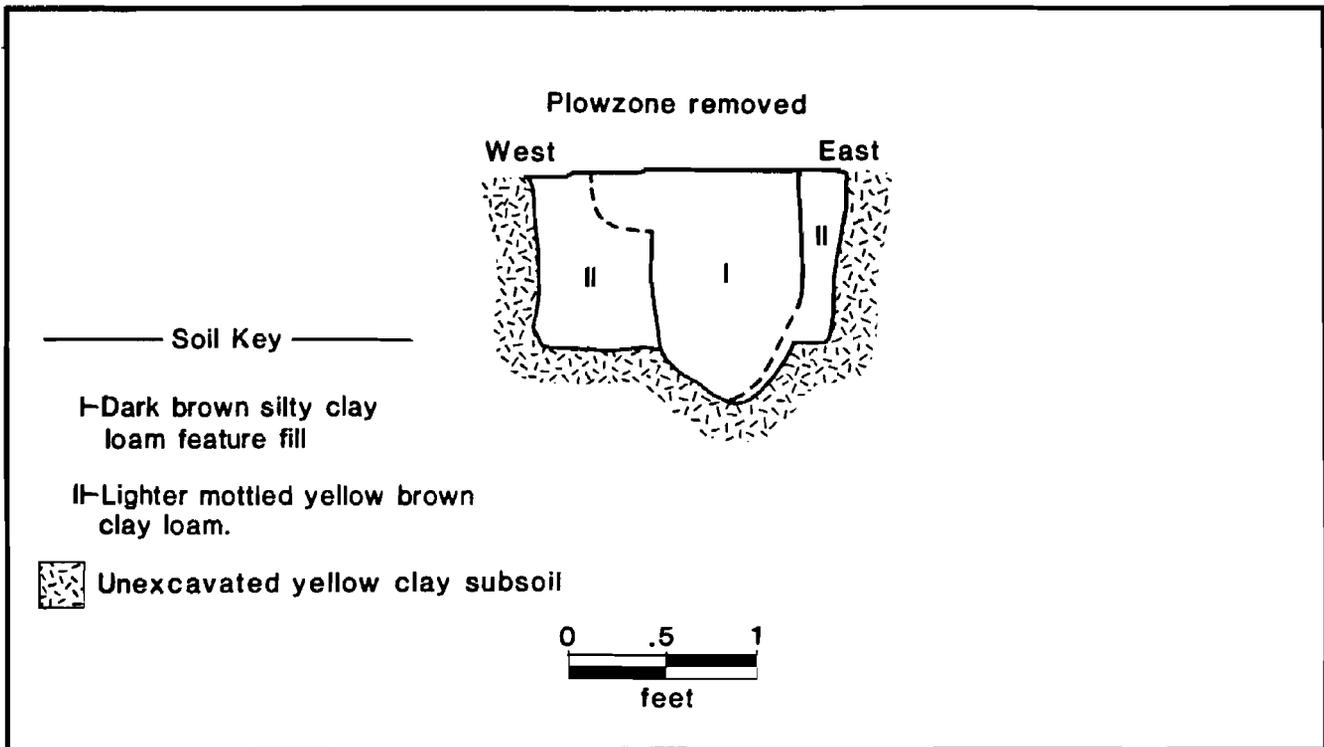
**FIGURE 35**  
**Profile of Feature 102**  
**(Structure III)**
