## HISTORIC COMPONENT RESULTS

In this discussion of the historic component of 7NC-D-100, a summary of the historic documentation related to the site will be presented followed by a description and interpretation of the historic features recorded at the site. These features include sets of posthole features which appear to be related to three structures and additional artifact-bearing features located both adjacent to and away from the postholes. Following the description and interpretation of features, the accompanying artifact assemblage and its distribution will be discussed. This analysis will provide information on the date-range of the historic occupation and data on the material culture assemblage of the historic occupants. Finally, the features and artifact assemblage will be considered in light of data from the documentary sources.

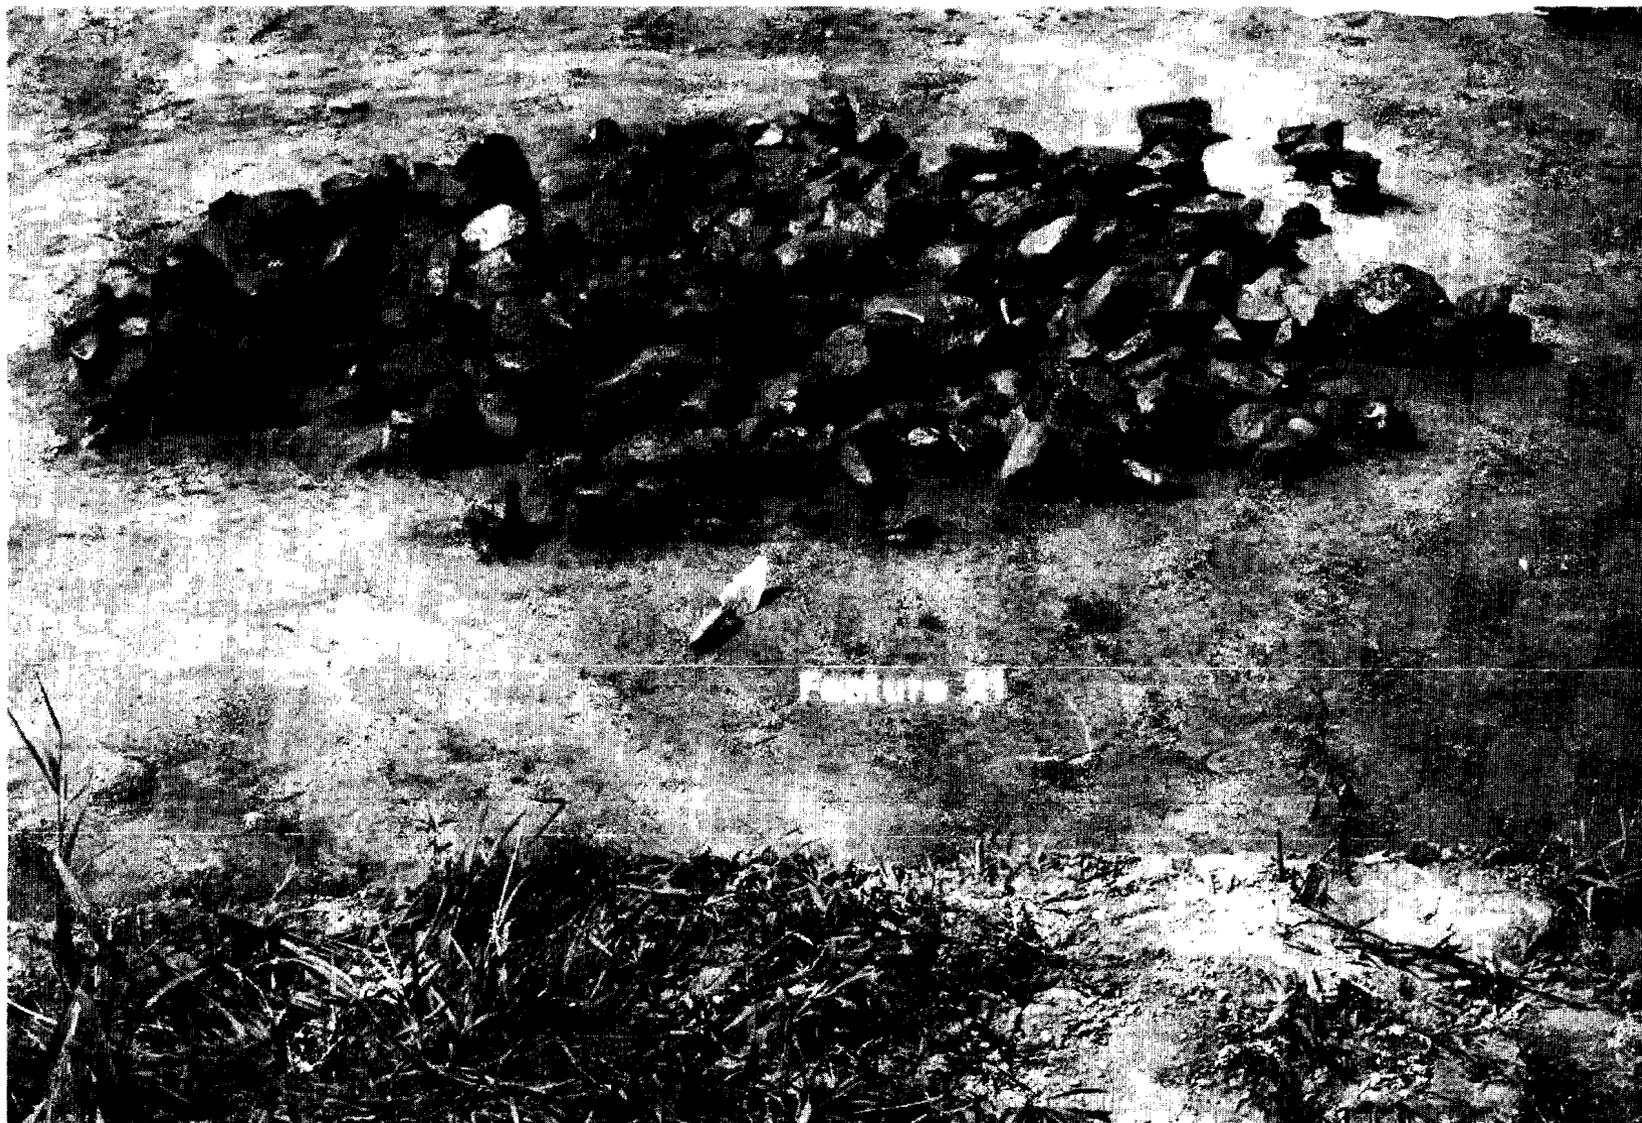
PLATE 8  
Feature 21, Planview

Several additional features were located near Structure III during the course of the intensive excavation and the most conspicuous of these was Feature 21, (Figure 36). Feature 21 differed from any other feature revealed through data recovery excavations in that it was somewhat intact within the plowzone and consisted of a compact cluster of rock which was oval in shape and rather large, measuring approximately nine feet in diameter (Plate 8, Figure 36). None of this rock concentration protruded above ground surface, but it was encountered within the top few inches of the plowzone and persisted throughout the entire depth of the plowzone. Once the feature had been exposed in its entirety, all of the rocks were mapped in situ. At this time it became apparent that the rocks rested upon a circular, uniformly dark soil which was clearly evident against the surrounding sterile orange clayey subsoil. Artifacts were also present among the rocks including several large conjoinable fragments of a Buckley-ware butter pot (Plate 9). In order to investigate the underlying dark feature fill, the rocks had to be removed, at which time they were measured and counted. Twenty-five cobbles measuring over eight inches in diameter were found as were 163 smaller or fragmentary cobbles. Of these, 124, or approximately 66% of the total were clearly fire-cracked.

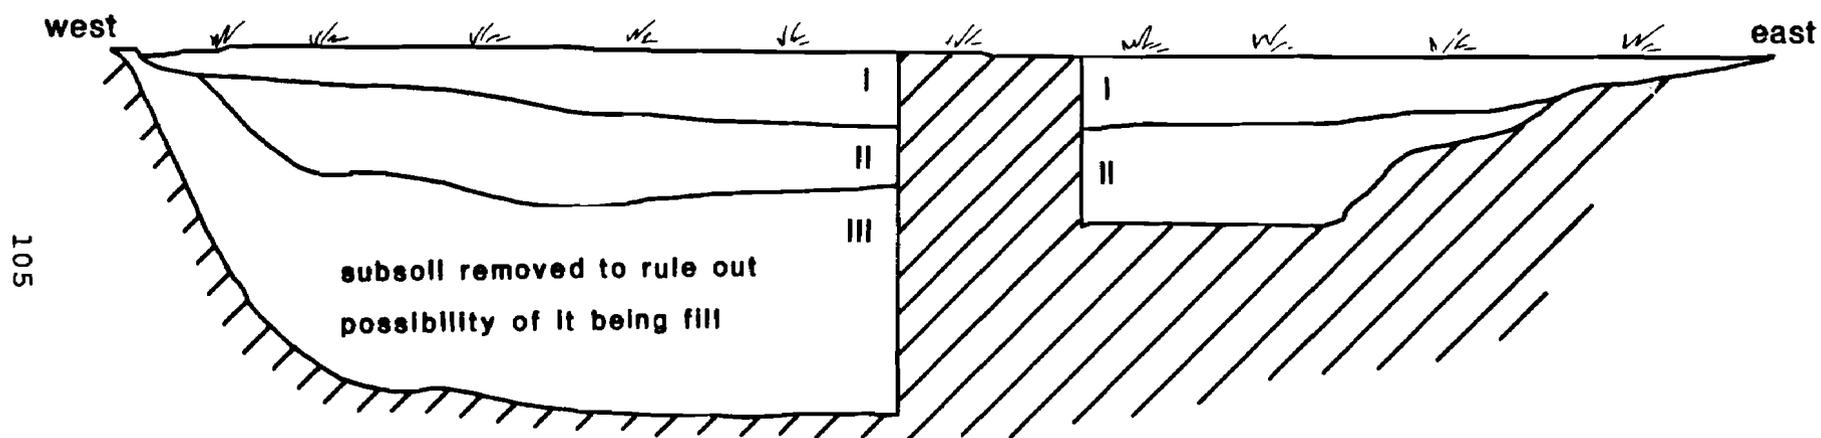
FIGURE 37  
Profile of Feature 21  
(Structure III Complex)

- Key
- I. brown silt loam with a few pebbles and artifacts, carbon and brick
  - II. yellow ochre/brown silty clay with some iron staining and very little brick and carbon
  - III. tan/grey dense clay with iron stains (sterile subsoil)

Like the circular configuration of the rock which overlay it, the uniformly dark feature fill was approximately nine feet in diameter. Excavation revealed that this deposit was only slightly less than five inches (0.4 foot) deep at which point sterile subsoil was encountered (Figure 37). The subsoil here was unusual in that it was mottled with iron oxide staining and took on a uniformly gray hue, suggesting the presence of water at a shallow depth. The bottom of this feature is not, however, near the natural water table. This uniformly dark soil contained very few artifacts and the majority recovered from the feature were found among the cobbles. The dark, shallow impression into the subsoil may actually have been produced by the weight of the rock rather than by the excavation of a pit.
