INTRODUCTION AND STATEMENT OF PURPOSE

This report presents the results and recommendations of a preliminary cultural resource survey, including archaeological excavations, historical research, and architectural recordation at the Cantrell Warehouse/Enterprise Mill on Stein Highway in Seaford, Sussex County, Delaware (Figure 1 & Plates 1 and 2). The project was undertaken by the Delaware Department of Transportation, Division of Highways, Location and Environmental Studies office. The purpose of the research was to satisfy requirements of Section 106 of the National Historic Preservation Act. In order to accomplish this goal, the site was researched in order to determine its limits, context, and integrity. The mill structure itself was architecturally assessed to determine its structural integrity and significance on both a local and regional scale. Historical research was designed to address several previously published and unpublished appraisals of the structure and the association of the structure with persons of historical significance.

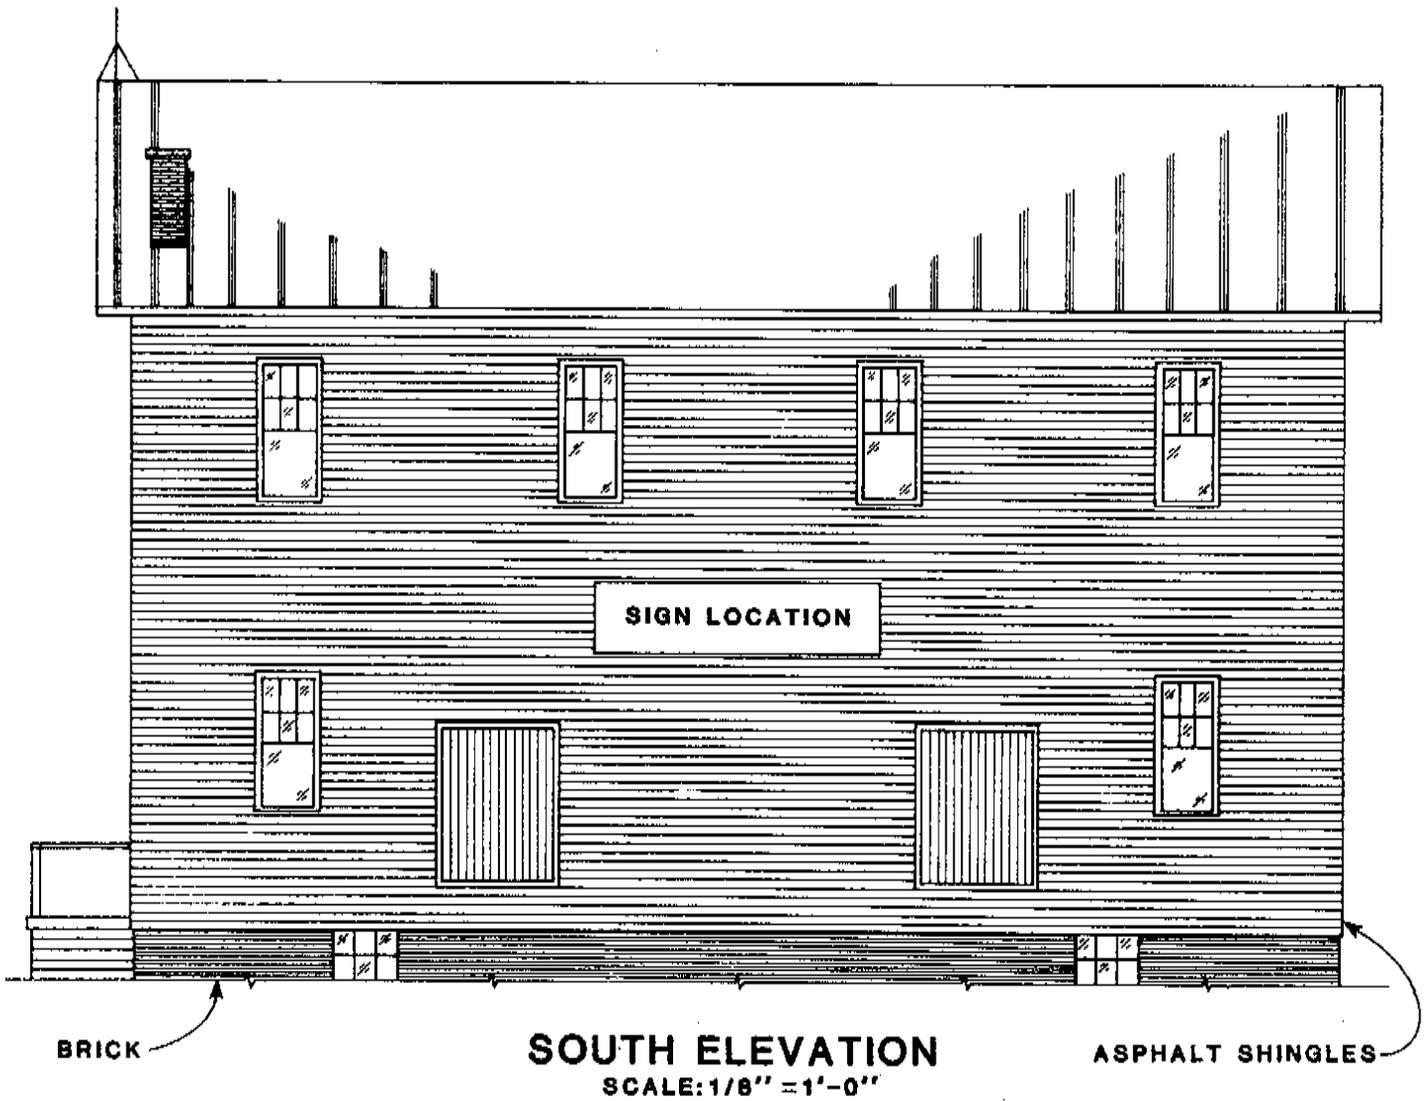
FIGURE 8

ELEVATION AND DETAIL

The extant structure is a rectangular (50' 6" x 40' 6"), two story, four bay wide by three bay deep wooden building with a full basement (Plates 1, 2, Figures 8, 9, 10). A common-bond brick foundation supports the oak members of the mortise-and-tenon, braced-frame structure. The beaded tin gable roof has projecting eaves with a plain fascia and exposed rafters on the side walls, and a plain bargeboard (with molded decoration) at the end walls.

On the first floor, the south wall maintains its exterior symmetry with one 5' 2- $\frac{1}{4}$ " wide wooden sliding door in each of the central bays and one six over one light double sash window with plain molding and sloping sill in each of the two exterior bays (Figures 8, 12, 14). All existing first and second floor windows (and probably all original windows on these floors) are of this type (Figure 23). Wainscoting is present to the window sill level as shown on Figure 12. The sliding doors on the south wall are attached by pulley-type rollers on the top and set on a track allowing them to be opened by sliding towards the center of the

The second floor windows on the south and west sides of the building are the same type as those of the first floor and one is located in the center of each bay (Plates 1,2, Figures 8, 9, 13, 23). Those on the north and east walls have been boarded up and covered with shingle siding as were those of the first floor. There is no evidence that a window ever existed in the west bay of the north wall which would have completed the second floor

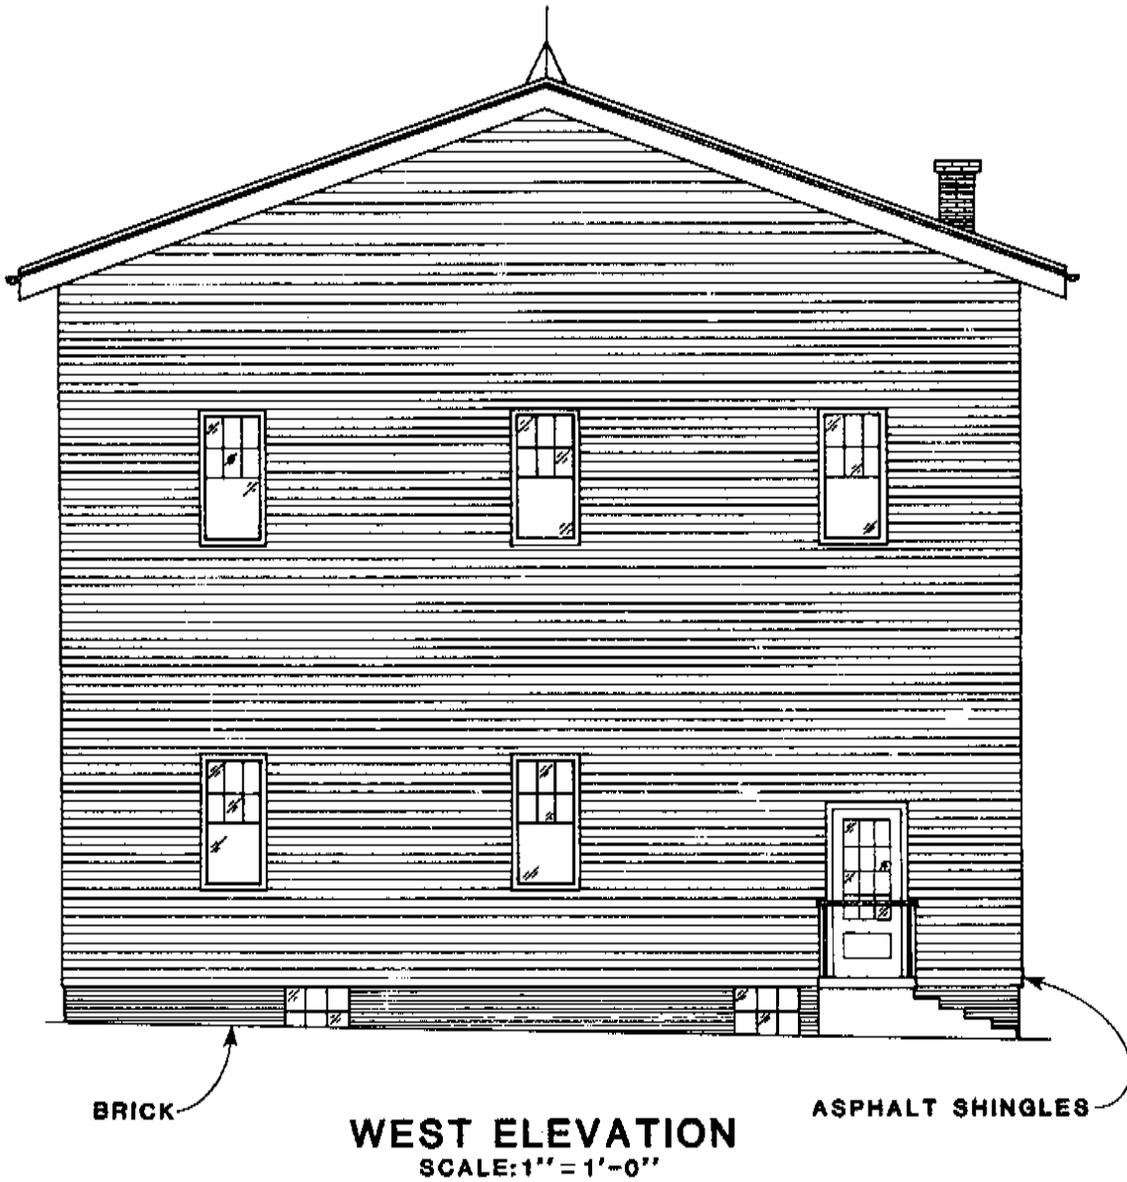
FIGURE 9
ELEVATION

MATERIALS
FOUNDATION: BRICK
WALLS: ASPHALT SHINGLES
ROOF: BEADED TIN
PORCH: CEMENT WITH CONCRETE BLOCK STEPS

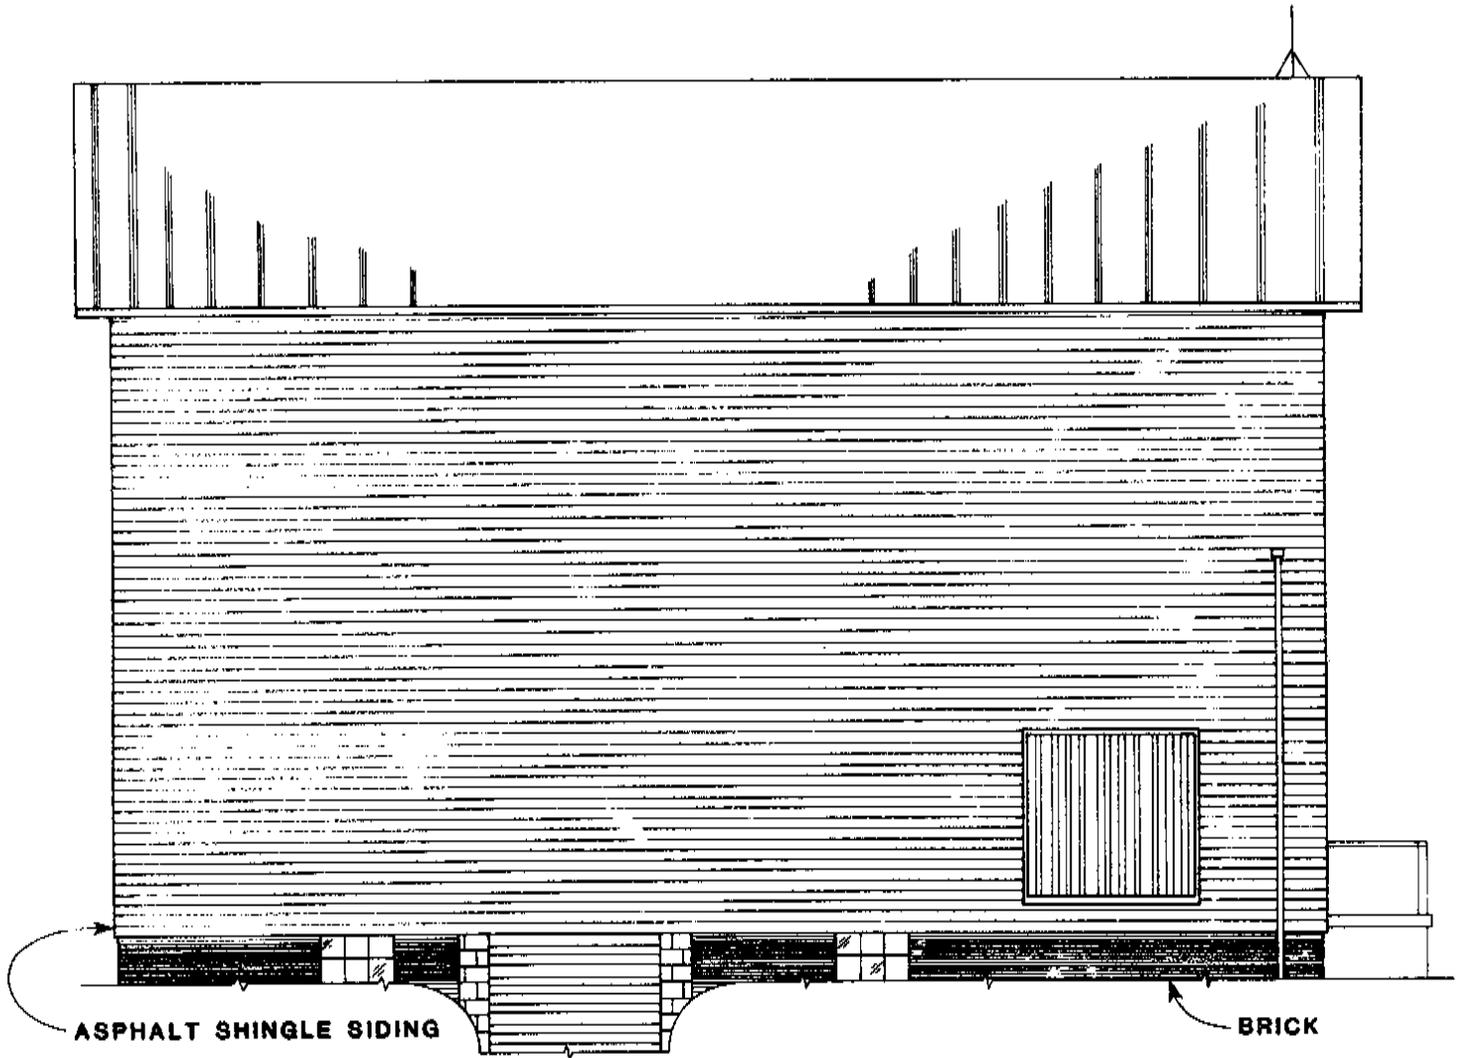
FIGURE 10

ELEVATION

NORTH ELEVATION

FOUNDATION: BRICK
WALLS: ASPHALT SHINGLE SIDING
ROOF: BEADED TIN

The basic floor plan of all three floors is an open rectangle four bays wide and three bays deep formed by the framing of the building (Figures 11, 12, 13, 14, 15, 16). The twelve bays per floor are created by the repetition four times front to back of five vertical support members. Along the walls, brick buttresses form these supports in the basement and 8" x 8" posts form them on the first and second floors. The six interior vertical supports are free-standing posts on each floor, 9-3/4" x 9-3/4" (on brick footings) in the basement and 8" x 8" on the first and second floors. Horizontal framing is by 10" x 10" sills, 8" x 8" girts and plates, and summer beams (9-3/4" x 9-3/4" above the basement, 8" x 10" above the first floor and 8" x 8" above the second floor) which parallel the end walls. The summer beams have scarf joints centered over interior posts so that in each case there is a two bay long summer beam connected by a scarf joint to another, one bay long, the location of these joints varies from bay to bay and floor to floor (Figures 10, 11, 12, 15).

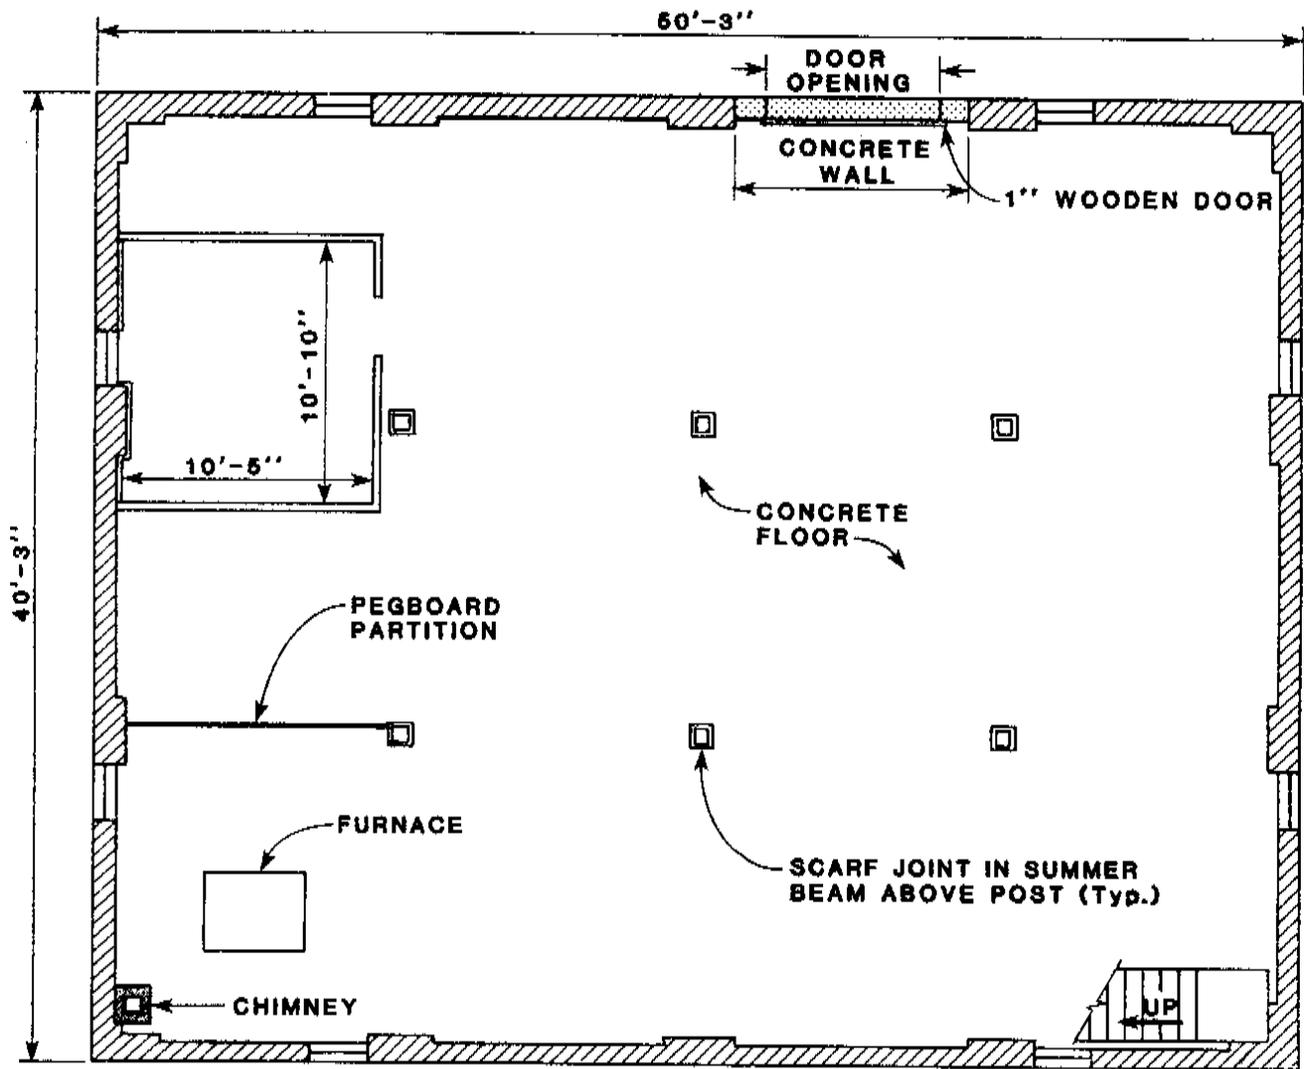
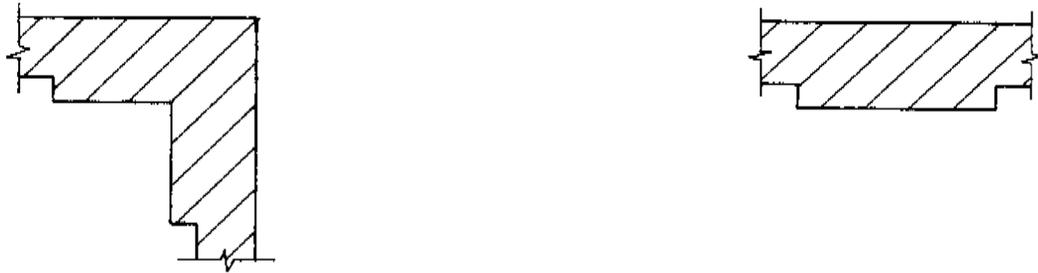
FIGURE 11

PLAN AND DETAIL

BASEMENT PLAN

DETAIL OF PILASTERS

The floor plan of the basement remains much as it was originally, although sheetrock and pegboard partitions have been added extending in from the west wall to form four areas one baywide and of varying depth (Figure 11). A brick chimney is against the west wall in the southernmost of these areas and a coal furnace, added later, is in front of it. Separated from this area by a pegboard partition, the area north of it is used as a shop/tool storage area. The presence of a series of cubbyholes along the western wall which may date to the original construction indicates that this area, although not always partitioned off, may always have been used similarly. North of this is a recent, uncompleted, sheetrocked room. The most northerly of these four areas is used only for storage. No other spacial separations are present in the basement, although temporary shelving has been placed in the two central bays at the east end of the building. A straight stairway leading to a trap door on the first floor is located in the southeast corner of the basement (Figures 11, 14).

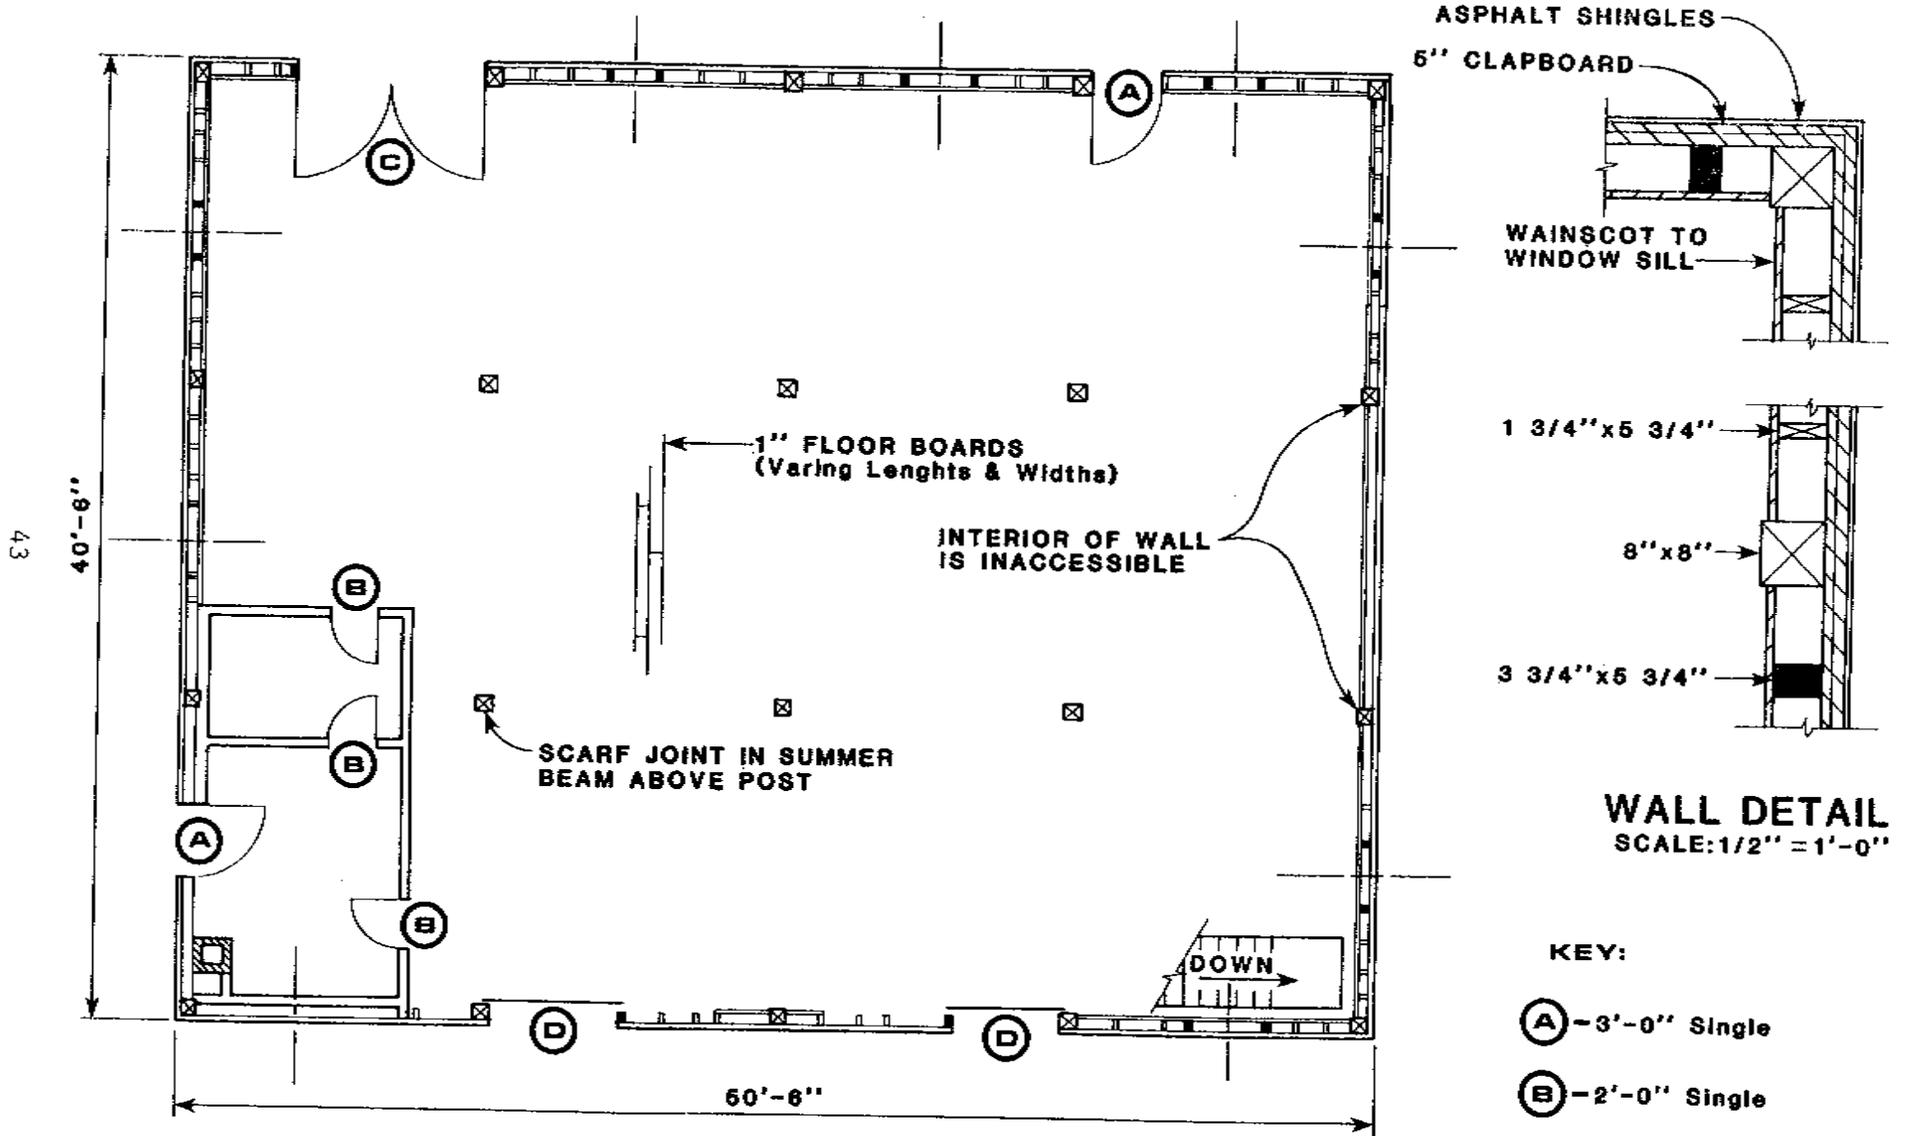
FIGURE 12

FLOOR PLAN AND DETAIL

FIRST FLOOR PLAN

The asphalt shingle siding has covered all features on the exterior of the north wall of the first floor except a 6' 8" high x 7' wide double door (Figure 12). This door is not original; its construction required the destruction of all but the lintel and top portions of the frame studs of a window which would have completed an original symmetry of one window centered in each bay of the north wall. All these windows were boarded up prior to or at the time of the placement of shingle siding on the exterior of the building. At the western end of the east bay of the north wall is framing for a pedestrian door, now boarded up and covered by siding. This door appears to have been included in the original construction of the structure and probably led into the shed attachment which housed the steam boiler (Figure 6) and later oil engine (Figure 7). Two windows are visible in the interior of the east wall, although both (and probably a third now covered by tongue-and-groove boards from floor to ceiling in the center bay) were boarded up and covered with shingle siding as were those of the north wall.

The plan of the first floor included a 10' 6" x 8' 0" room in the southwest corner (Figure 12). It appears to be original

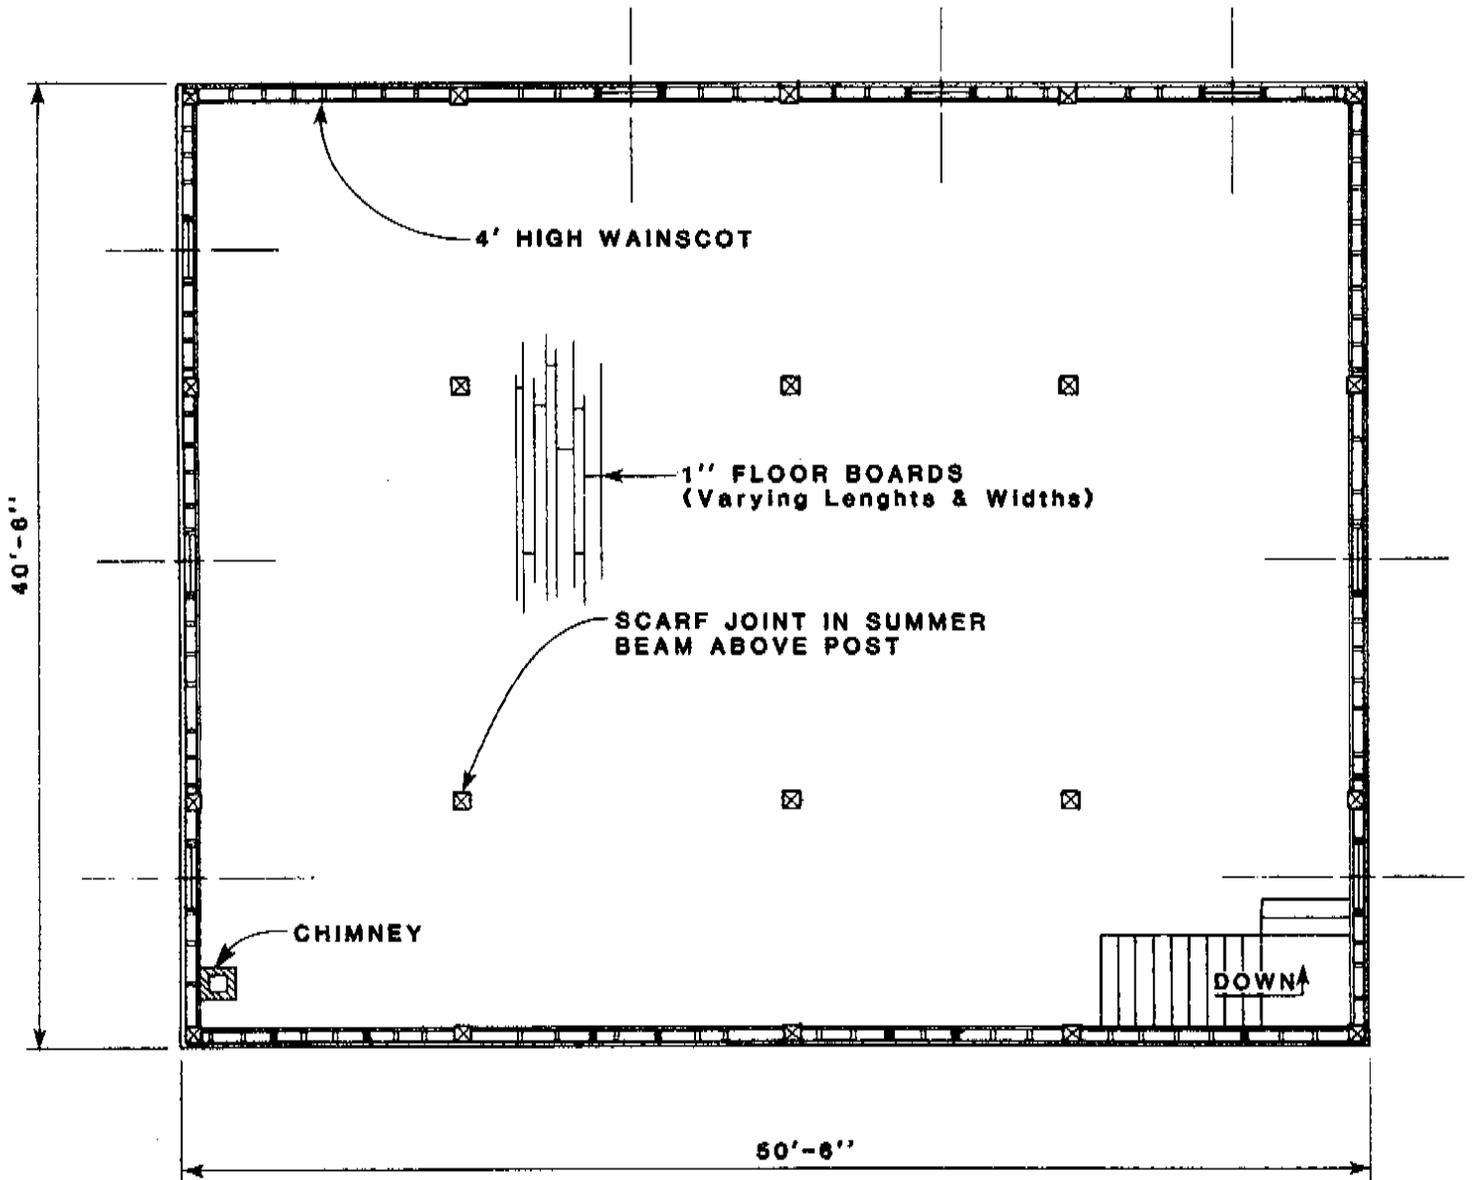
FIGURE 13

FLOOR PLAN

SECOND FLOOR PLAN

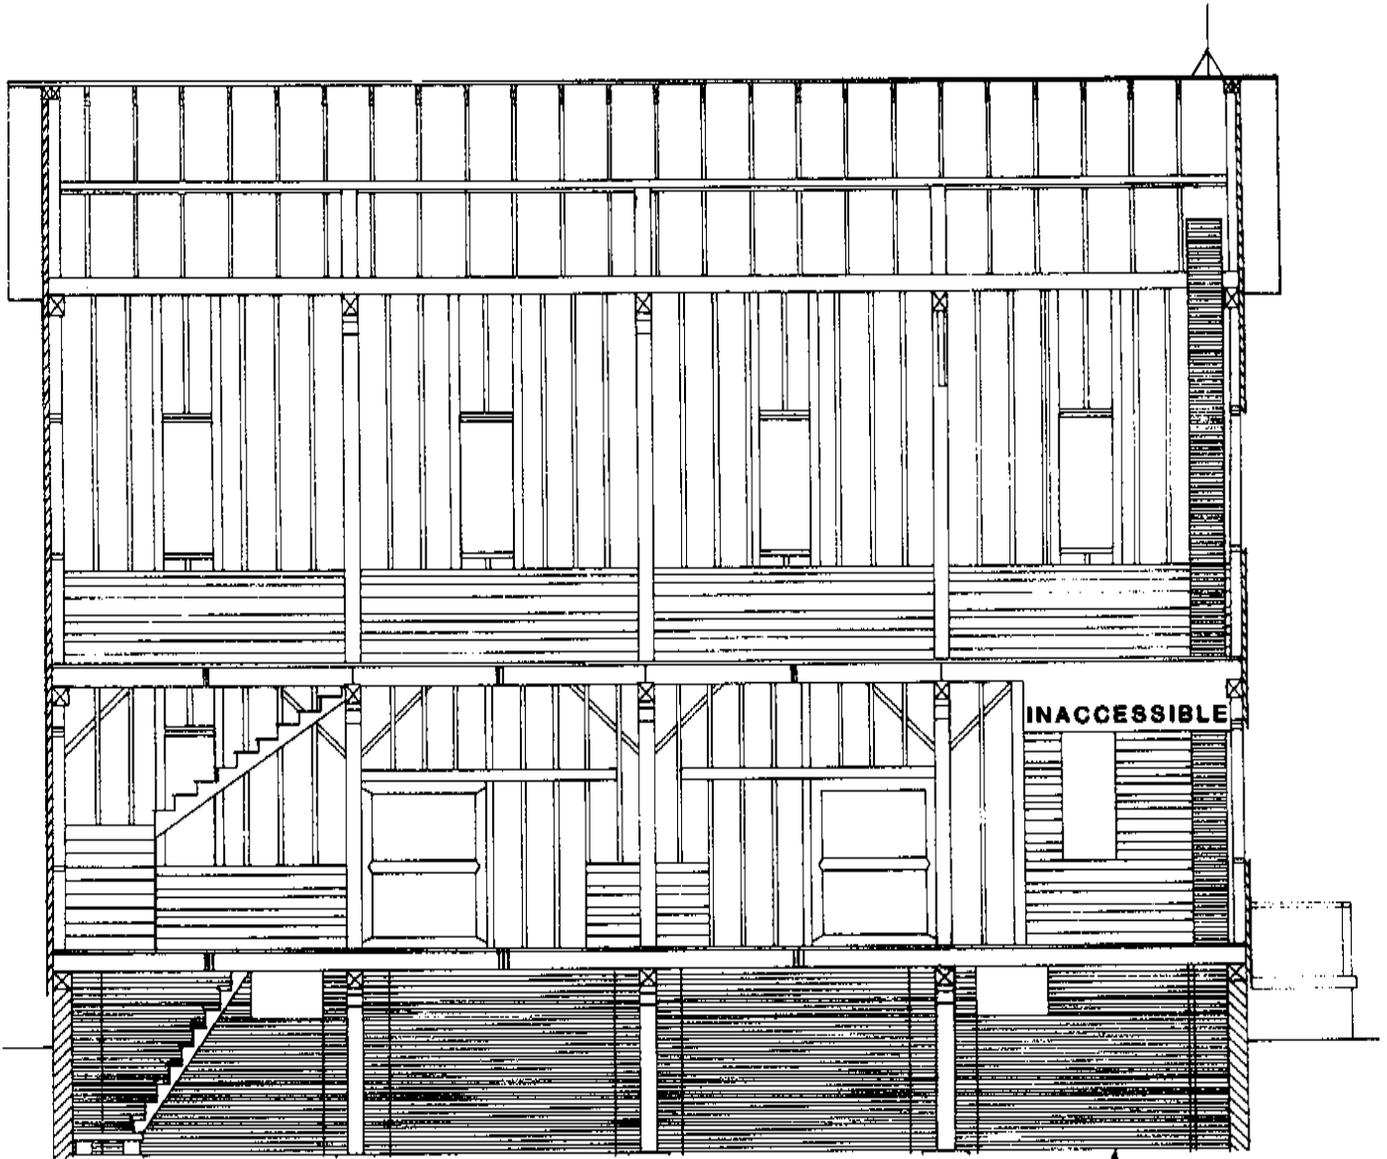
FIGURE 14
CROSS SECTION

SOUTH CROSS SECTION
SCALE: 1/8" = 1'-0"

1. Exterior Clapboard Siding, Visible Between Studs, And Roof Boards, Visible Between Rafters, Omitted For Clarity
2. For Machine Bracing Above Second Floor, See Fig. 22
3. Basement Windows Boarded Up On Interior
4. Rafter Spacing And Exterior Roof Inaccessible, So Sizes Are Estimated

FOUNDATION: BRICK
STRUCTURAL SUPPORT: OAK
NON-STRUCTURAL ELEMENTS: PINE
ROOF: BEADED TIN

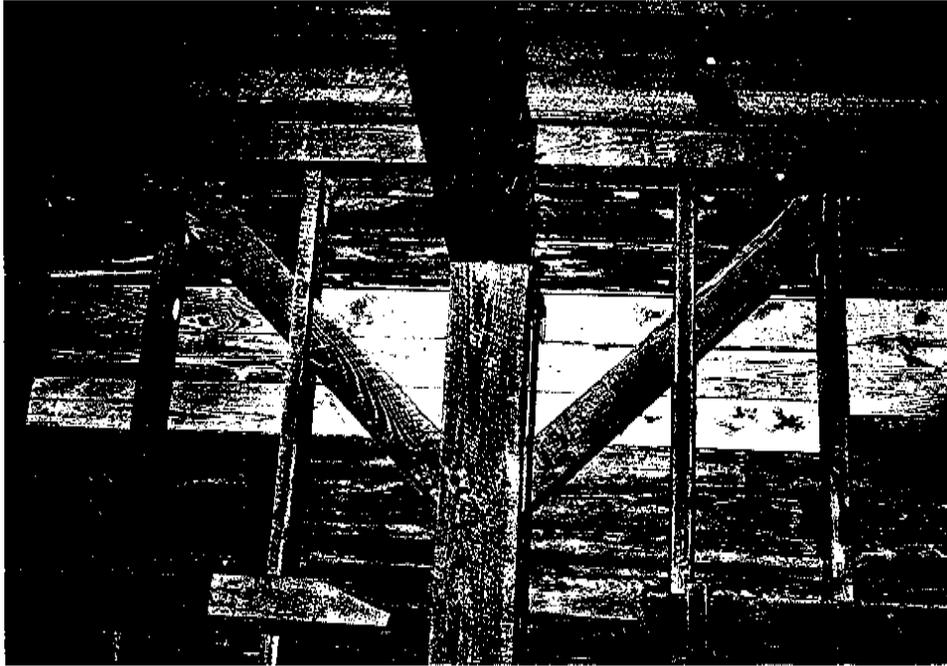
PLATE 8

DETAIL OF POST AND GIRTS,
MORTISED AND TENONED BRACING

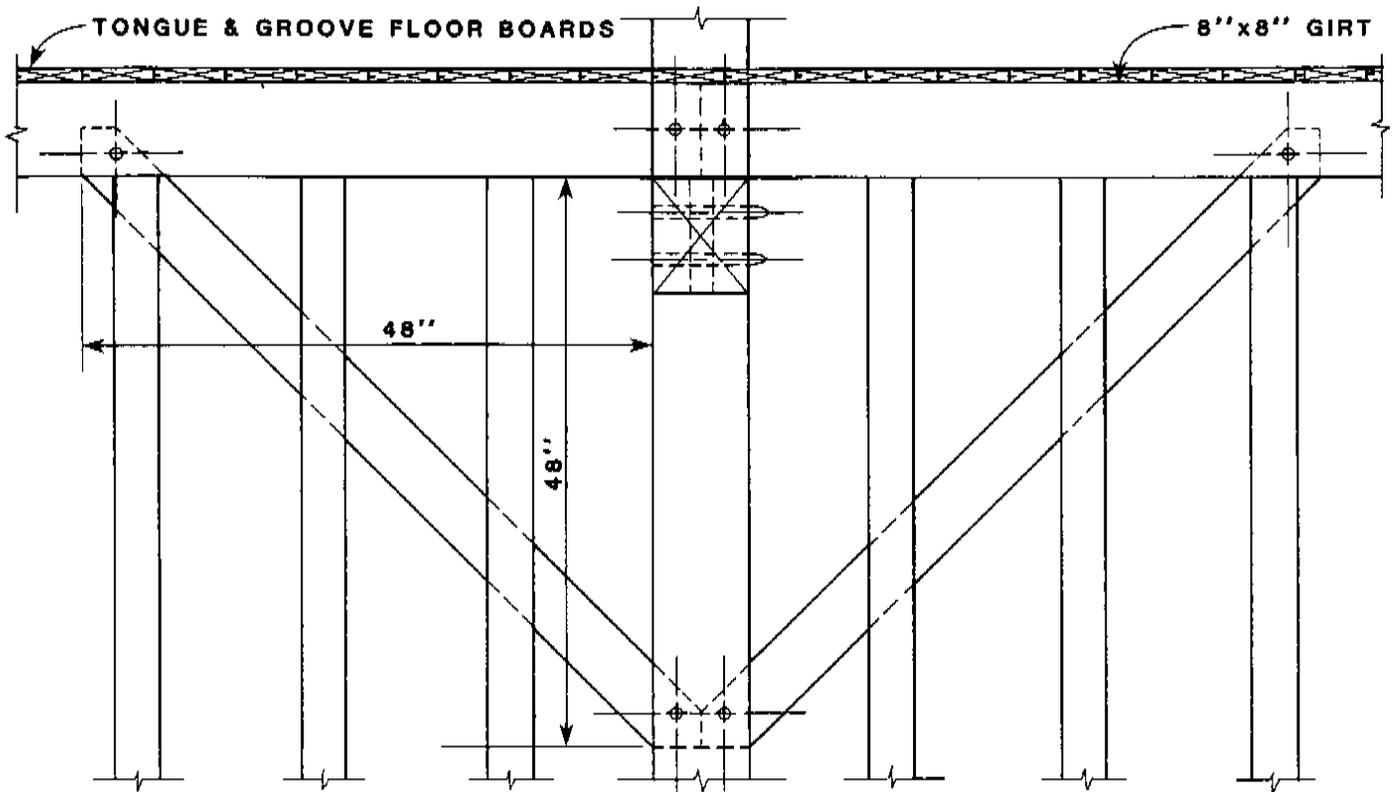
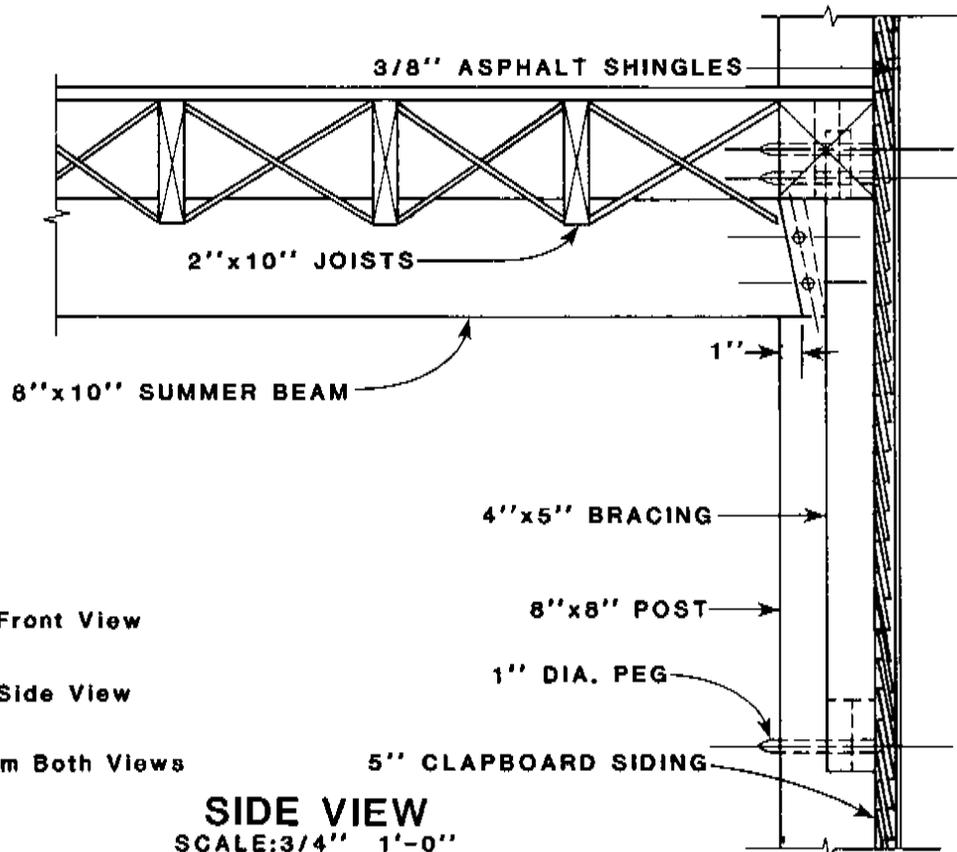
FIGURE 17

WALL BRACING DETAIL

FRONT VIEW
SCALE: 3/4" 1'-0"

1. Joists Omitted From Front View
2. Studs Omitted From Side View
3. Wainscot Omitted From Both Views

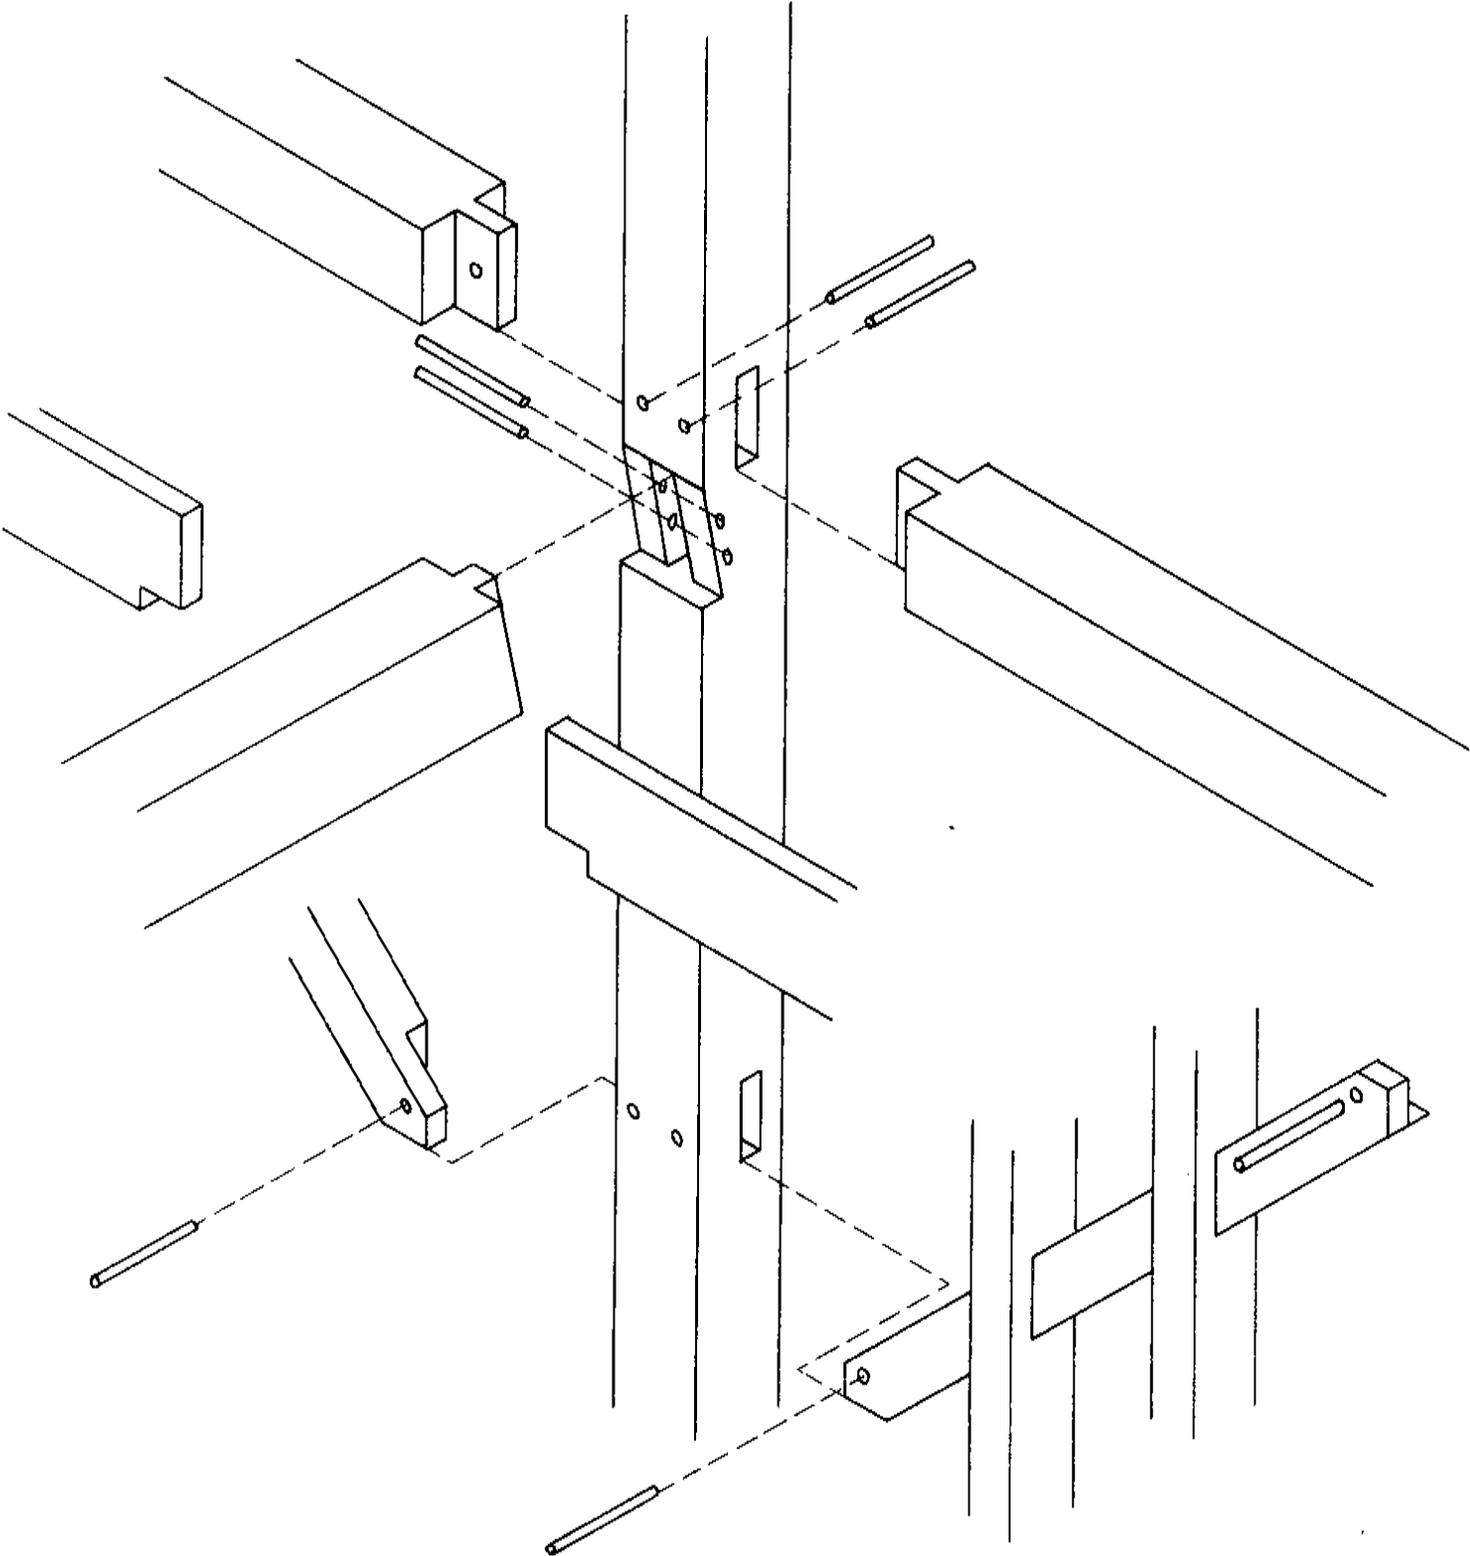
FIGURE 18

EXPLODED VIEW OF WALL BRACING DETAIL

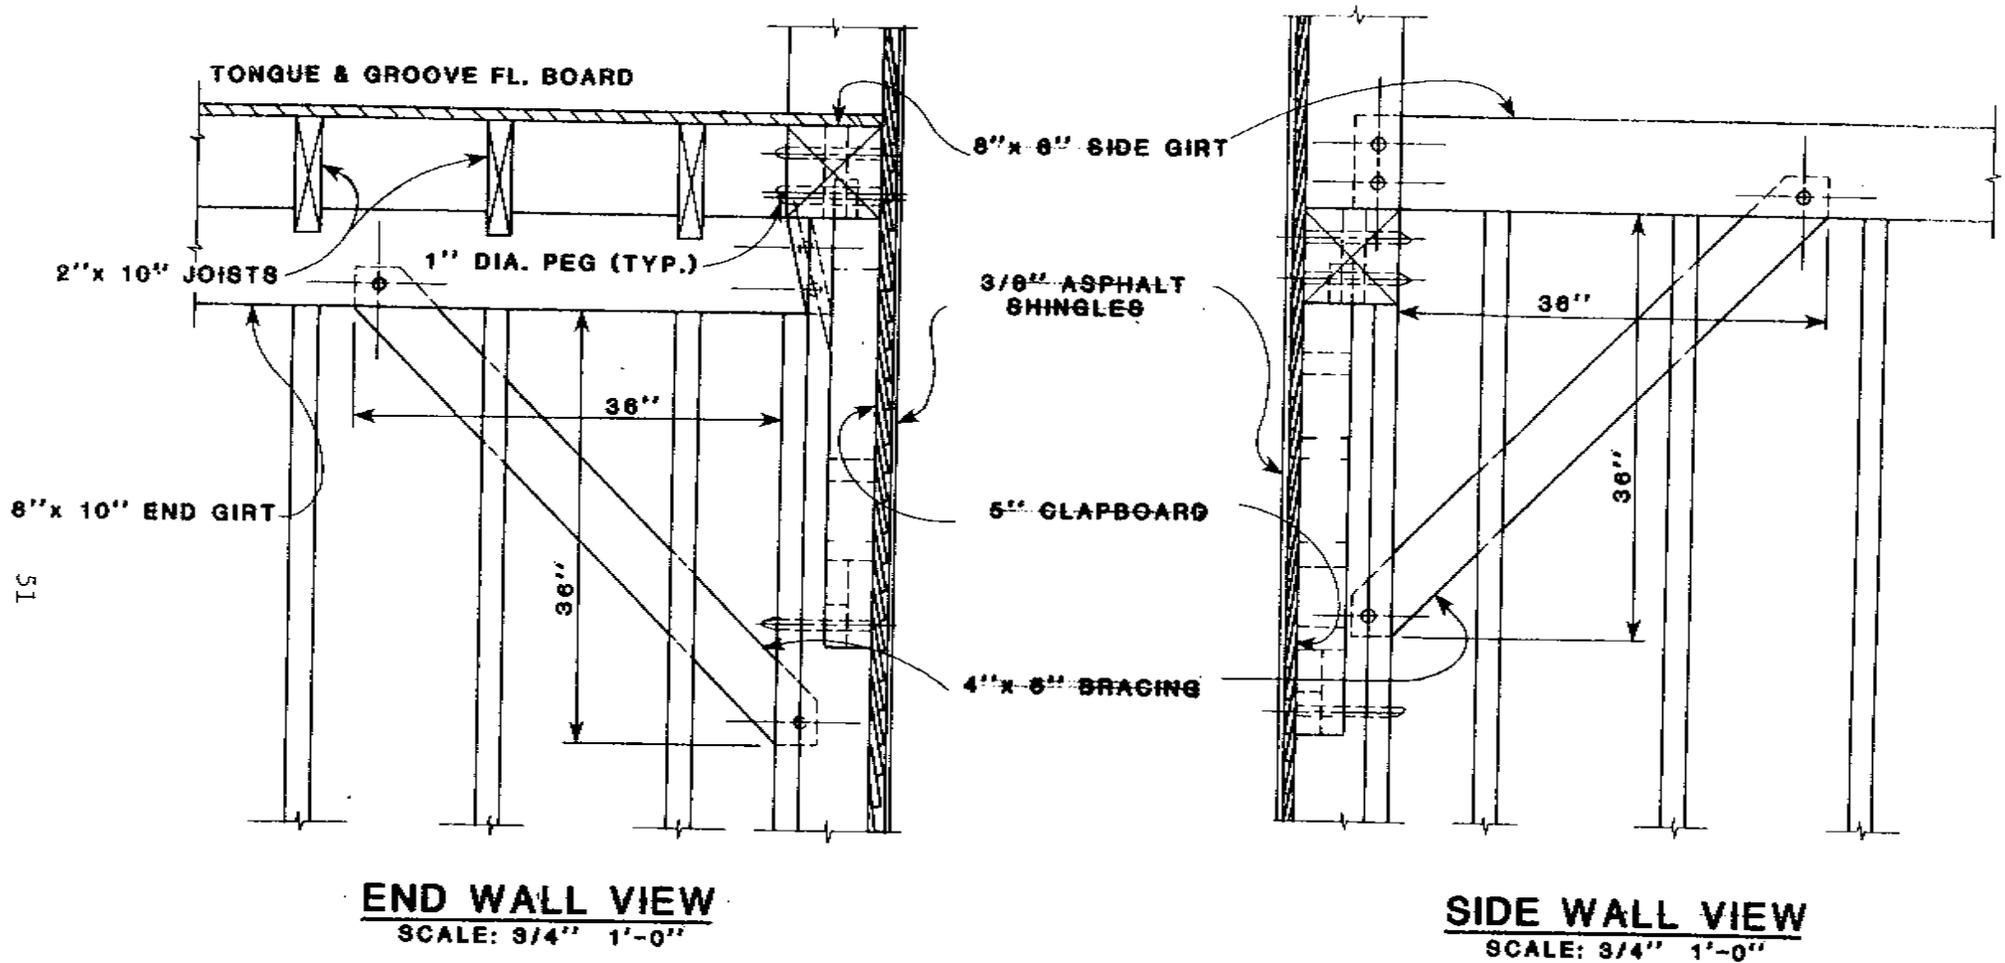
FIGURE 19

CORNER BRACING DETAIL

1. For Clarity, Clapboarding And Studs On End, Are Shown Only In Cross Section.
2. For Clarity, Joists Are Omitted From Side Wall View And Wainscot From Both.

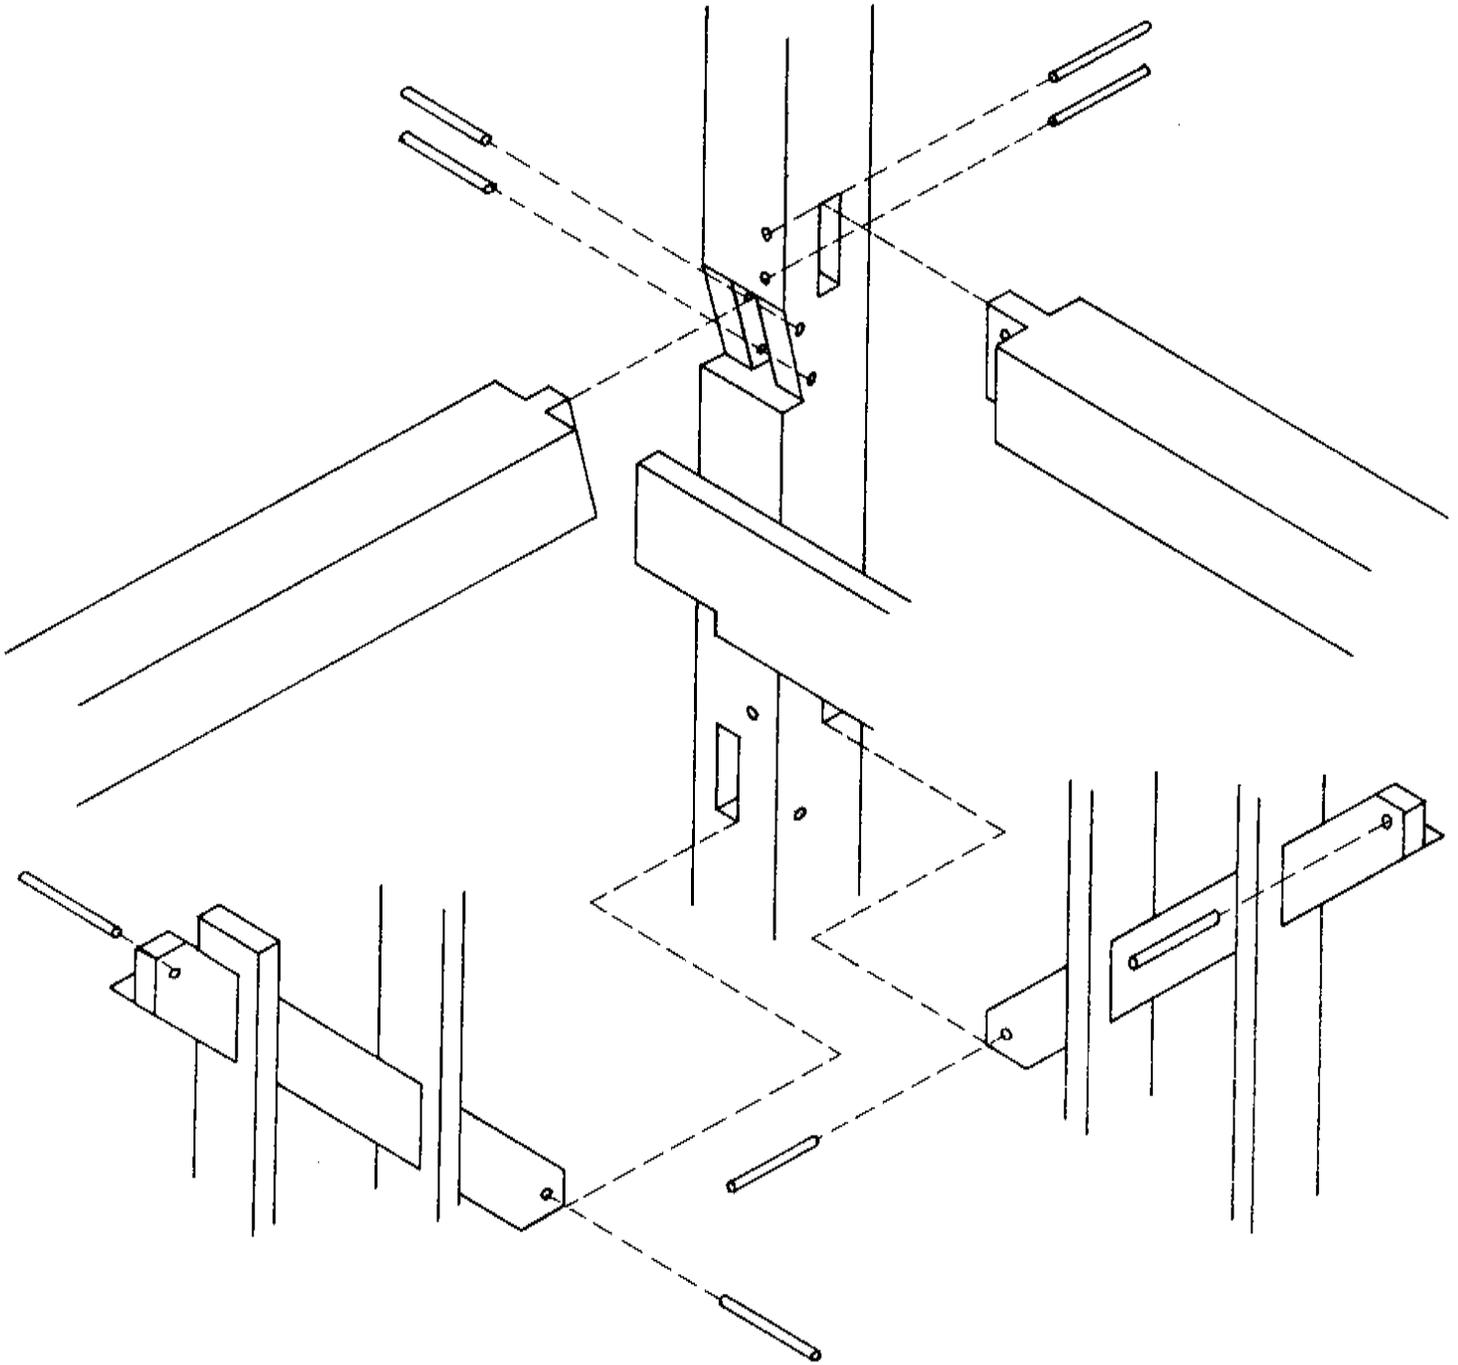
FIGURE 20

EXPLODED VIEW OF CORNER BRACING DETAIL
