INTRODUCTION AND STATEMENT OF PURPOSE

This report presents the results and recommendations of a preliminary cultural resource survey, including archaeological excavations, historical research, and architectural recordation at the Cantrell Warehouse/Enterprise Mill on Stein Highway in Seaford, Sussex County, Delaware (Figure 1 & Plates 1 and 2). The project was undertaken by the Delaware Department of Transportation, Division of Highways, Location and Environmental Studies office. The purpose of the research was to satisfy requirements of Section 106 of the National Historic Preservation Act. In order to accomplish this goal, the site was researched in order to determine its limits, context, and integrity. The mill structure itself was architecturally assessed to determine its structural integrity and significance on both a local and regional scale. Historical research was designed to address several previously published and unpublished appraisals of the structure and the association of the structure with persons of historical significance.

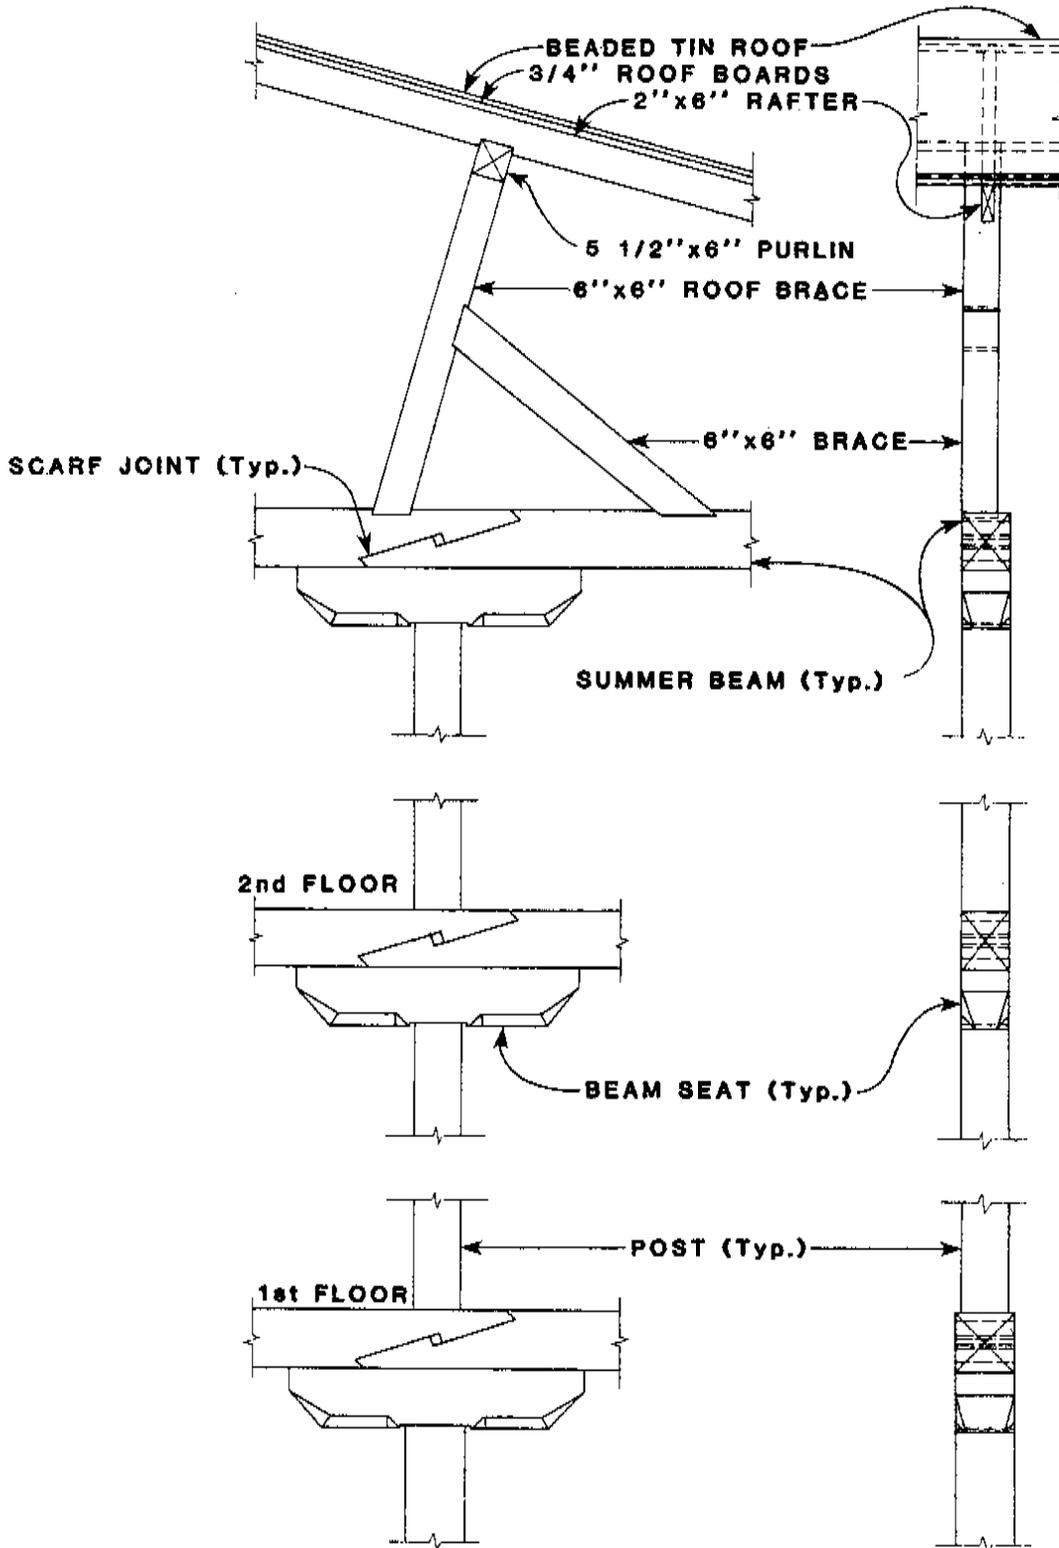
FIGURE 21

DETAIL AND SECTION OF RAFTER AND BEAM SEATS

POST	BEAM SEAT	SUMMER BEAM
BASEMENT	10"x10"	10"x10"x60"	10"x10"
1st FLOOR	8"x8"	10"x8"x48"	10"x8"
2nd FLOOR	8"x8"	10"x8"x48"	10"x8"

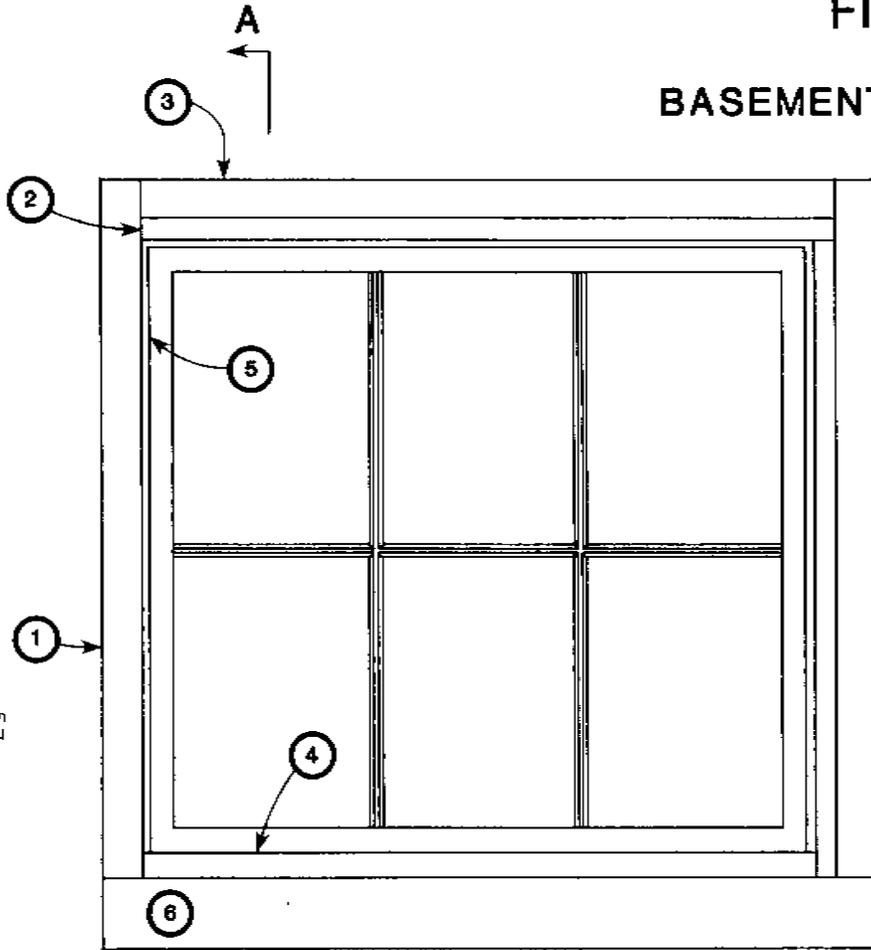
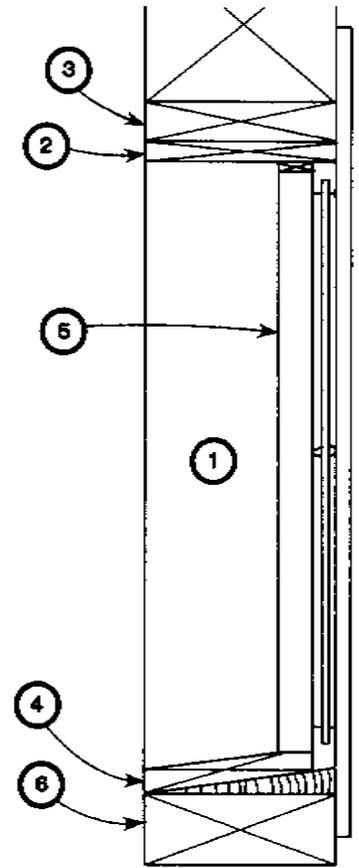
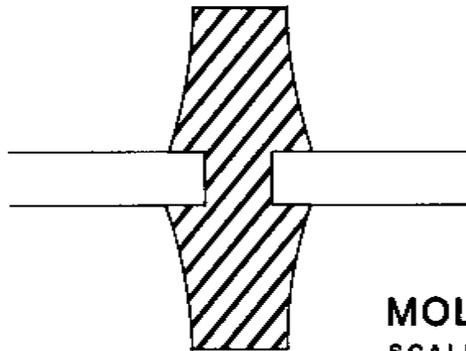
FIGURE 22

BASEMENT WINDOW DETAIL

- 1 - 1 3/4" x 27"
- 2 - 7/8" x 29"
- 3 - 1 5/8" x 29"
- 4 - 1" x 28 1/8"
- 5 - 1/4" x 1 3/8"
- 6 - 3" x 32"

EXTERIOR ELEVATION

VIEW OF WINDOW CASING
SCALE 1 1/2" = 1'-0"

MOLDING DETAIL

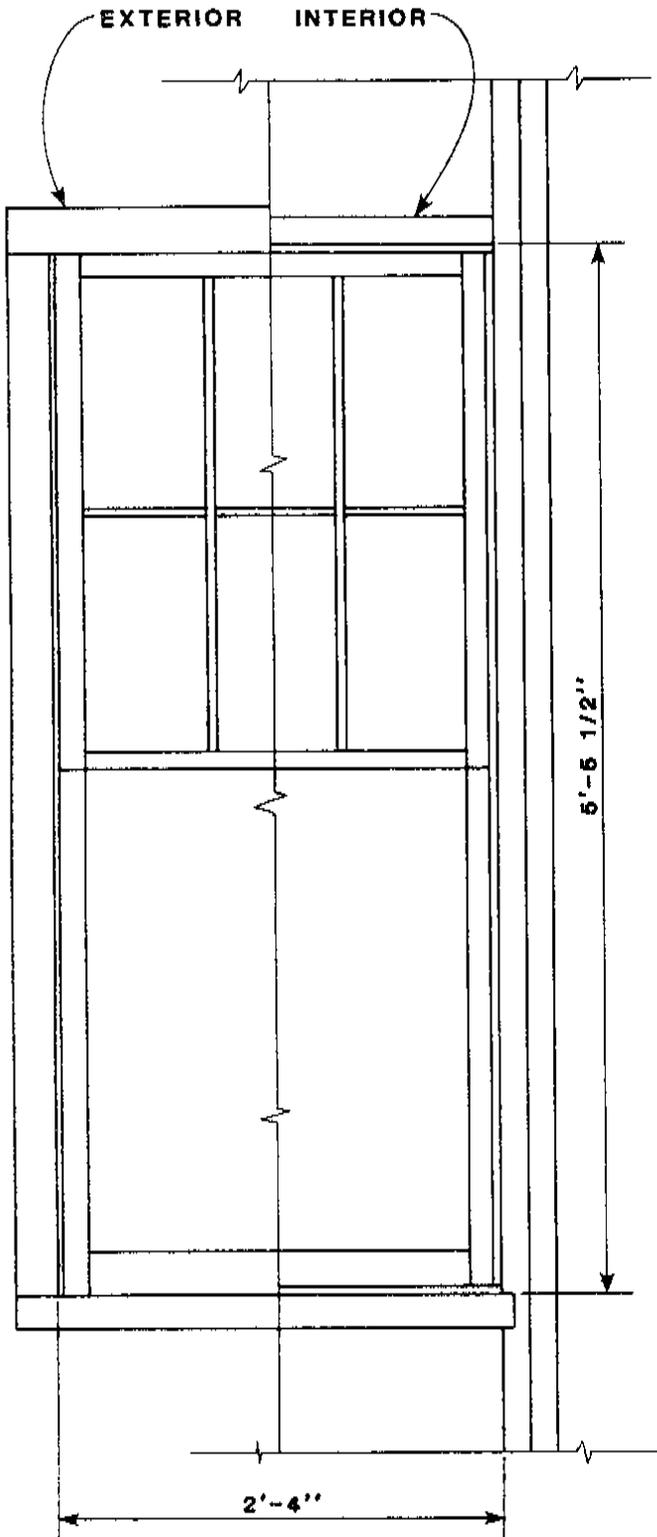
FIGURE 23

WINDOW AND MULLION DETAIL

MULLION
SCALE: FULL

WINDOW
SCALE: 1" = 1'-0"

The second floor windows on the south and west sides of the building are the same type as those of the first floor and one is located in the center of each bay (Plates 1,2, Figures 8, 9, 13, 23). Those on the north and east walls have been boarded up and covered with shingle siding as were those of the first floor. There is no evidence that a window ever existed in the west bay of the north wall which would have completed the second floor

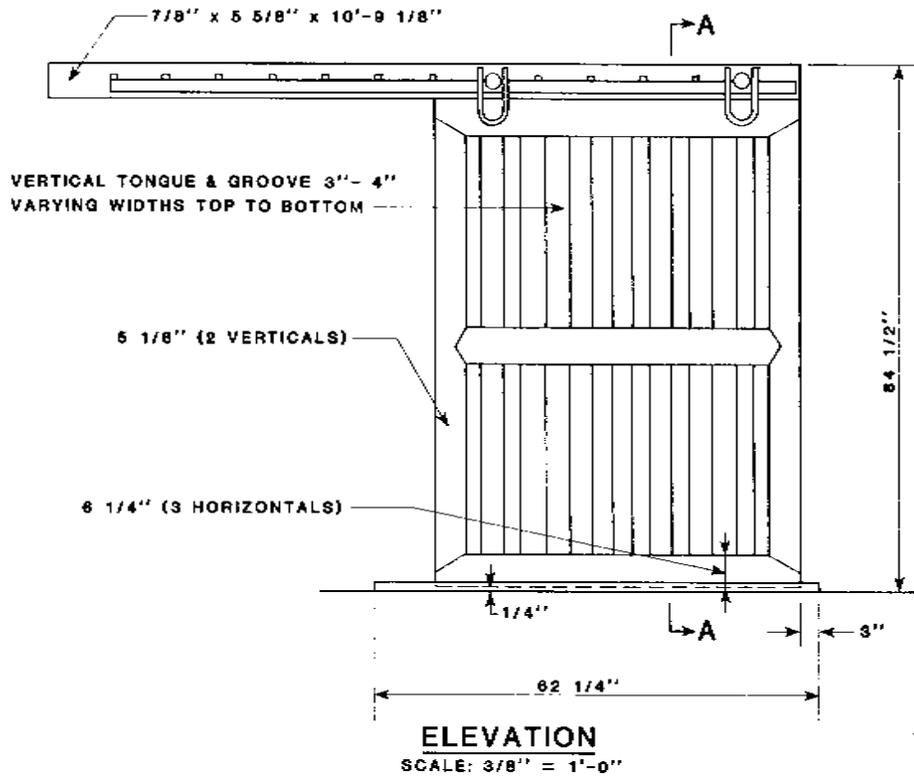
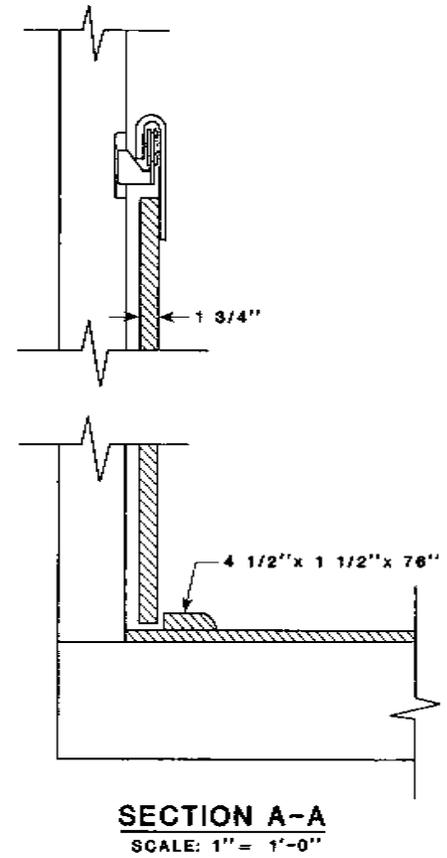
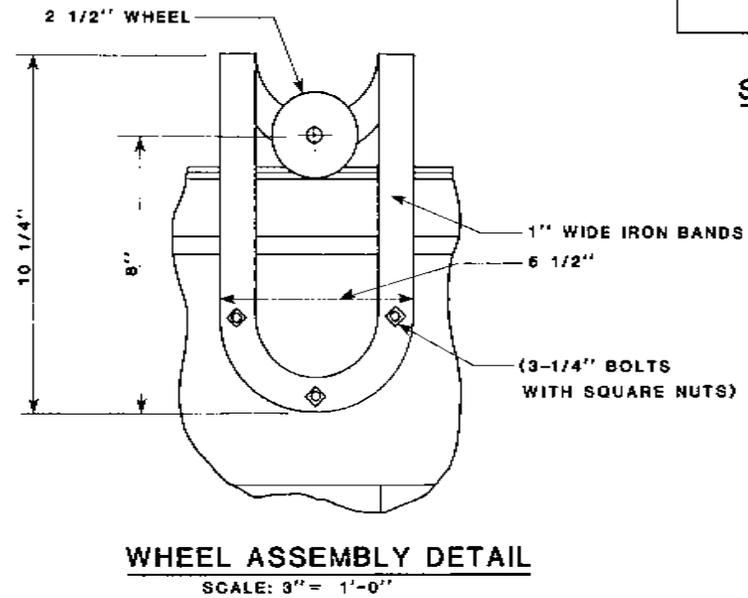
FIGURE 24

SOUTH SIDE LOADING DOORS
(EAST SIDE DOOR OPPOSITE)

On the first floor, the south wall maintains its exterior symmetry with one 5' 2- $\frac{1}{4}$ " wide wooden sliding door in each of the central bays and one six over one light double sash window with plain molding and sloping sill in each of the two exterior bays (Figures 8, 12, 14). All existing first and second floor windows (and probably all original windows on these floors) are of this type (Figure 23). Wainscoting is present to the window sill level as shown on Figure 12. The sliding doors on the south wall are attached by pulley-type rollers on the top and set on a track allowing them to be opened by sliding towards the center of the

building (Figure 24). They appear to be the original means by which grain was brought in and finished products were removed as they are the only wide doors included in the original construction of the building. An exterior near-symmetry is created on the west wall of the first floor by a pedestrian door (Figure 25) which opens into an office in the south bay and one window in each of the central and north bays.

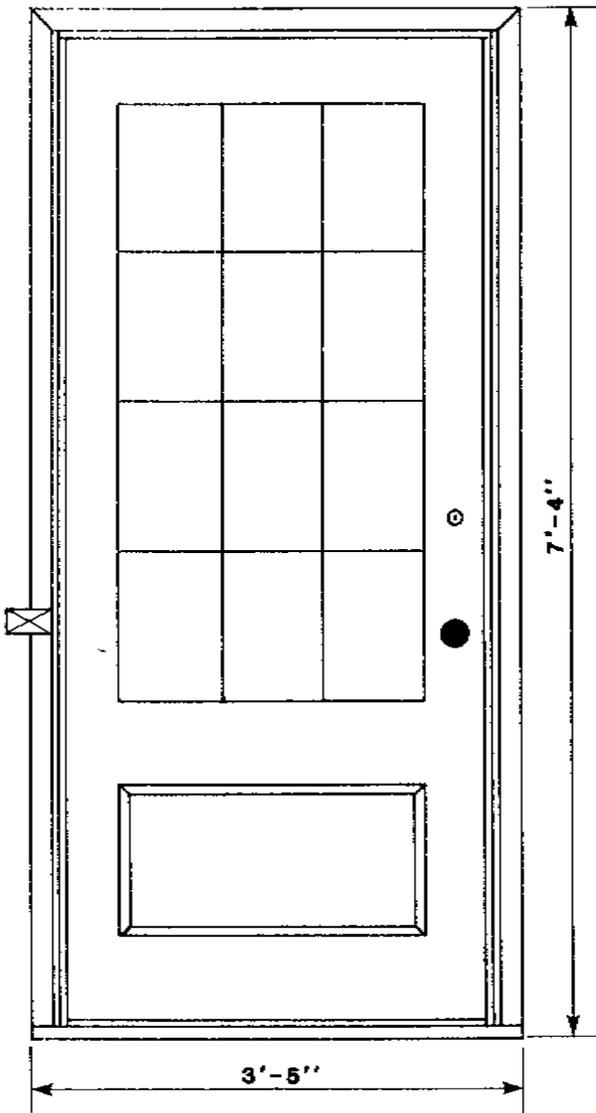
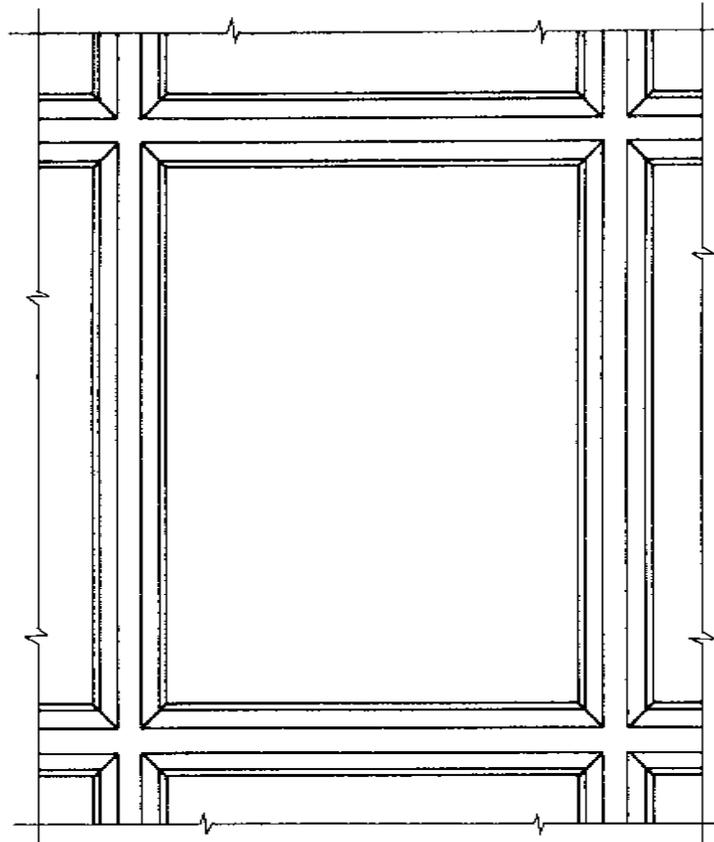
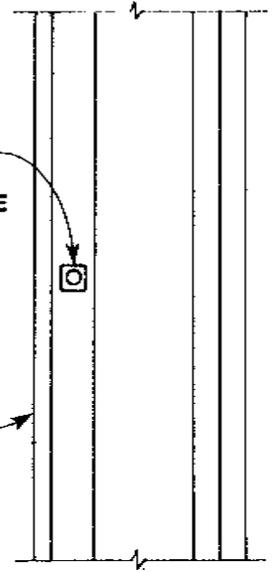
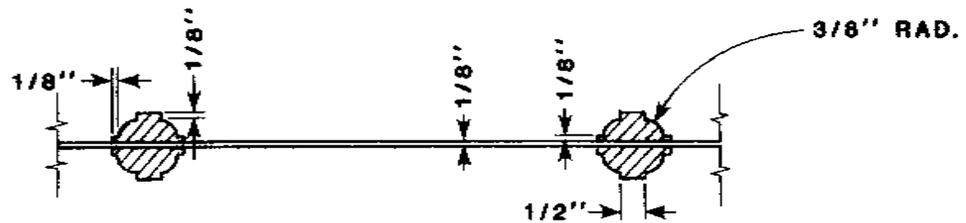
PEDESTRIAN DOOR DETAILS

DOOR
SCALE: 3" = 1'-0"

DOOR LOCK
HOLE LEVEL
W/KEY HOLE

JAMB
SCALE: 1 1/2" = 1'-0"

WINDOW PANE
SCALE: 3/4" = 1'-0"

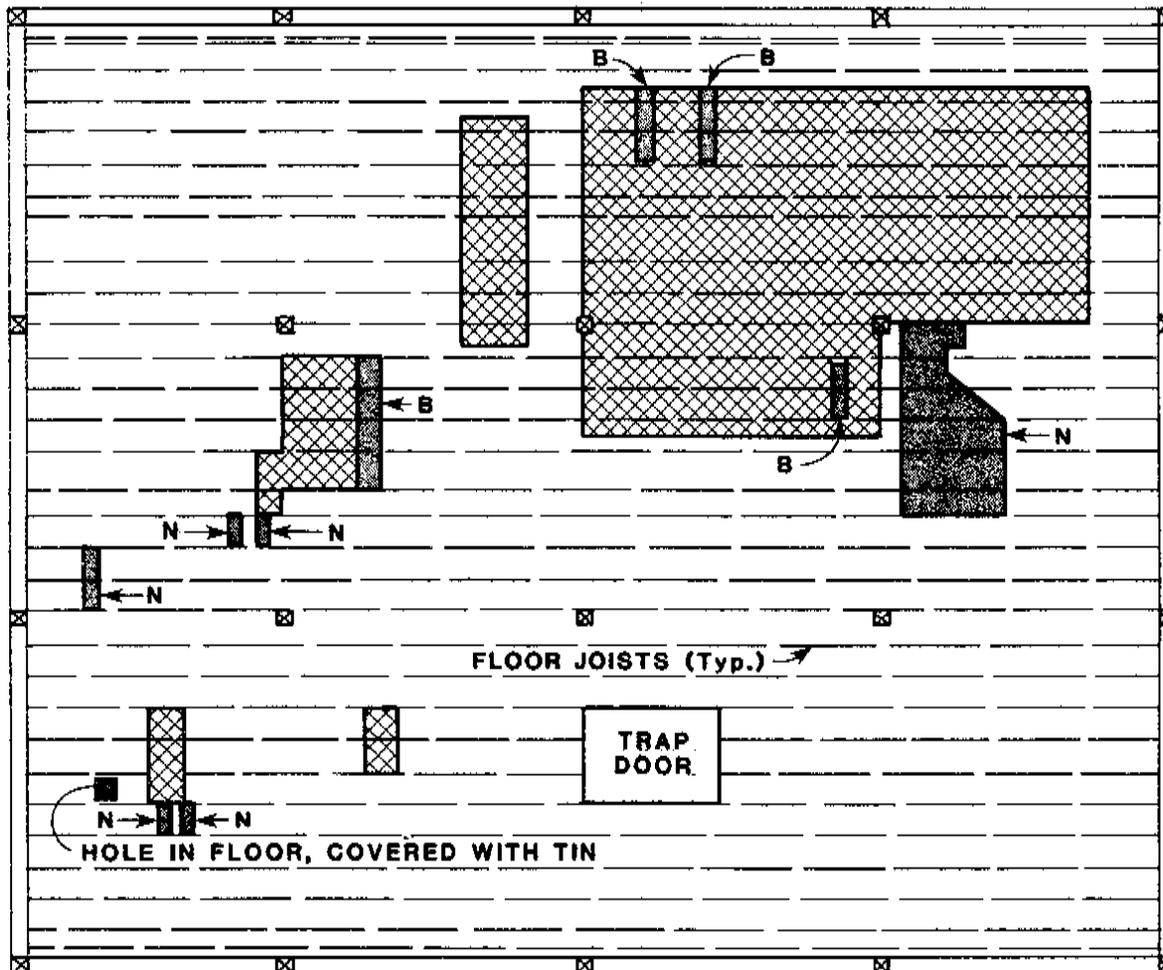
FIGURE 26

POSSIBLE LOCATIONS OF ARCHITECTURAL VESTIGES OF THE MILLING OPERATION - FIRST FLOOR

Although it is beyond the remains of the extant structure to provide an engineering study of the mill operation, some vestiges of that operation remain. Portions of the floorboards of both the first and second floor have been replaced and holes in the floors have been patched, some of which certainly were part of the mill operation. Although materials being stored in the mill probably prevented locating all such vestiges of the operation, those visible have been mapped and are shown on Figures 26 and 27. Also to be noted on these figures are items related to the mill operation which are visible from the floor below that which the figure represents. Specifically, some remains of the top portions of gravity chutes (e.g. Plate 11) by which grain was moved from the second floor to the mill stones and/or rollers on the first floor are visible when looking up from the first floor. Similarly visible are boards which have been bolted or nailed to the joists of both the first and second floors (e.g. Plate 12). These probably served as machinery mounts. Although some of

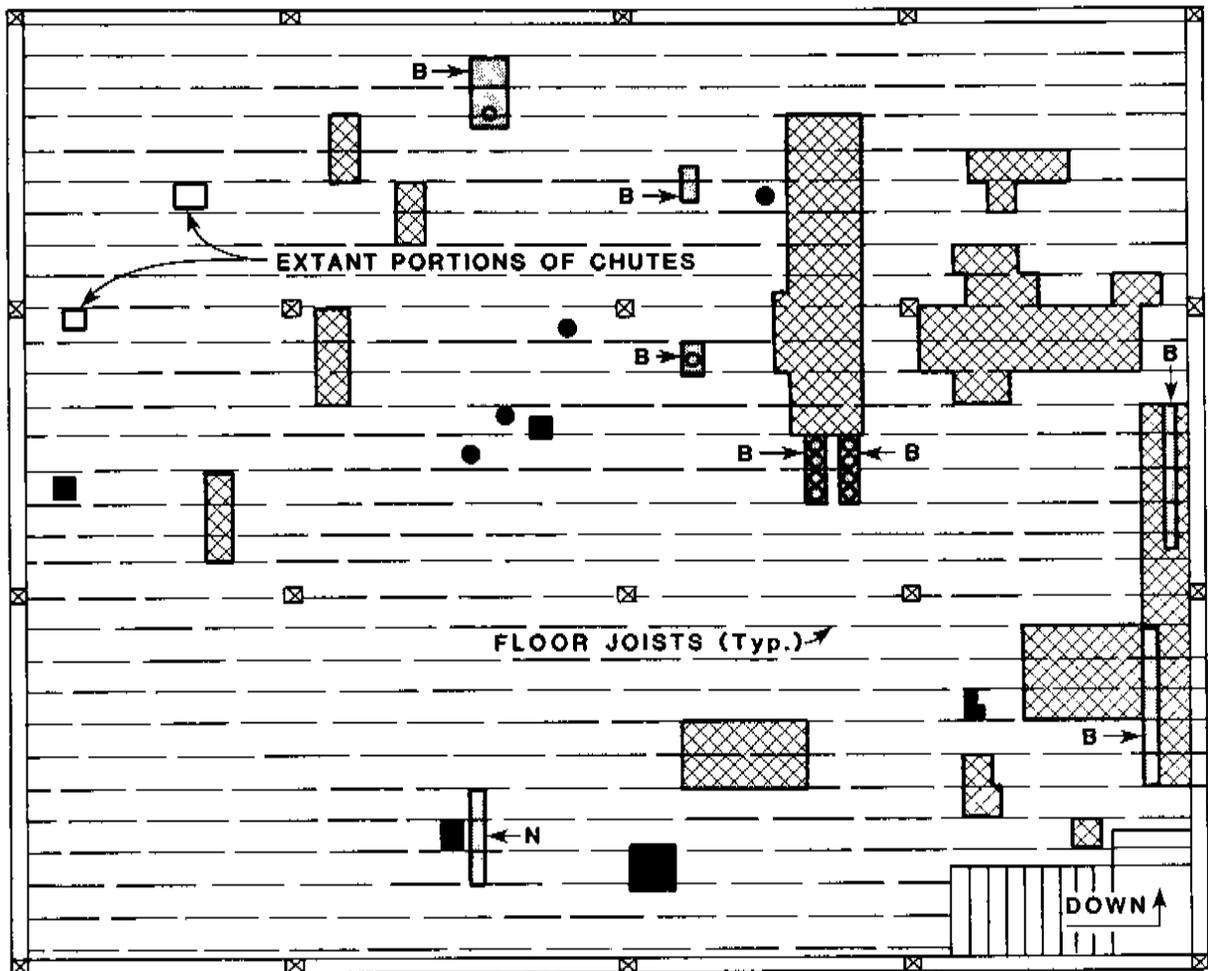
FIGURE 27

POSSIBLE LOCATIONS OF ARCHITECTURAL VESTIGES OF OF THE MILLING OPERATION - SECOND FLOOR

- ← B - Vestiges Bolted To Floor Joists
- ← N - Vestiges Nailed To Floor Joists
- Replaced Floor Boards
- Holes In Floor, Covered By Tin

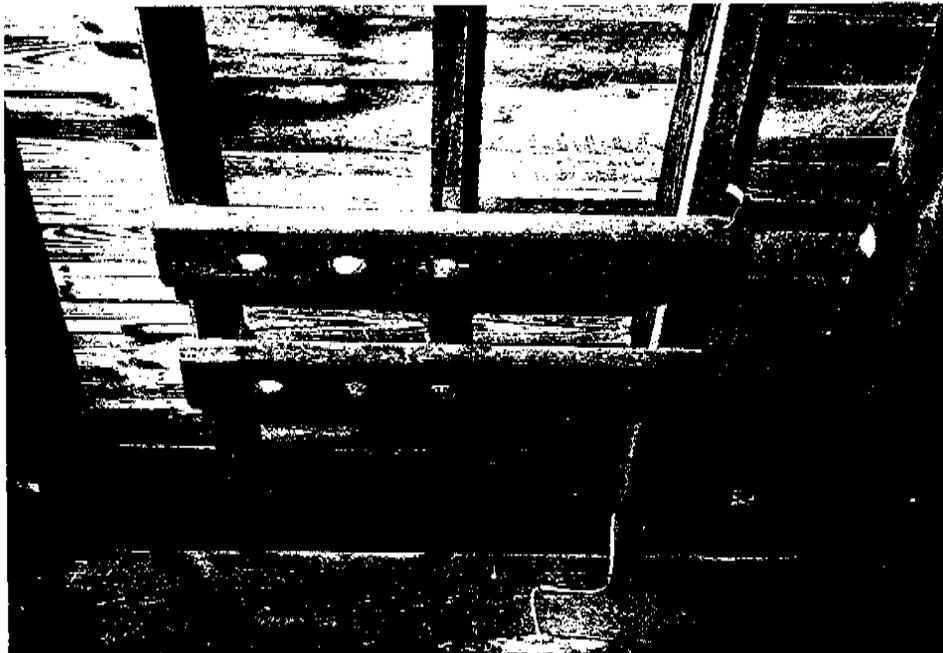
PLATE 12

DETAIL - MACHINE MOUNT

these boards are plain and probably served only as structural supports for machinery, others have holes drilled in them which possibly served as guides for turning axles.

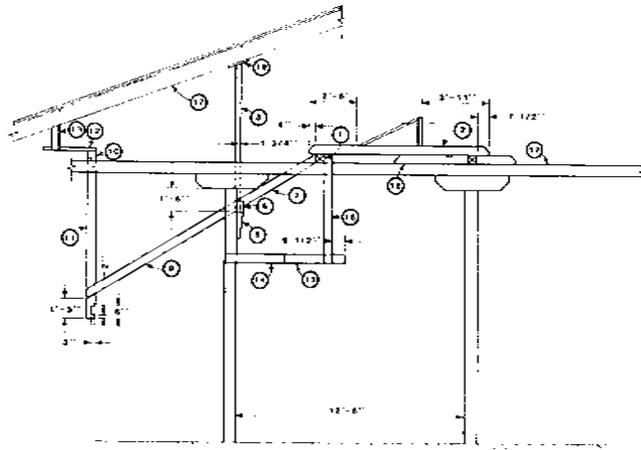
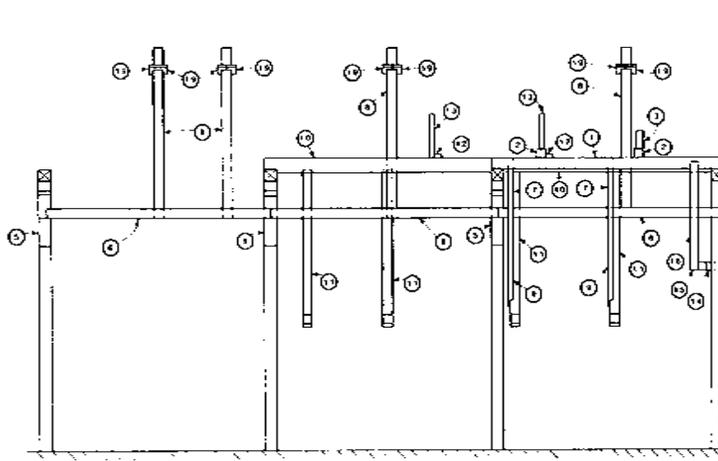
FIGURE 28 MACHINERY BRACING DETAIL

WEST ELEVATION
SCALE: 1/8" 1'-0"

SOUTH ELEVATION
SCALE: 1/8" 1'-0"

Above the second floor, supported by the main structural members of the building, is framework for equipment related to the operation of the mill (Figure 28). Although the specific function of this woodwork remains undetermined, the presence of large bolts at the center of circular grease stains indicates that it at least partially was used as support for a pulley and belt system. This suggests that the framework probably functioned as the uppermost support for the overall power transmission system in the mill and/or was the uppermost bracing of the belt elevator system which carried grain and partially processed materials to the second floor for further processing. However, portions of this framework do not seem to have served this function, and hence the utility of the entire framework is only partially suggested here.

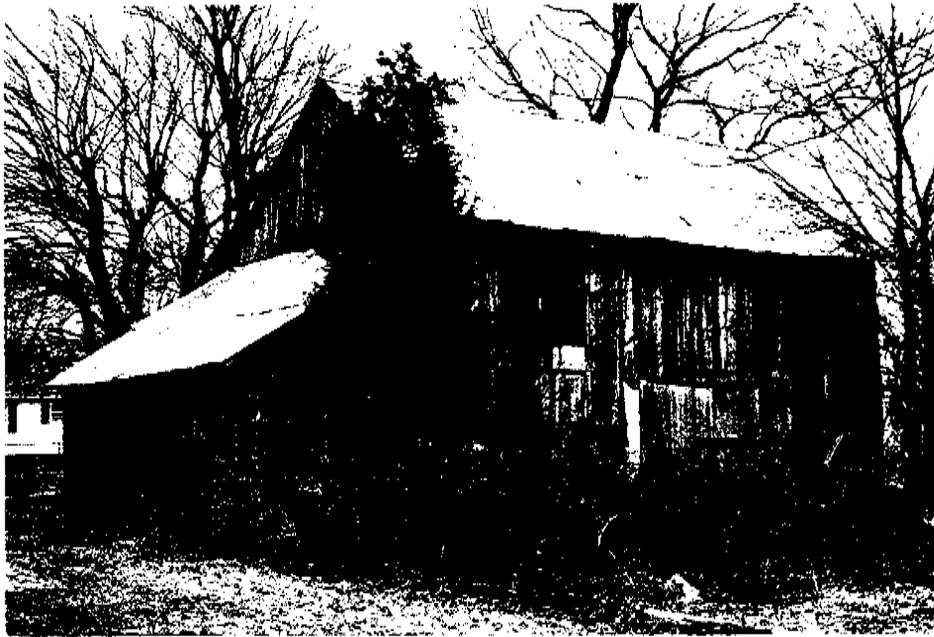
PLATE 13

BARN,
SOUTHWEST CORNER ELEVATION

Although the barn located at the rear of the project property (Figure 29) was not recorded architecturally, it was investigated and photographed (Plates 13, 14). The braced frame barn is a one-and-one-half story structure, suggesting that the second story was used for storage and that it therefore might be the "grainary" mentioned in a 1920 deed (222-201). Although the second story of the barn is vacant, the first floor and the attached lean-to shed are used as storage space for parts of the original mill workings (e.g. Plate 15) primarily those made of wood. These include a vat which enclosed a millstone, an

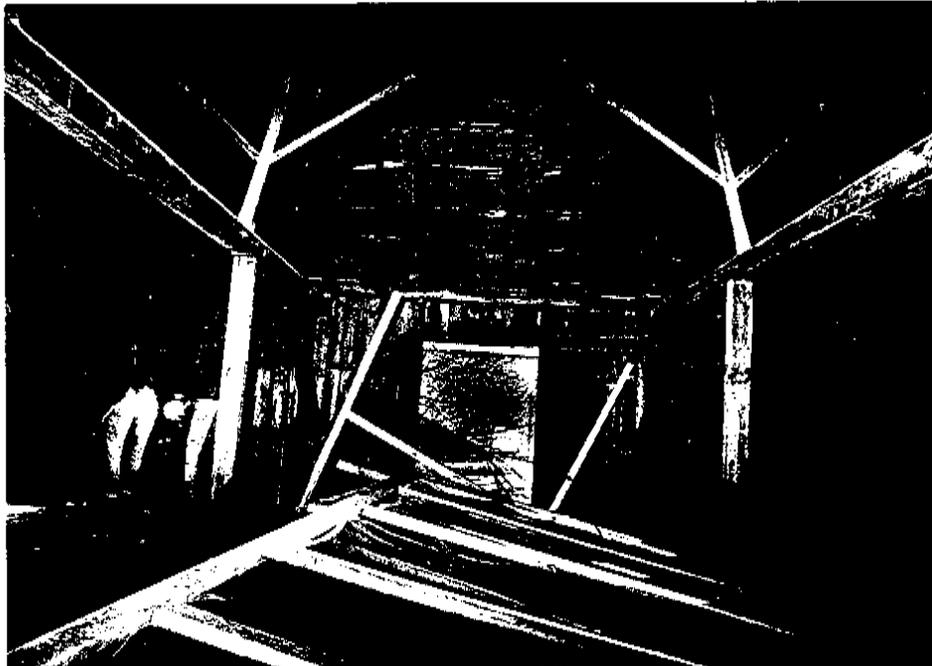
PLATE 14

BARN INTERIOR, SECOND FLOOR,
CENTER BAY

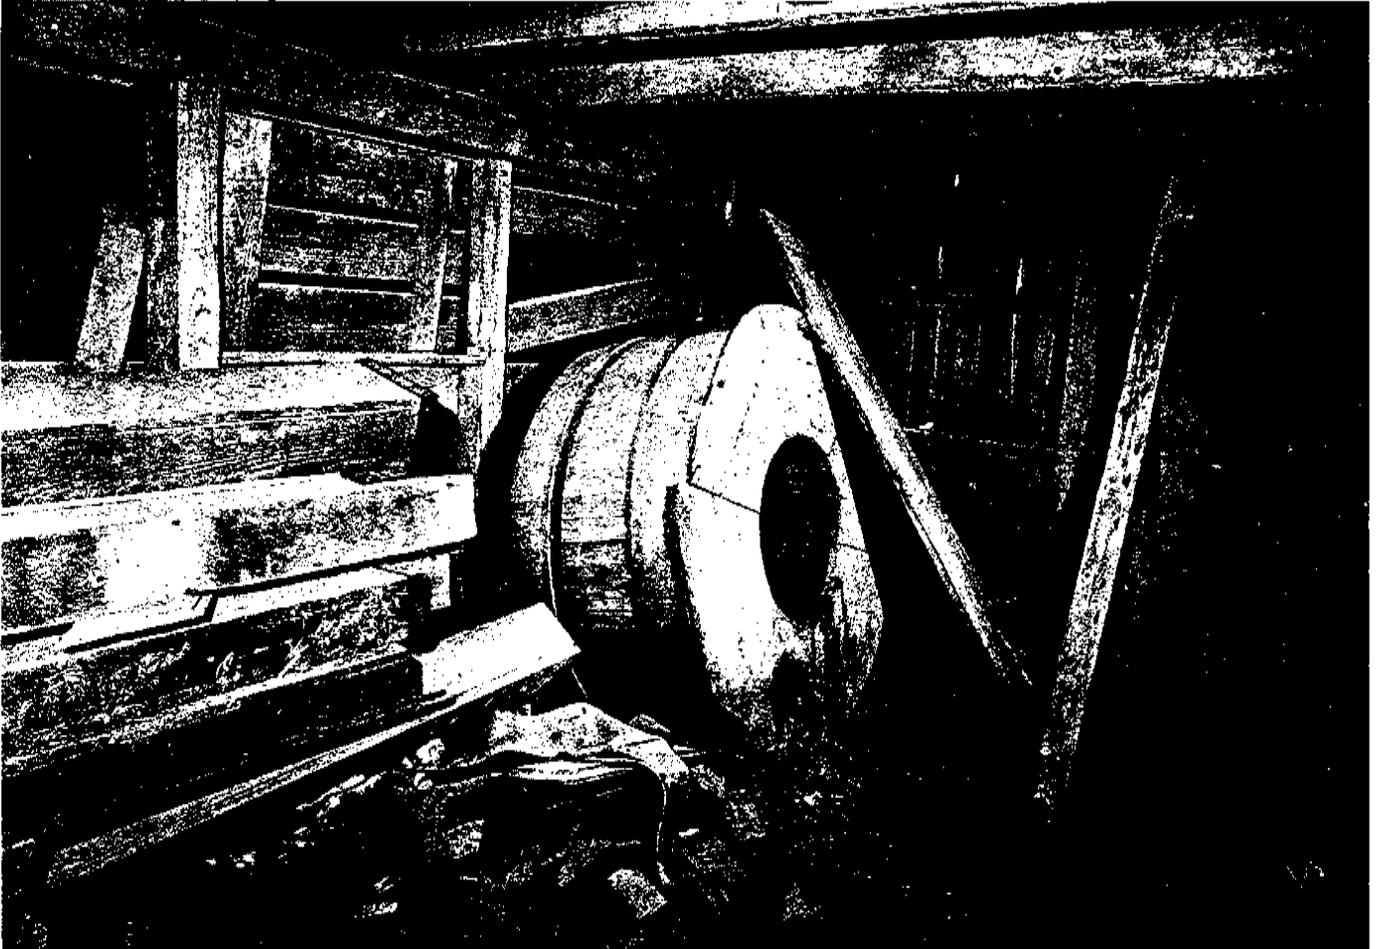
PLATE 15

MILL OPERATION
EQUIPMENT REMAINS

extensive amount of wooden chuting, a hopper, a probable flour dresser, fabric belt and metal cup grain elevators, wooden pulleys, portions of large tenoned beams, and several pieces of metal machinery. The workings listed all appear to be in excellent condition and others lie buried between them and the dirt floor of the barn.

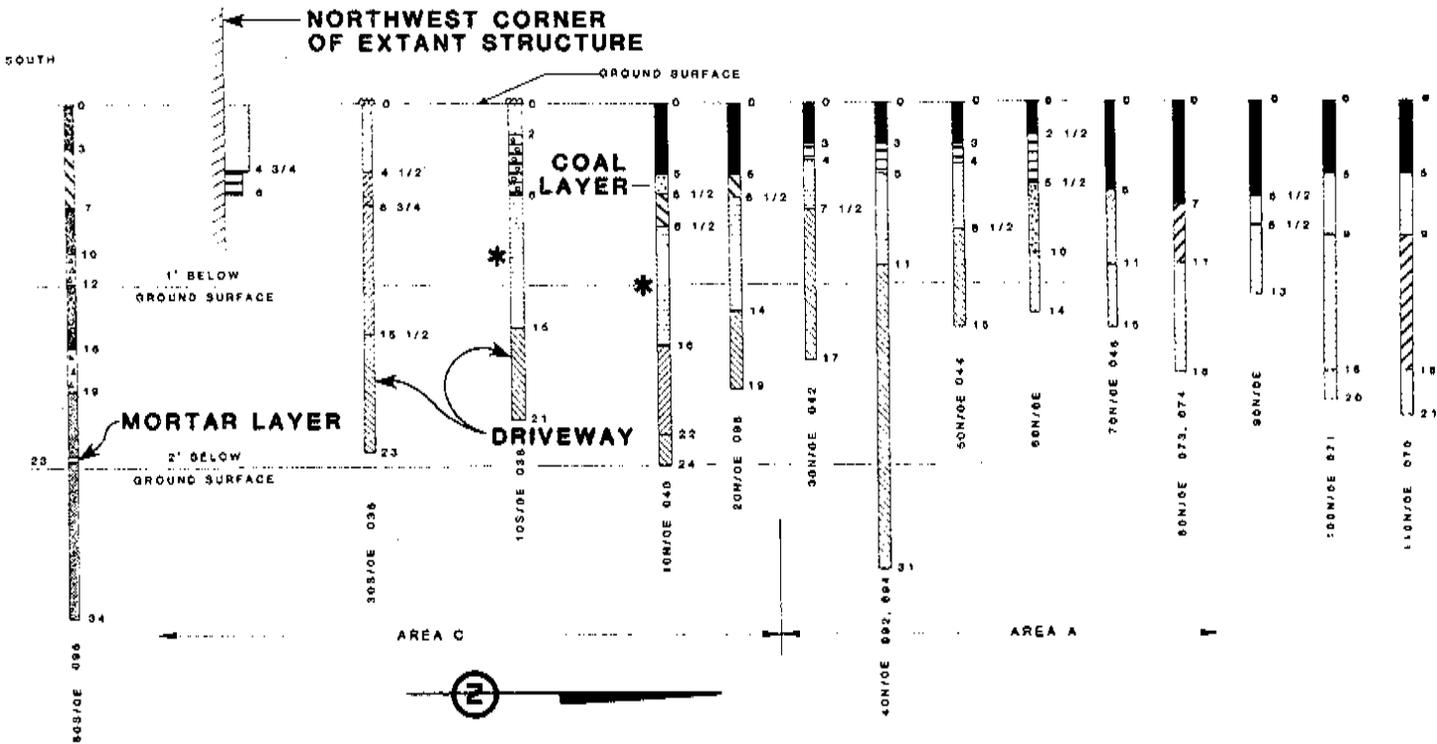
FIGURE 30

SOIL PROFILES ON NORTH/SOUTH BASELINE OF EXCAVATION (Shown by Location on Grid and Provenience Number)

subsoil (Level D) devoid of cultural remains. The results of shovel test 60S/0E (see Figure 30) indicated the extreme complexity of the stratigraphy adjacent to the standing structure. Here excavations revealed a 3" of humus over a mottled sandy clay layer (Level A), underlain by a 3" and 4" layer of black sandy silt (Levels B and D) separated by a 2" coal and ash layer (Level C). Below this was a 3" grey sandy clay layer containing coal and ash (Level E) and a grey brown sandy clay layer (Level F) that extended to 34" below the ground surface containing a lense of mortar 23" below the surface. These different layers represent different episodes of deposition of cultural fill with the deepest layers probably being placed at or near the time of the original construction of the building and other layers being deposited during the 20th century. Within Area C, for the stone driveway and ramp to the basement, the stratigraphy and artifact deposits were created during the utilization of the structure as a mill (Floyd Cantrell: pers. comm.: 1982).

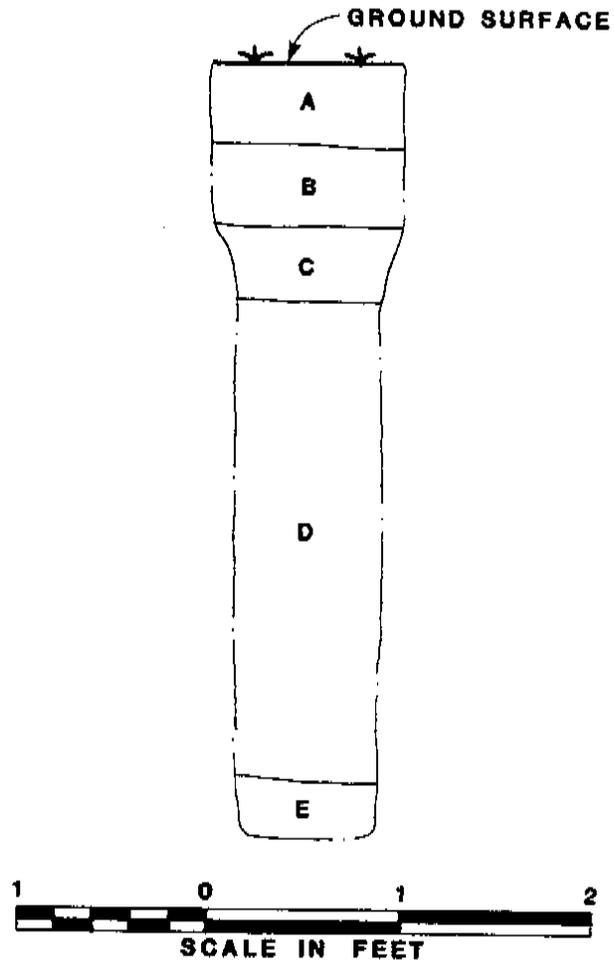
FIGURE 32

EXAMPLE OF SOIL PROFILE OF "DEPRESSED AREA" AREA B

- A - Dark Brown Sandy Clay
- B - Very Mottled Sandy Clay (Yellow, Gray, Black)
- C - Black Coal/Charcoal
- D - Brown Sandy Loam, Fill
- E - Light Brown Sandy Clay (Yellow, Gray, Black)

depressed area and an area interpreted as being functionally associated with it. On the surface Area B was partially covered with modern trash which appears to have been pushed there during the 1981 demolition of a dwelling on the adjacent property. The stratigraphy of the depressed area (Figure 32) is 4" to 6" of topsoil (Level A) over a very hard, mottled layer of sandy clay 2" to 9" thick (Level B) underlain by coal lens (Level C), which in turn was underlain by a 30" thick layer of fill (Level D) resting on the subsoil (Level E). During excavation it was noted that the deeper layers exuded an oil or gasoline odor. The stratigraphy of the remainder of Area B was of a topsoil (Level A) above a very dark brown sandy silt layer containing brick, gravel, slag, and coal (Level B) to a depth of approximately 12". Below this was a gray clayey sand (Level C) varying in thickness from 2" to 10" underlain by a brown clay-sand level (Level D) which extended to 16" to 24" below the ground surface to the top of the natural subsoil.

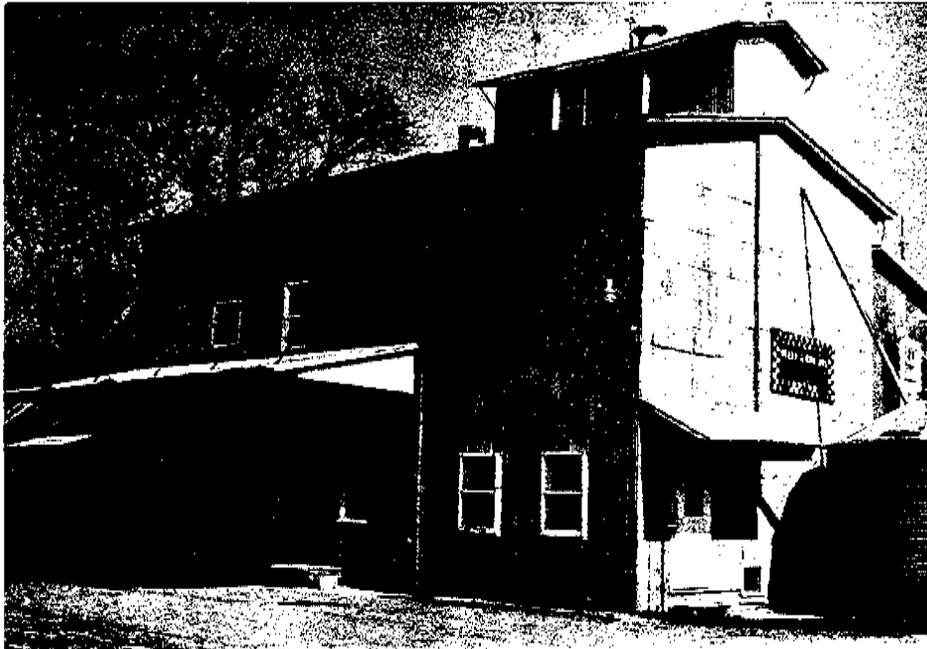
PLATE 17

HEARN AND RAWLINS MILL,
SOUTHWEST CORNER ELEVATION

The architectural significance of the Cantrell Warehouse/Enterprise Mill site has been compromised by a loss of integrity through the removal of the mill machinery and power source and through the alteration of the interior and exterior fabric as a result of the conversion from a mill to a warehouse. Historical research associated with the project concluded that the structure did not contain distinctive architectural characteristics of a late 19th century industrial mill structure, and that there are still many surviving structures from this period that exist in the area (Plates 17 and 18) and region. Also the method of construction of the mill, braced frame, was
