This picnic area appears to be an individually eligible complex constructed by the Civilian Conservation Corps during the Great Depression in 1937 (F.W.P. 1938). The Redden Forest was designated a state forest a year later. Although the CCC did vast amounts of work all over the country during the 1930s, very little was actually done in Delaware (LeeDecker et. al. 1989:90). This picnic area recreates, on a much smaller scale, the Adirondack woodland retreats of New York State that captivated thousands of tourists a year. The CCC did much to turn inhospitable woodland settings along America's rural highways into inviting and charming rest stops for travelers. A two mile hiking trail along the stream was also laid out by the CCC when this shelter was built (F.W.P. 1938). A similar CCC camp still exists on Route 113 (LeeDecker et. al. 1989:90), but this is the only one located within the project corridor.

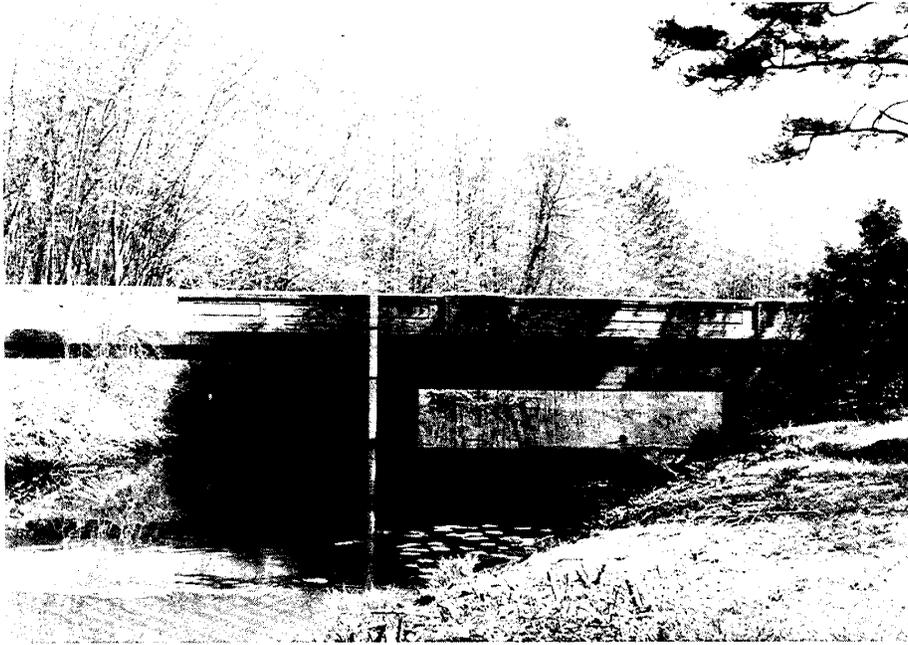
CRS S-4022
Previously Surveyed
Previously Determined Not Eligible
Plate 103; Appendix A, Plat 16

This previously surveyed bridge is located on Road 40, in the Redden State Forest. The bridge crosses over Gravelly Branch Creek, a tributary of the Nanticoke River. Situated on the south side of the road is a picnic facility, S-8442, that was discussed earlier in this report. The concrete and steel girder bridge is thirty-eight feet long with reinforced concrete walls. The bridge was constructed in 1930 (Spero 1991). The bridge was determined not to be eligible by the BAHP as it is an undistinguished example of this type of bridge construction.

PLATE 103: CRS S-4022
View of concrete bridge, looking north, adjacent to Redden State Forest.

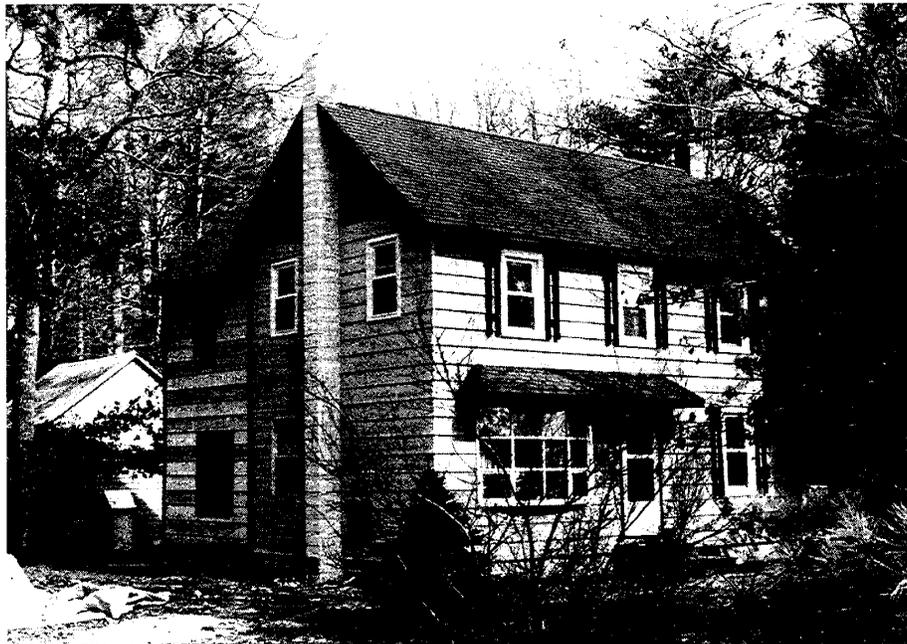
CRS S-8443
More Work Needed
Plates 104a and 104b; Appendix A, Plat 16

This dwelling complex is located on the north side of Road 40. The dwelling is a two and one-half story I-house, three bays wide and two bays deep with a rear, two and one-half story addition. The entrance is situated in the center of the front or south facade. A single, one over one, double hung window with wooden, slat shutters is placed in the eastern bay. A modern, bay window with twelve panes has been inserted in the western bay. A pent roof extends over the door and bay window. There are three, symmetrically placed, one over one, double hung windows in the second story. All of these windows have wooden, slat shutters. The gable roof is sheathed in composition shingles.

PLATE 104a: CRS S-8443
View of south and west facades of house, looking northeast.
Note obtrusive picture window.

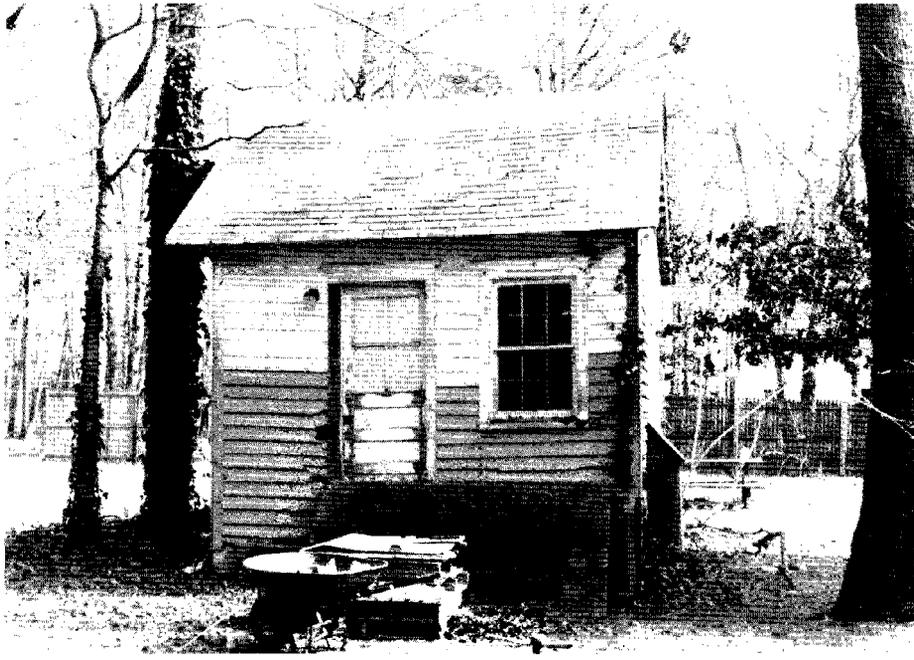
PLATE 104b: CRS S-8443
View of frame structure adjacent to house. May be a playhouse.

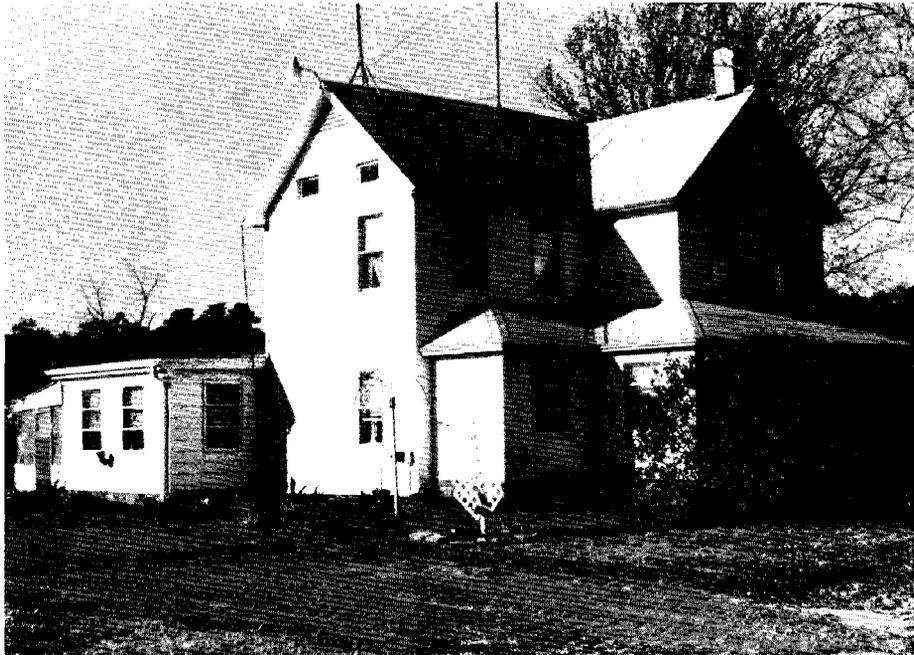
CRS S-8444
Not Eligible
Plate 105; Appendix A, Plat 16

PLATE 105: CRS S-8444
View of south and east facades of house, looking northwest.
Note enclosed porches across facade, as well as addition on rear of dwelling.

Except for a small, modern, one over one window in the first story, the east facade is void of any fenestration. An exterior, concrete block chimney is centered in the facade. The west facade has a single window in the first story and two windows in the second story. All are one over one and double hung. There is a second concrete block chimney along the exterior of this facade. A two and one-half story, one bay wide and deep addition with a gable roof has been constructed on the north facade, creating an L-shaped house. All of the windows in this section are modern. A one story, shed roofed, screened in porch extends outward from the north facade of the house, adjacent to the rear wing. Currently, this porch is boarded over. The house is clad in both gray, blue and green vinyl siding, and rests on a concrete foundation.

The rear wing is also two and one-half stories, and is two bays wide and deep with a gable roof. The windows in this part of the house are one over one and double hung. There are two, small windows in the attic story. These windows are identical to those on the east facade. A flat roofed, one story addition has been added onto the west facade of the rear wing. The house sits on a brick and concrete foundation and is clad in white, aluminum siding. There is an outhouse and modern, storage shed on the property.

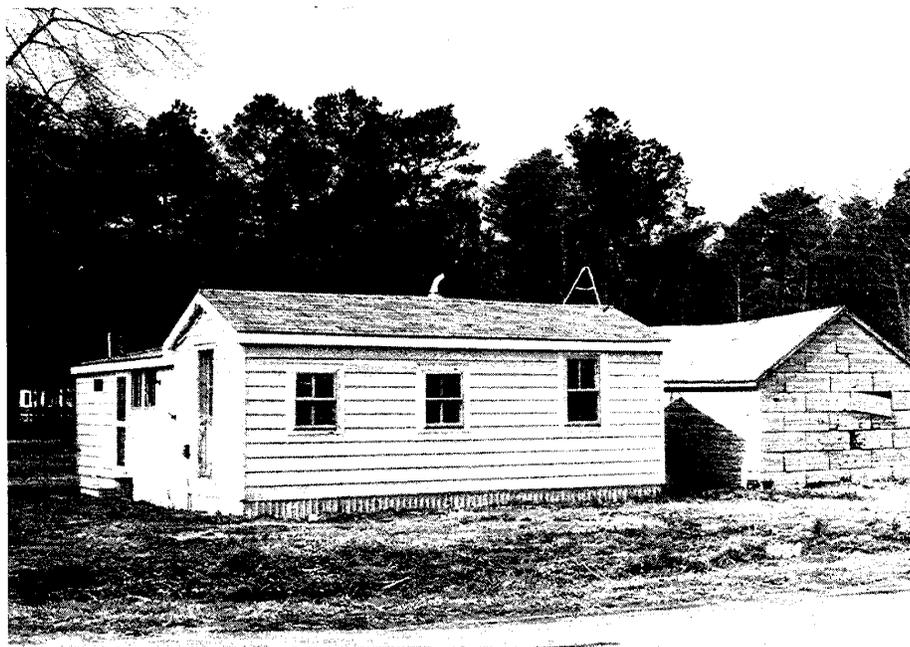
CRS S-8445
Not Eligible
Plate 106; Appendix A, Plat 16

This small, L-plan cottage is situated at the northwest corner of the intersection of Roads 40 and 579. The house is one story with a shallow, gable roof and variety of windows and doors. There are two doors on the south facade, and a third entrance on the north facade. An exterior, concrete block chimney is placed on the north facade, adjacent to the doorway. A modern, wood deck has been built across the facade as well. The house is raised on a concrete foundation and is clad in yellow, aluminum siding. A rectangular plan, frame garage with a gable roof is adjacent to the north side of the house. The building is clad in composition shingle siding and has an opening on the west facade.

PLATE 106: CRS S-8445
View of east and south facades of house, looking west.

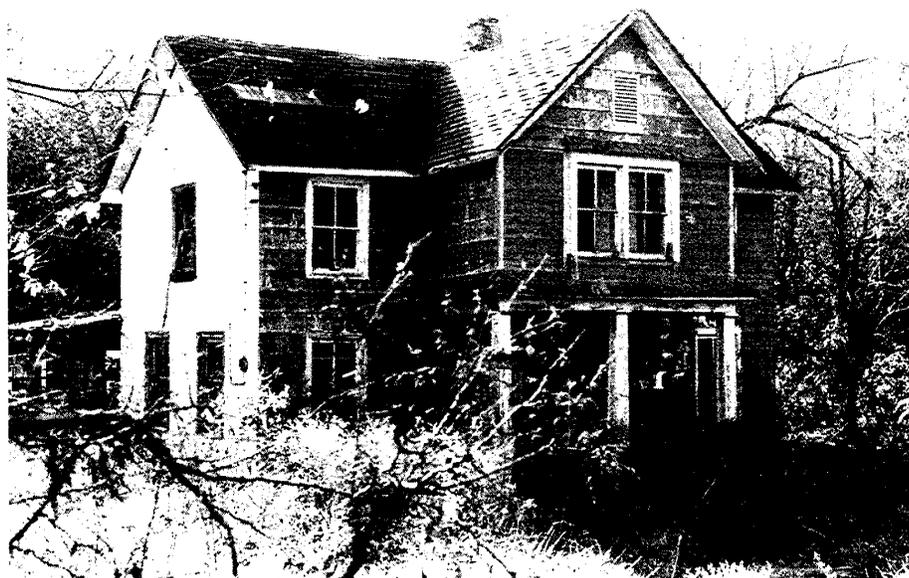
CRS S-8446
Individually Eligible
Plate 107; Appendix A, Plat 19

The east and west facades have two windows in the first story and a single window centrally placed in the second story. These windows appear to have been two over two; however, most of them are covered over with boards or missing altogether. A cement covered chimney is centrally placed along the ridge of the roof.

A one story, gable roofed structure with flanking shed roofed additions is located at the rear of the building. This addition, which has been partially destroyed by fire, appears to have been used as a summer kitchen. An exterior chimney once stood along the south facade of the kitchen. All of the windows and doors in this portion of the house are missing. The entire house is covered in composition shingle siding. There is a variety of outbuildings on the property. Most of structures have been severely damaged by fire.

This house type is unique to the project area. There are no other examples of the I-house form with the projecting, two story, cross gable. Although the house has been damaged by fire, it still retains its original form. The existence of the attached summer kitchen and various outbuildings add to the overall integrity of the structure. This property appears to date to the mid-nineteenth century and is individually eligible. As a unique architectural example of this type of design, the building is significant. In addition, it is significant under the priority theme of Agriculture within the temporal period 1830-1880 (Ames et. al. 1989).

PLATE 107: CRS S-8446
View of north and east facades of house, looking southwest.
Note projecting two story cross gable and original fenestration.

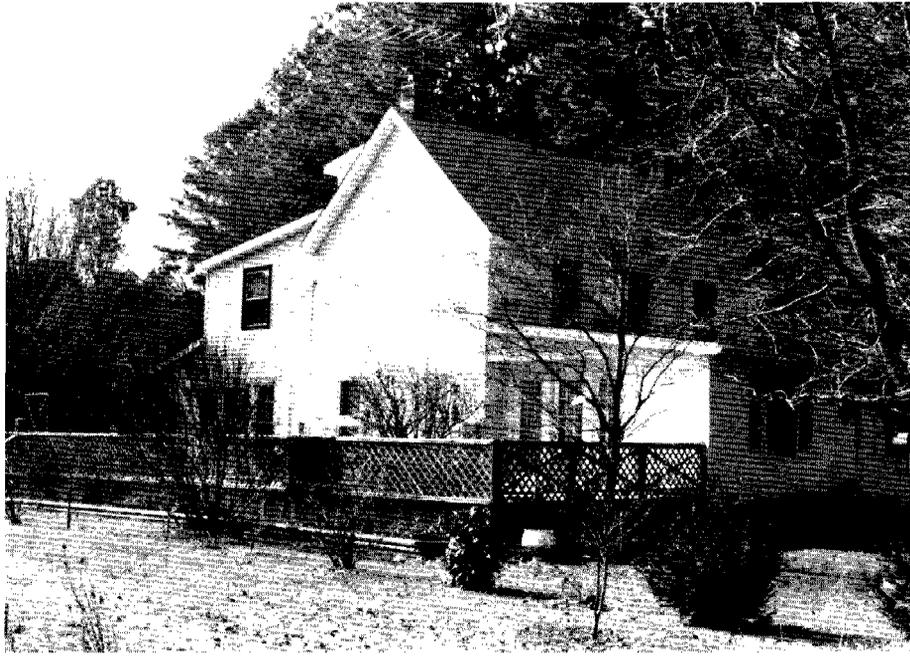
CRS S-8447
Not Eligible
Plate 108; Appendix A, Plat 19

A large, two story, shed roofed addition with a shed roofed dormer, has been constructed on the eastern end of the south facade of the house. This addition has a variety of modern windows and doors. The entire house is clad in yellow, aluminum siding and rests on a concrete foundation. A wood fence surrounds the rear of the property preventing additional views of the exterior.

PLATE 108: CRS S-8447
View of north and east facades of house, looking southwest.
Note heavy alterations to exterior fabric.

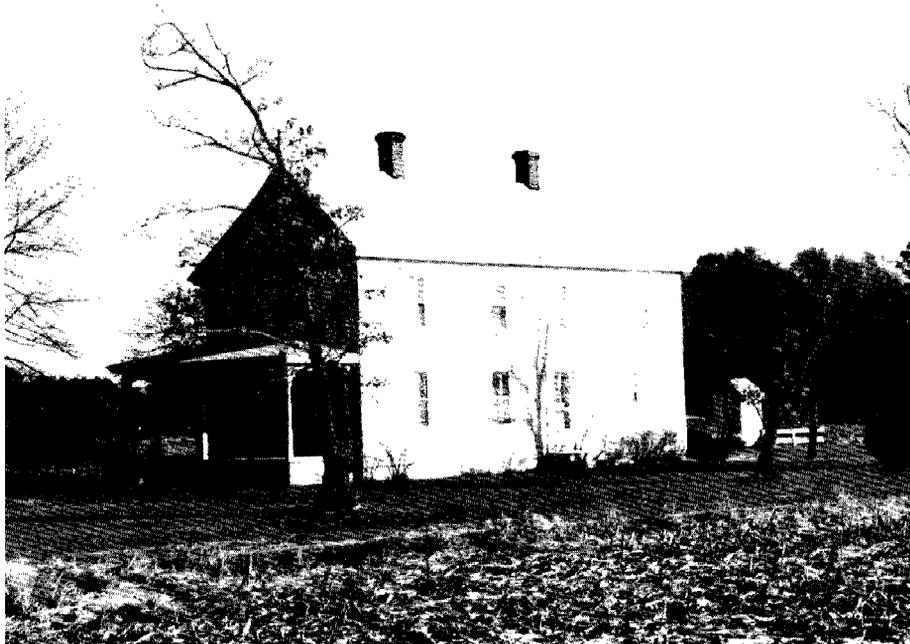
CRS S-3189
Previously Surveyed
Individually Eligible
Plate 109; Appendix A, Plat 19

This previously surveyed property is located on the south side of Road 565. The dwelling is a two and one-half story, T-plan I-house with intersecting gable roofs. The main block of the house is perpendicular to the road and is four bays wide and two bays deep. The original front facade faced west, with the doorway located in the third bay from the north. The entrance is currently placed in the rear section of the house. There are two, interior, brick chimneys centered along the ridge. A frame outhouse is present at the rear of the property.

This house appears to date to the mid-nineteenth century. The house no longer fits neatly into the four bay I-house category as the west facade has been slightly altered with the insertion of a modern, double window in the southernmost bay. The house represents a change in orientation, with the main entrance now positioned in the rear of the house. This change in the "traffic pattern," seems to coincide with a change in the use of the land surrounding the house. The west facade now faces a cultivated field, and the rear facade faces the main road and the driveway. Much of the land surrounding the house has yielded to a modern housing development, thus forcing a change in the orientation of the main entrance. The building appears to be individually eligible as a unique adaptation of a typical, four bay I-house. Unique architecturally, the building is significant within temporal period 1830-1880, and the historic context of Architecture (Herman et. al. 1989).

PLATE 109: CRS S-3189
View of north and west facades of house, looking southeast.
Note twin internal chimneys and Victorian detailing on porch.

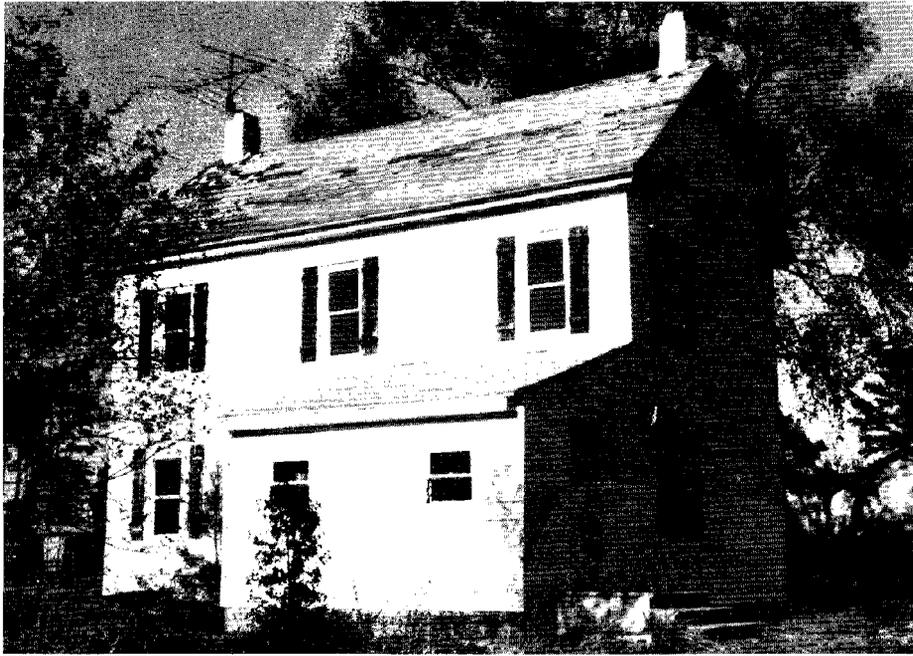
CRS S-7958
Previously Surveyed
Not Eligible
Plate 110; Appendix A, Plat 19

There is a single window in both the first and second stories on the north and south facades. These are also one over one and double hung with wooden slat shutters. There are two, small, fixed, two pane windows in the attic story on both facades. The gable roof is sheathed in asphalt shingles and has a wooden box cornice with returns. An interior end, brick chimney covered in cement is located at either end of the building. The house is clad in aluminum siding and rests on a concrete foundation.

PLATE 110: CRS S-7958
View of west and south facades of house, east.
Note enclosed entry and modern replacement windows.

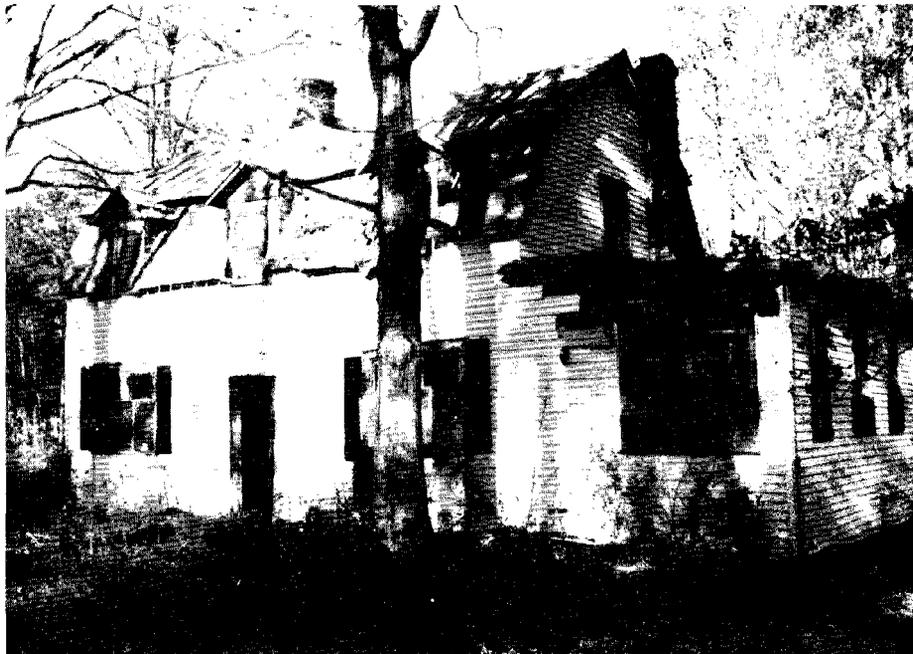
CRS S-3236
Previously Surveyed
Not Eligible
Plate 111; Appendix A, Plat 19

The north facade has a single window in the first level and in the upper story. Both of these windows are currently boarded over. A one story, flat roofed addition has been constructed on the south facade and continues to wraparound to the east facade, completely covering the first story. A band of windows, now covered over, extended along the south and east facades of the addition. A single window is still visible in the upper story of the original south facade, it is also boarded over. An exterior brick chimney is located at this end of the building.

This house is in extremely poor condition and has been heavily altered. It does not appear to be an eligible structure. The building no longer reflects its original nineteenth century, I-house form, due to the replacement of the roof and the insertion of three dormer windows on the west facade. There are many examples of the three bay I-house throughout the corridor in better condition and with greater integrity.

PLATE 111: CRS S-3236
View of west and south facades of house, looking east.
Note deteriorated condition.

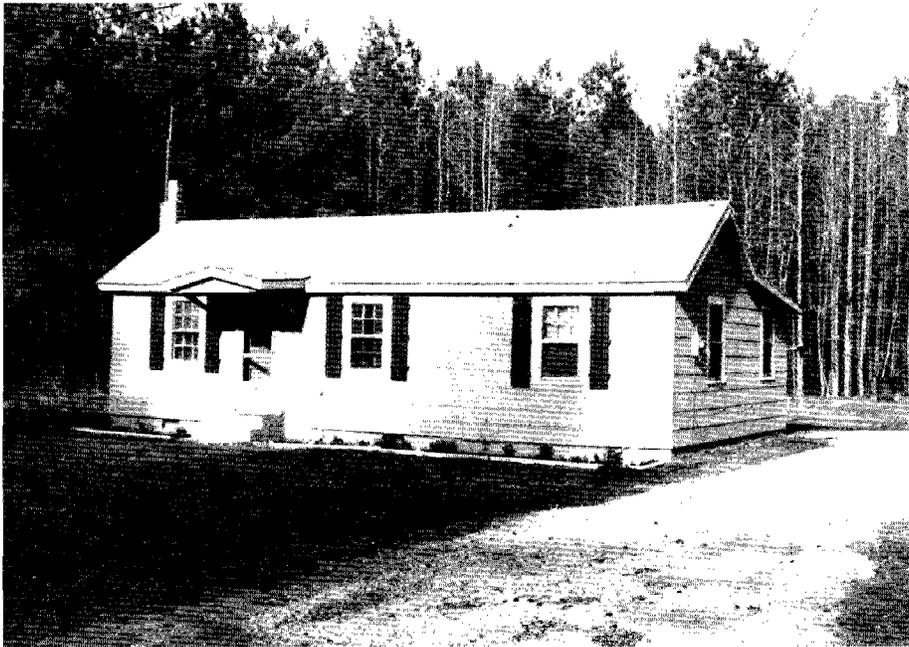
CRS S-8448
Not Eligible
Plate 112; Appendix A, Plat 19

This small, one story cabin is positioned on the east side of Route 113. The house is four bays wide and one bay deep with a gable roof and a shed roofed addition across the rear facade. The entrance is placed in the second bay from the north. Six over six, double hung windows with slat type shutters occupy the three remaining bays. An exterior, concrete block chimney is located on the north facade. The house rests on a concrete foundation and is clad in blue, composition shingle siding. A modern, frame shed with a gambrel roof sits at the rear of the property.

This house appears to date to the 1930s or 1940s. Although it is in good condition, it possesses little architectural detailing or style, and is not eligible. In accordance with guidance from the BAHP, buildings from this time period do not form a preservation priority in the state (Personal Communication with Steve DelSordo May 1991).

PLATE 112: CRS S-8448
View of south and west facades of house, looking northeast.

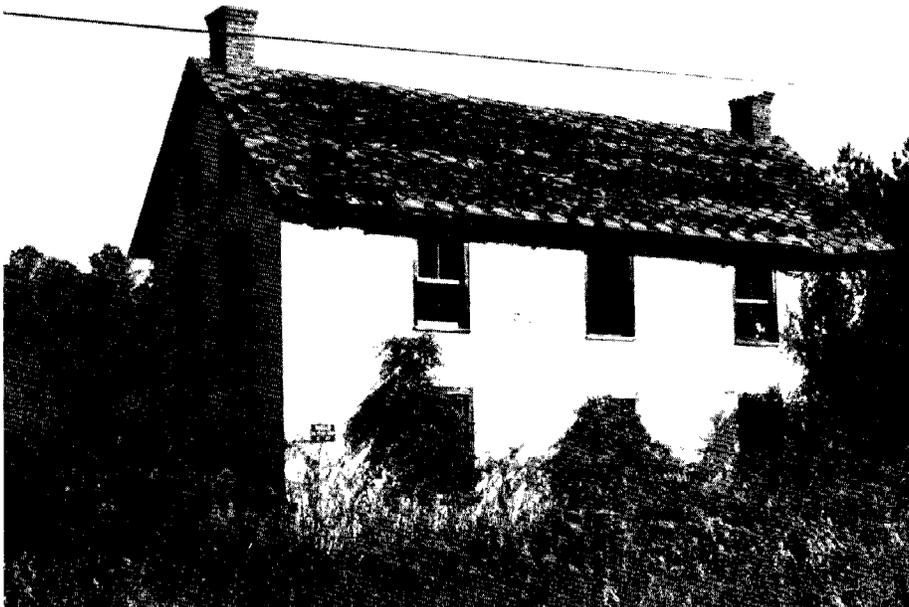
CRS S-8515
Previously Surveyed
Eligible: Three Bay, I-House, Multiple Property Submission
Figure 5; Plate 113; Appendix A, Plat 19

Located on the east side of Route 113, north of Georgetown, this abandoned, two and one-half story I-house was previously surveyed. The house is three bays wide and two bays deep with a center entrance in the west facade facing the road. The windows appear to have been two over two and double hung, although most of them are missing or have been boarded over. There are two, interior, end, brick chimneys on the rear or east facade. A one story, shed roofed addition extends across the rear facade. The house is set on brick piers and has composition shingle siding.

This house appears to be eligible as a contributing part of the proposed Three Bay, I-House, Multiple Property Submission. While the house is abandoned, its basic form and fenestration are intact. A survey conducted of this property in 1989 by Louis Berger & Associates, notes that this parcel belonged to David W. Maull in 1865 (LeeDecker et. al. 1989:177). The evaluation of their study also indicated that this house was architecturally significant and eligible under Criterion C, of the National Register Criteria for Evaluation.

PLATE 113 CRS S-8515
View of west and north facades of house, looking east.
Note three bay fenestration.

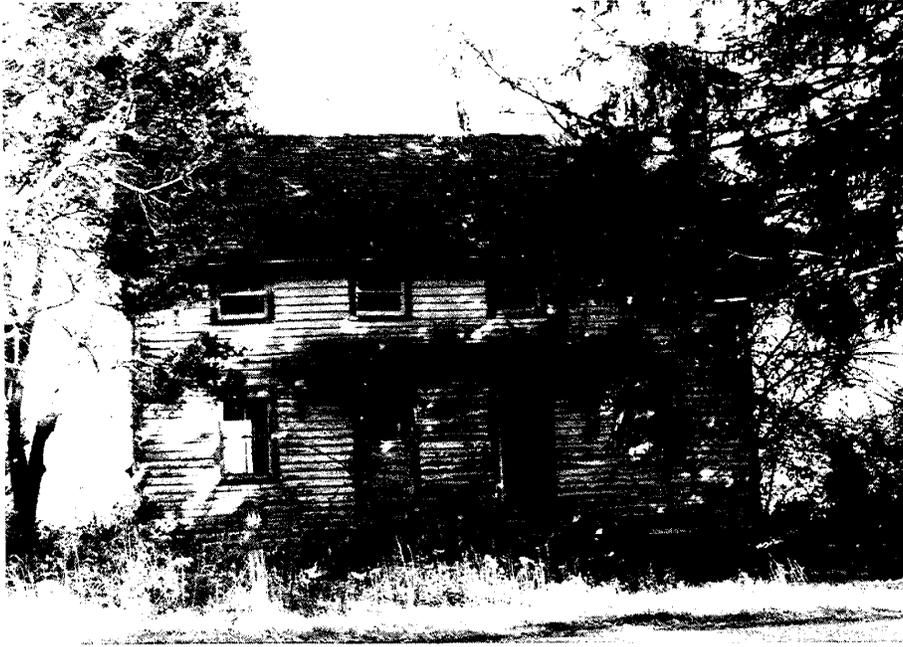
CRS S-8449
Previously Surveyed
Eligible: Four Bay, I-House, Multiple Property Submission
Figure 6; Plate 114; Appendix A, Plat 19

This house is eligible as part of the proposed Four Bay, I-House, Multiple Property Submission. It is one of only eight examples of the four bay I-house in the project corridor. Two of these have been selected to represent the Four Bay, I-House, Multiple Property Submission. The four bay I-house is an uncommon form in this region, and appears to be the only type of I-house constructed with two center doors in the main facade. This house retains its basic form, fenestration, siding and foundation, and is an excellent example of the style. In 1989, this house was surveyed by Louis Berger & Associates (LeeDecker et. al. 1989:180). Their study determined that the dwelling belonged to Jacob Sharp circa 1875 (LeeDecker et. al. 1989:184). The house was determined by Louis Berger & Associates to be eligible under Criterion D, as having the "potential to yield information that would contribute to a broader understanding of forms and varieties of nineteenth-century rural domestic architecture in the lower Delaware region" (LeeDecker et. al. 1989:185). It is the opinion of CHRS, Inc. that the house is eligible under Criterion C, architectural significance, of the National Register Criteria for Evaluation. As a four bay dwelling in the study area, the building clearly embodies a distinctive type of I-house construction that is rarely found in the region.

PLATE 114: CRS S-8449
View of west facade of house, looking east.
Note four bay fenestration and original windows on second story.

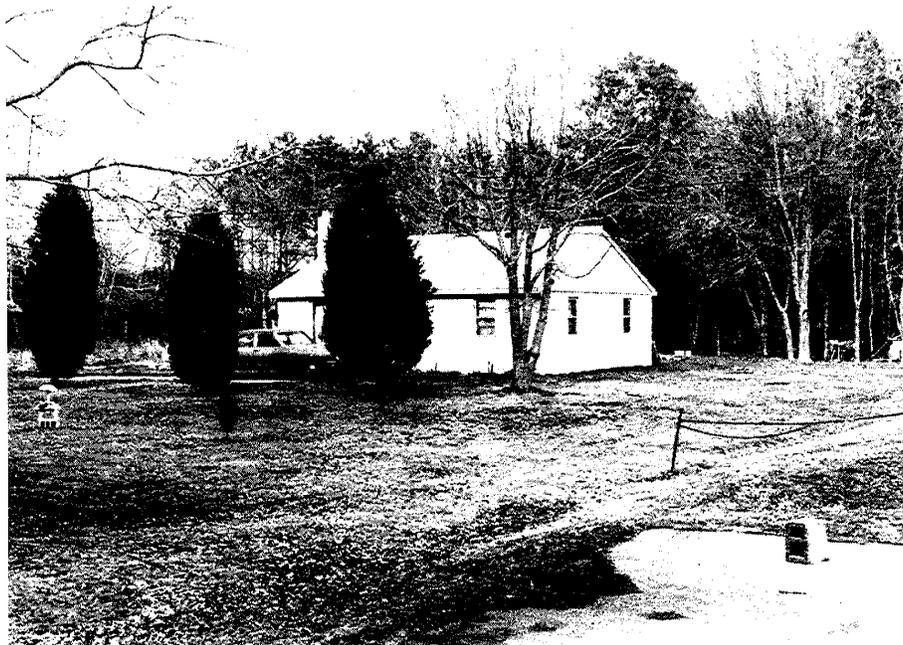
CRS S-8450
Not Eligible
Plate 115; Appendix A, Plat 19

This rectangular plan cottage with a gable roof is located on the east side of Route 113. The house is constructed of concrete block and is three bays wide and two bays deep. The entrance is centrally placed in the front or west facade, facing the road. The windows are all modern. A concrete block, exterior chimney is situated in the center of the north facade. This house lacks architectural merit or known historical significance and appears to postdate 1945, making it ineligible based on National Register criteria.

PLATE 115: CRS S-8450
View of south and west facades of house, looking northeast.

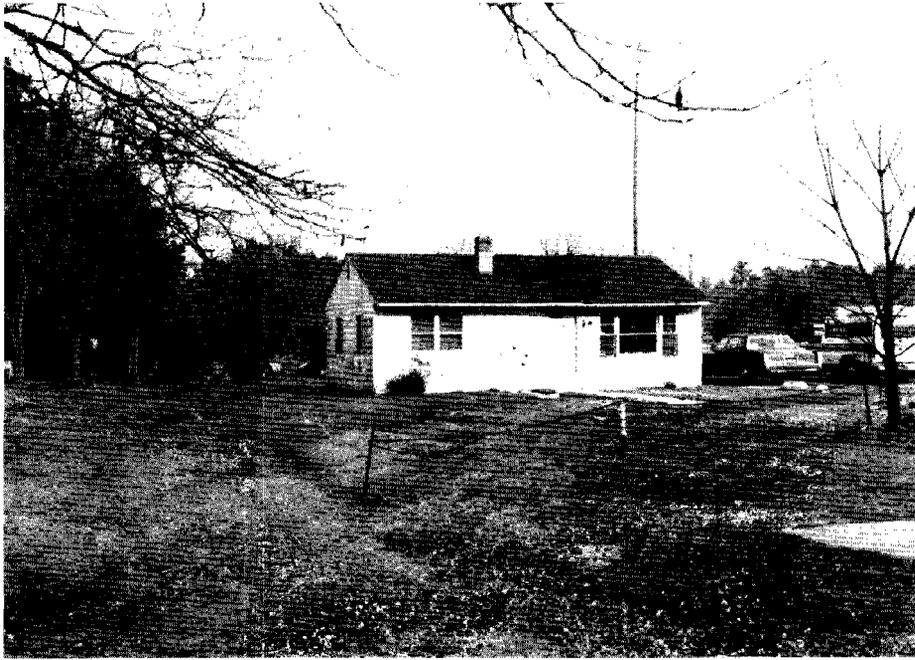
CRS S-8451
Not Eligible
Plate 116; Appendix A, Plat 19

PLATE 116: CRS S-8451
View of west and north facades of house, looking east.

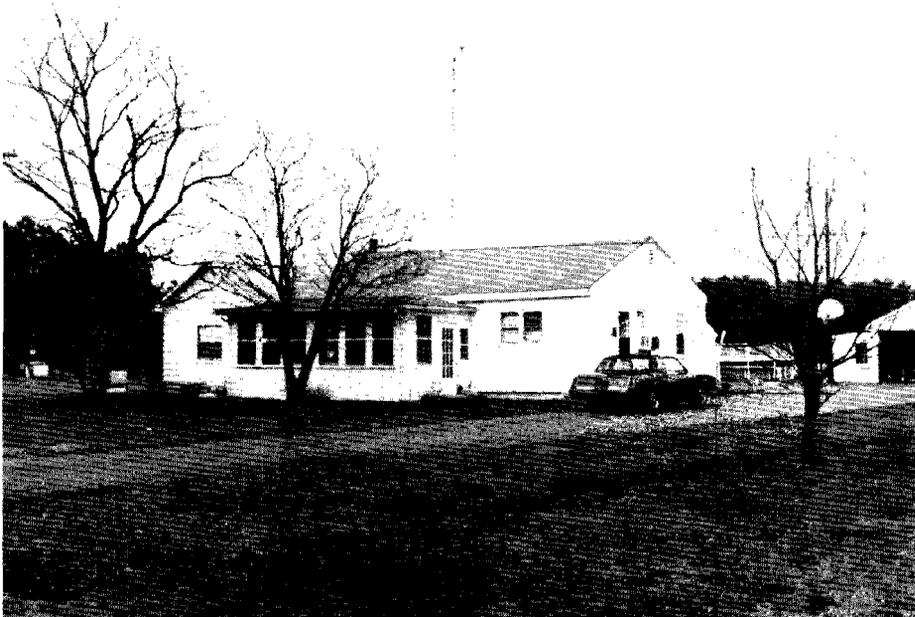
CRS S-8452
Not Eligible
Plate 117; Appendix A, Plat 19

PLATE 117: CRS S-8452
View of south and west facades of house, looking northeast.

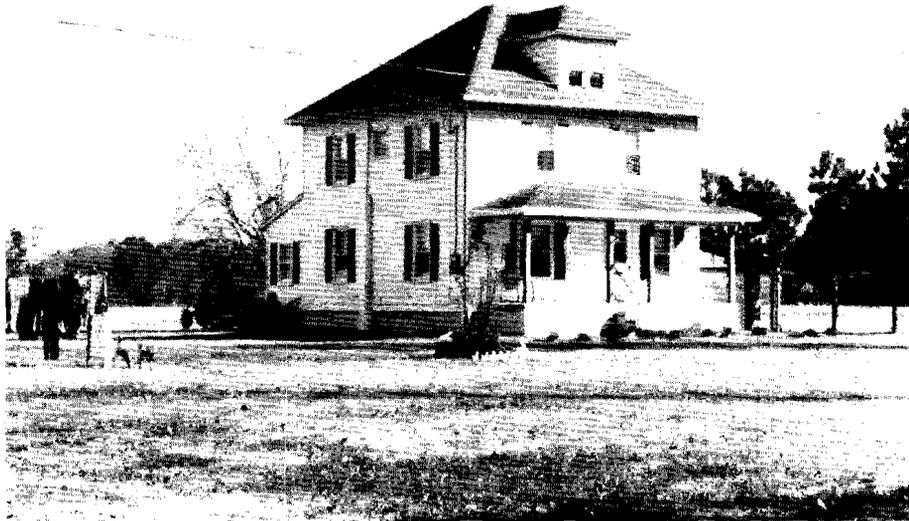
CRS S-8453
Previously Surveyed
Eligible: Classical Box, Multiple Property Submission
Figure 8; Plate 118; Appendix A, Plat 19

The north facade has two, symmetrically placed windows in the first and second stories. All of these windows are one over one and double hung with louvered shutters. A small, square window is centrally placed between the two upper story windows. The window pattern in the south facade is irregularly spaced with a window in the easternmost bay of the second story and another window in the middle of the facade. The window in the middle of the facade is most likely located in a stairwell leading from the first to the second story.

A one story, shed roofed addition is built across the entire east facade. This addition, as well as the remainder of the house, is clad in white vinyl siding. The house rests on a raised concrete foundation. There are no chimneys visible in the house. A rectangular plan, gable roofed, frame garage with a drive through bay is positioned just north of the house.

PLATE 118: CRS S-8453
View of west and north facades of house, looking southeast.
Note pyramidal roof.

This house appears to be eligible as part of the proposed Classical Box, Multiple Property Submission. This house is one of twelve Classical Box houses located within the study area. Five of these twelve have been selected as the best examples of the style and are included in the multiple property submission. These houses are characterized by their symmetry of form, fenestration, pyramidal roof line, and plan. A previous survey conducted by Louis Berger & Associates in 1989, determined that this building "does not appear to meet National Register Criteria for Evaluation" (LeeDecker et. al. 1989:99). It should be noted that CHRS, Inc. disagrees with this assessment of the property and believes it to be eligible for listing on the National Register of Historic Places. As examples of the important trend and historic context of Suburbanization within the corridor, this building contributes to the submission and is significant (Herman et. al. 1989:61-2).

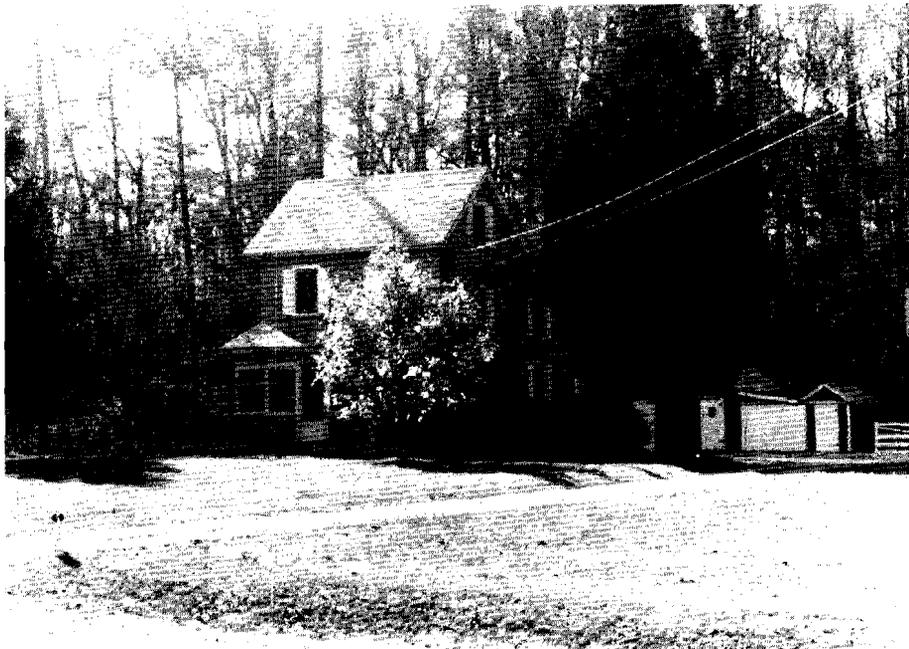
CRS S-3235
Previously Surveyed
More Work Needed
Plate 119; Appendix A, Plat 19

PLATE 119: CRS S-3235
View of east and north facades of house, looking southwest.
Note original windows and fenestration.

According to a previous survey, this house was moved to this site (Vessels 1983). It is unclear when this move occurred. The house appears to date to the mid-nineteenth century. Its two bay wide and one bay deep form is unusual to the project area, and differs from the more typical three, four or five bay I-houses found in the region. The building retains its basic form and fenestration, including two over two, double hung windows. An evaluation of this house in 1989 by Louis Berger & Associates, Inc., determined that building warranted "further investigation," to "fully assess the building's architectural character and integrity and to develop historical background for evaluation" (LeeDecker et. al. 1989:100). CHRS, Inc. concurs with this assessment of the property, and adds that no determination of eligibility can be made without further research.

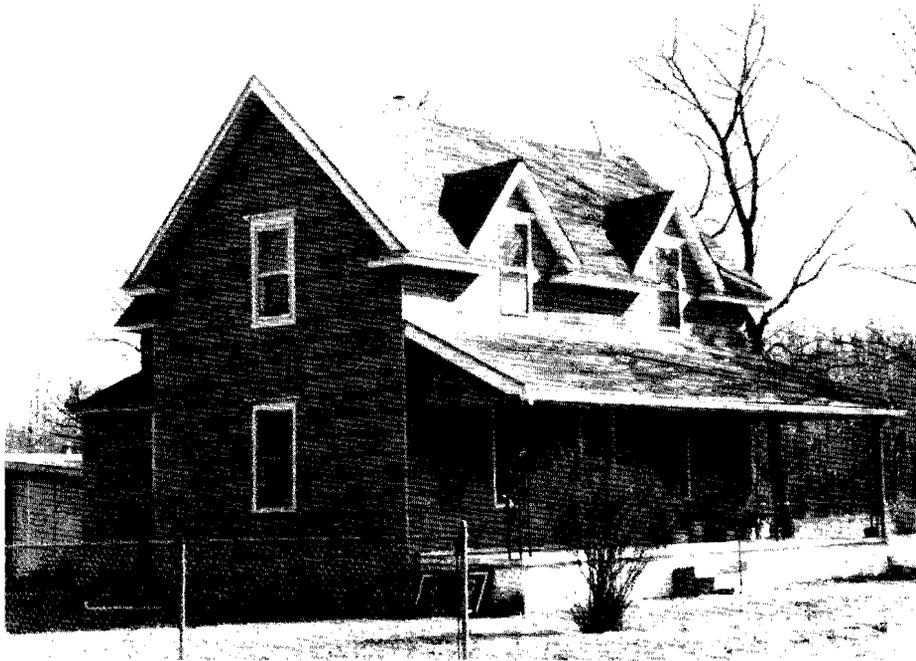
CRS S-8454
Not Eligible
Plate 120; Appendix A, Plat 19

The dwelling is a heavily altered, two story, L-plan I-house. It is three bays wide and one bay deep with a gable roof. The front facade faces west and has a center entry. A single, one over one, double hung window is present on either side of this entrance. A modern, shed roofed porch supported by decorative iron railings extends over the first story. Two, symmetrically placed, gable roofed dormers protrude from the second story of the front facade. These windows are also one over one and double hung.

A single window is placed in the first and second stories of the north facade; both one over one, double hung. A one story, shed roof, enclosed porch extends across the first story of the south facade and along the rear ell. An entrance is located in the south facade of this enclosed porch. A single, one over one, double hung window is visible in the second story.

PLATE 120: CRS S-8454
View of east and north facades of house, looking southeast.

Due to the heavy alterations, the original form of this dwelling has been lost. The insertion of gable roofed dormers, the addition of a modern front porch, the replacement of all the windows, and the application of green, aluminum siding all greatly detract from the overall appearance of the structure. Complex rear and side additions also compromise the integrity of the house. In addition, there are no extant outbuildings associated with this property. The house is not eligible.

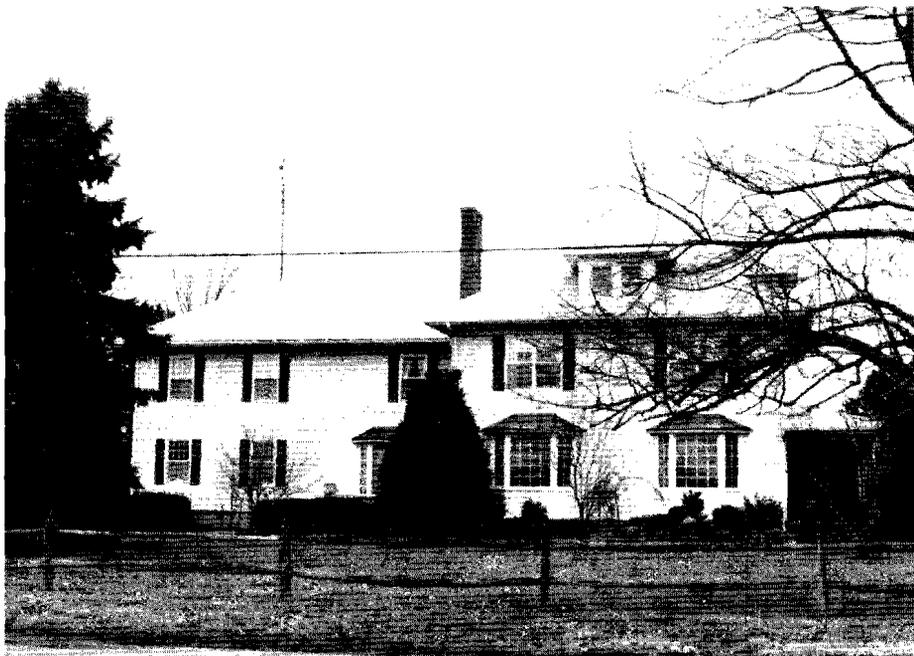
CRS S-8455
Not Eligible
Plate 121; Appendix A, Plat 7

PLATE 121: CRS S-8455
View of heavily altered facade of house, including massive rear addition.

A rear, two story wing has been constructed at the southeast corner of the house. This addition has a cross gable dormer on the north and south facades. The entire house is clad in green, aluminum siding and sits on a raised concrete foundation. There are no visible chimneys.

This heavily altered, early twentieth century, Classical Box dwelling sits on the west side of Road 561, just outside of Bridgeville. The original house was a two and one-half story, two bay wide and deep Classical Box style building. It has a pyramid roof and three, hipped roofed dormers. A large, two story, three bay wide and two bay deep addition with a hipped roof has been added onto the north end of the house. This addition is modern and has a garage located in the northern end of the first floor. All of the windows in the house have been replaced with modern, six over six, double hung sashes as well as bay windows. A hipped roofed, wrap-around porch extends across the east and south facades of the original dwelling. The house is clad in yellow, vinyl siding and has red, louvered shutters. There is an inground pool and a two and one-half story barn positioned on the property.

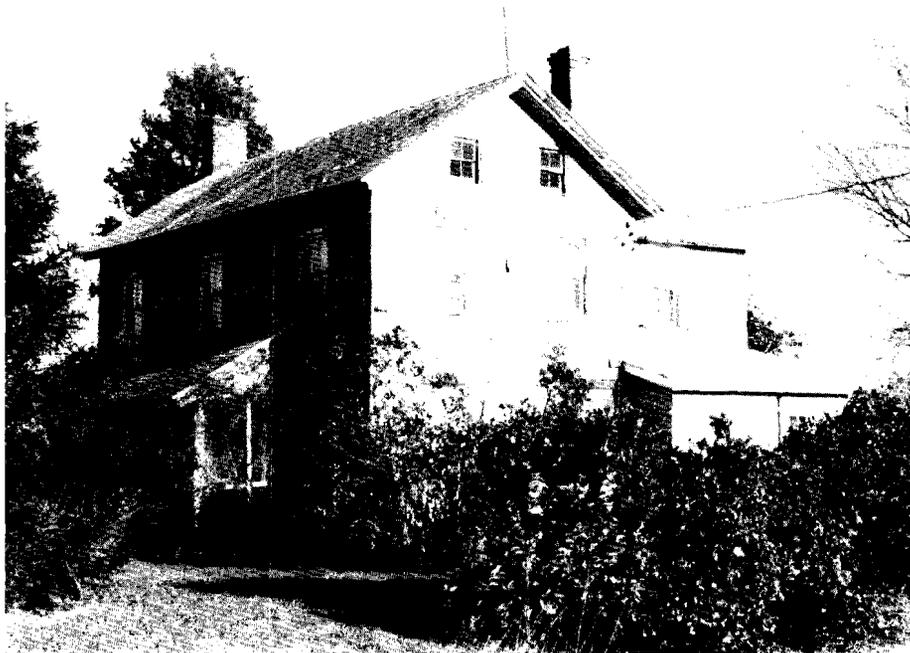
CRS S-1688
Previously Surveyed
Eligible: Three Bay, I-House, Multiple Property Submission
Figure 5; Plate 122; Appendix A, Plat 7

This two and one-half story I-house is located on the south side of Route 18, west of Bridgeville. The T-shaped house is three bays wide and two bays deep with a rear addition. The front or north facade, facing Route 18, has a centrally placed door flanked by a single, two over two, double hung window in a plain wooden frame. A shed roofed, screened in porch extends across part of the first story of this facade. The porch is supported by square, wooden posts. The shed roof is sheathed in composition shingles. There are three, symmetrically placed windows in the second story. All of these windows are two over two and double hung in plain, wooden frames. The gable roof is sheathed in composition shingles. The entire house is clad in composition shingle siding.

The east facade has two, symmetrically placed, two over two, double hung windows on the first story and two, small, fixed, four pane windows in the attic story. There are no windows in the second story. There is an interior end brick chimney on this facade. The west facade has two windows in each story, all two over two and double hung in plain, wooden frames. The two, small windows in the attic story match those on the east facade.

PLATE 122: CRS S-1688
View of west and south facades of house, looking north.
Note three bay fenestration, original windows, shed roofed porch, and rear kitchen wing.

This mid to late nineteenth century dwelling complex appears to be eligible as part of the proposed, Three Bay, I-House, Multiple Property Submission. The house retains its basic form and fenestration and individual details including: brick chimneys; small, attic story windows; and a frame barn/storage shed. Three bay I-houses are significant remnants of the basic vernacular dwelling type found throughout Sussex County. The majority of the houses in this submission, including this one, were part of working agricultural complexes, and are also significant under the priority of Agriculture (Ames et. al. 1989:79, 83).

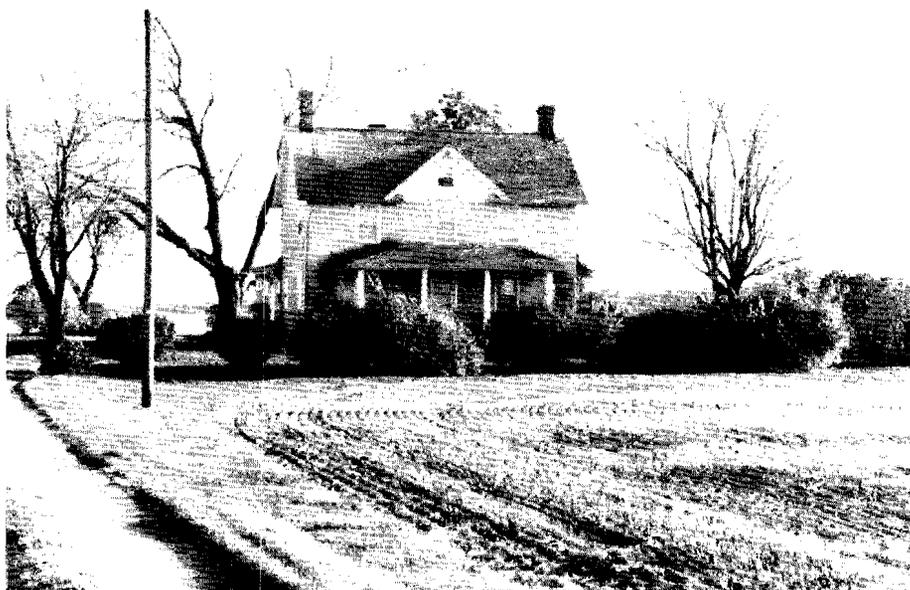
Eligible: Three Bay, I-House, Multiple Property Submission
Figure 5; Plate 123; Appendix A, Plat 7

PLATE 123: CRS S-1687
View of west facade of house, looking east.
Note three bay fenestration, cross bay, end brick chimneys, original porch and windows.

A two story, two bay wide and one bay deep addition with a gable roof has been constructed at the rear of the house creating a T-plan. A one story, shed roofed addition was added onto both the east and west facades of the rear wing. All of the windows in the rear addition are two over two and double hung in plain, wooden frames. A brick chimney is situated along the ridge near the center of the gable roof. The roof is sheathed in composition shingles.

This mid to late nineteenth century dwelling complex appears to be eligible as part of the proposed, Three Bay, I-House, Multiple Property Submission. The house is in good condition and retains its basic form and fenestration pattern, as well as its rural setting and two outbuildings. Three bay I-houses are significant remnants of the basic vernacular dwelling type found throughout Sussex County. The majority of the houses in this submission, including this one, were part of working agricultural complexes, and are also significant under the priority of Agriculture (Ames et. al. 1989:79, 83).

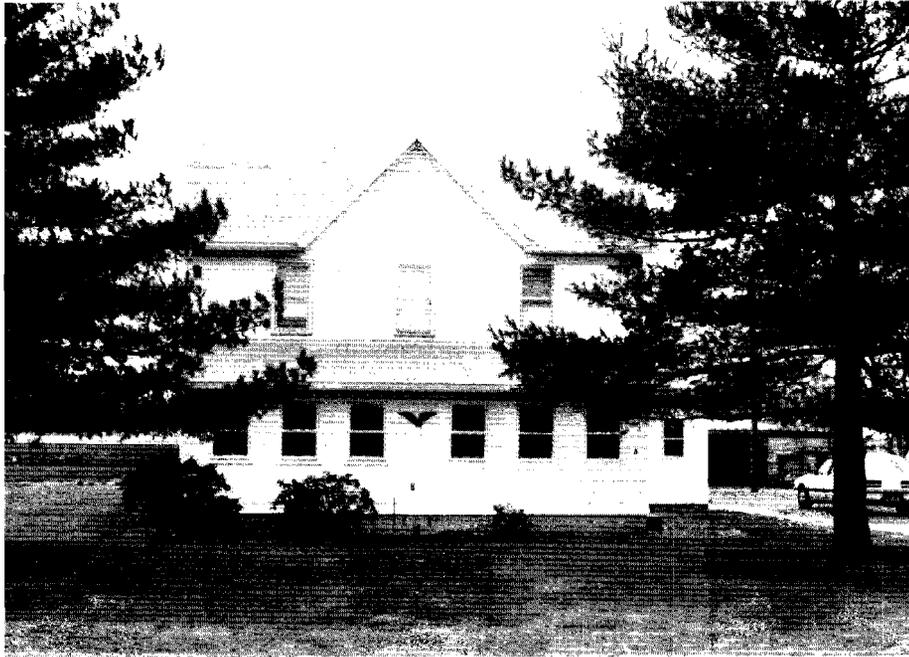
CRS S-1669
Previously Surveyed
Not Eligible
Plate 124; Appendix A, Plat 7

This late nineteenth century, previously surveyed, dwelling complex is located on the east side of Road 561. This T-plan I-house is three bays wide and two bays deep with a gable roof and a two story, rear addition. A shed roofed, enclosed porch with a band of one over one, double hung windows, extends across the first story of the front or west facade. The house is raised on a concrete foundation and is covered in white, aluminum siding. There are two, frame sheds on the property.

Due to alterations, this house is not eligible either individually or as part of the Three Bay, I-House, Multiple Property Submission. All of the windows in the house have been replaced; a concrete block, exterior chimney is located on the south facade of the house; and the enclosed front porch totally obscures the entire first floor of the building. Throughout the project corridor there are other examples of the three bay I-house that retain their basic form and fenestration and possess greater integrity.

PLATE 124: CRS S-1669
View of west facade of house, looking east.

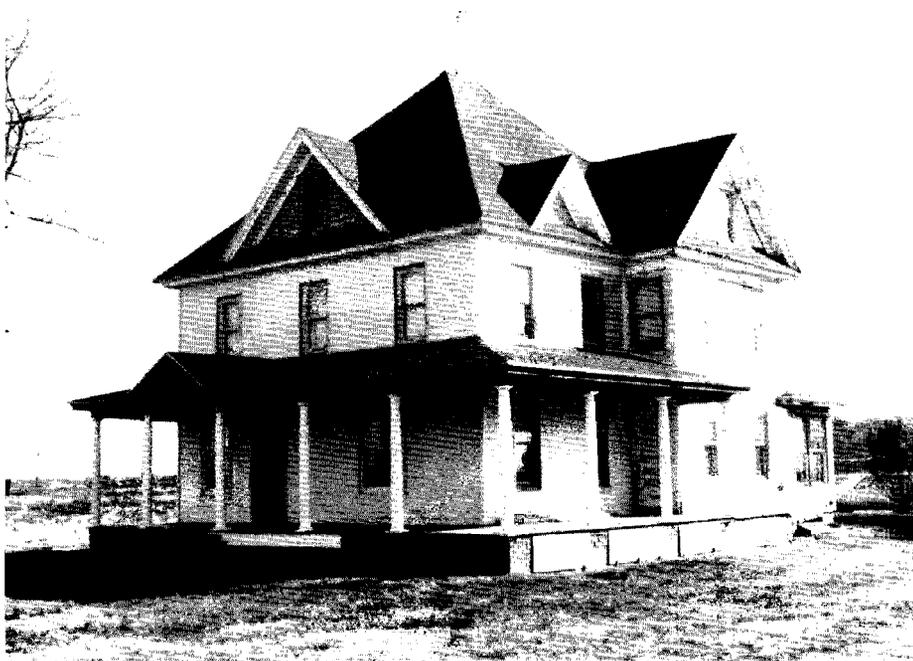
CRS S-1668
Previously Surveyed
Individually Eligible
Plate 125; Appendix A, Plat 7

A combination I-house and Classical Box dwelling complex is located on the south side of Road 561. A two and one-half story, three bay wide and deep Classical Box appears to have been attached to an already existing I-house; of which only the west end of the house can still be seen. The front or north facade, facing Road 561, has three, asymmetrically placed bays in the first story. The doorway is placed off center, and is flanked by a single, one over one, double hung window. A hipped roofed, raised porch extends across the full facade of the first story, and continues to wraparound to the west facade. The porch is supported by Doric, wooden columns and has a cross gable over the front door. The second story has three, symmetrically placed, one over one, double hung windows. A gable roofed dormer projects from the attic story with a single, one over one, double hung window. Wood shingles surround the window in the dormer. The main roof, sheathed in composition shingles, is pyramid shaped with a boxed cornice.

The fenestration on the east facade is irregularly spaced with two windows on the first floor and three windows on the second level. A sixth window is situated in between the first and second stories in the center of the facade. This window appears to be placed in a stairwell leading to the second story. All of the windows are one over one and double hung; however, there is a pair of smaller, one over one, windows in the southernmost bay of the first story. In addition, there is a gable roofed dormer in the attic story of this facade identical to the one described above in the north facade.

PLATE 125: CRS S-1668
View of south and west facades of house, looking northeast.
Note original frame exterior, varied roof line, wraparound porch, and projecting cross gable.

The west facade of the Classical Box is only two bays deep with two, single, one over one, double hung windows in each story. The hipped roofed porch continues to wraparound to this facade and extends over the first story. There is a small, projecting gable in the attic story with no window. The original west facade of the I-house projects out from the rear of this facade. It is two and one-half stories and two bays wide with a gable roof. There are two, single, one over one, double hung windows in the first and second stories, and a matching window in the attic story. A wood panel door on the north facade of the I-house leads into the first story. There is a single, one over one, double hung window above it in the second story.

A one story, shed roofed addition extends across the entire rear or south facade of the house. The entire building is covered in white aluminum siding and has a brick foundation.

This dwelling is one of only two, combination I-house/Classical Box structures in the project corridor. The house successfully blends two distinct building types, from both the nineteenth and twentieth centuries, into a single home. The house reflects the changing attitudes of its owners, and their desire to "modernize" their home from a traditional I-house to a more "up to date" home of the early twentieth century. The house is in excellent condition and appears to be individually eligible within the context of architecture and the temporal period of 1880-1940 (Herman et. al. 1989).
