This picnic area appears to be an individually eligible complex constructed by the Civilian Conservation Corps during the Great Depression in 1937 (F.W.P. 1938). The Redden Forest was designated a state forest a year later. Although the CCC did vast amounts of work all over the country during the 1930s, very little was actually done in Delaware (LeeDecker et. al. 1989:90). This picnic area recreates, on a much smaller scale, the Adirondack woodland retreats of New York State that captivated thousands of tourists a year. The CCC did much to turn inhospitable woodland settings along America's rural highways into inviting and charming rest stops for travelers. A two mile hiking trail along the stream was also laid out by the CCC when this shelter was built (F.W.P. 1938). A similar CCC camp still exists on Route 113 (LeeDecker et. al. 1989:90), but this is the only one located within the project corridor.

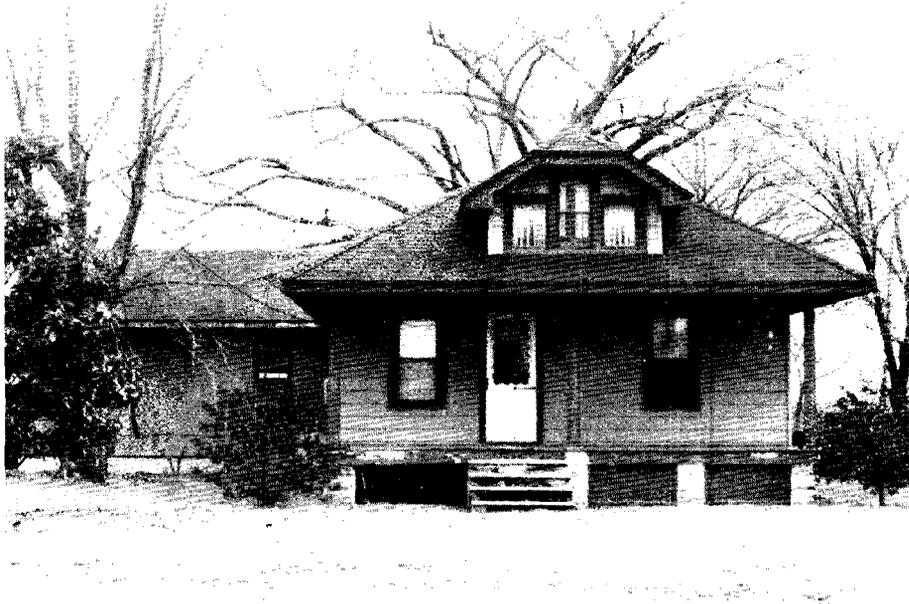
Plates 126a and 126b; Appendix A, Plat 7

A one story, gable roofed addition has been added onto the north facade of the house. This addition appears to be modern, and has a large, garage door in the east facade. This part of the building seems to be used as a mechanic shop or for vehicle storage. The eastern end of the original house has been screened in and is used as a porch. The house is clad in a combination of green, aluminum and vertical board siding.

A covered walkway, open on both sides connects this dwelling to a larger structure next door that functions as a print shop. The print shop is constructed on concrete block and appears to date to the 1950s or 1960s.

PLATE 126a: CRS S-1710
View of west facade of dwelling, looking east.

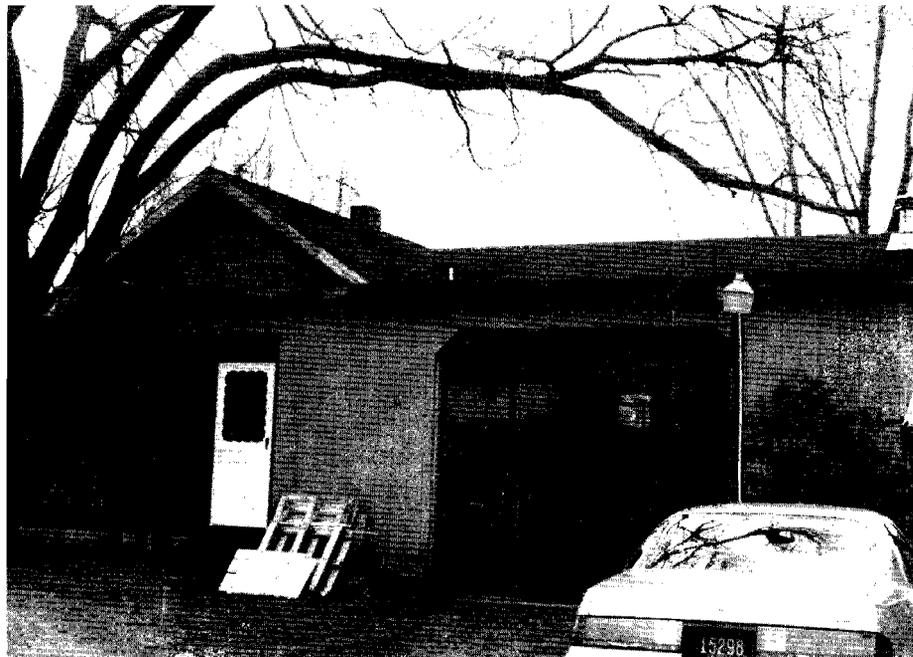
PLATE 126b: CRS S-1710
View of rear of dwelling, looking west. Note modern garage addition.

This property is not eligible due to severe alterations. The large addition at the rear of the house, functioning as a garage/shop, greatly detracts from the formerly symmetrical Bungalow. Changes in fenestration in the side facades, as well as the construction of a screened in porch in the eastern end of the house, also compromise the integrity of the structure. Today, the house appears to serve both as a residence and as part of the print shop operating next door.

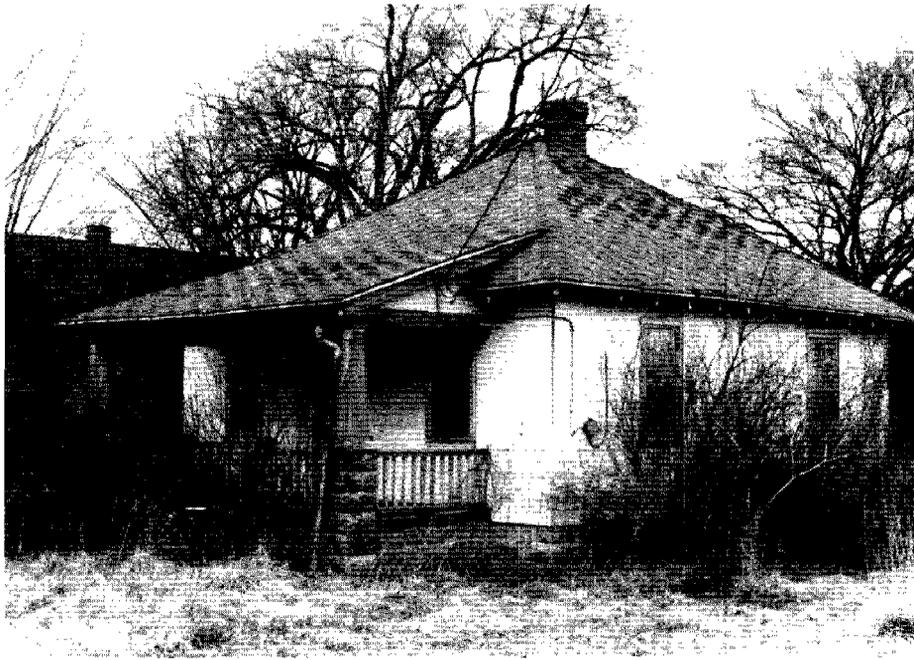
PLATE 127: CRS S-1711
View of west and south facades of house, looking northeast.
Note pyramidal roof.

This property appears to be individually eligible. The square plan cottage with a pyramid roof is the only one of its kind surveyed within the project corridor. The building, which appears to date to the early twentieth century, retains its basic form and fenestration, as well as several outbuildings, and is in fair condition. The building is architecturally significant within the temporal period of 1880-1940, Suburbanization (Herman et. al. 1989:59).

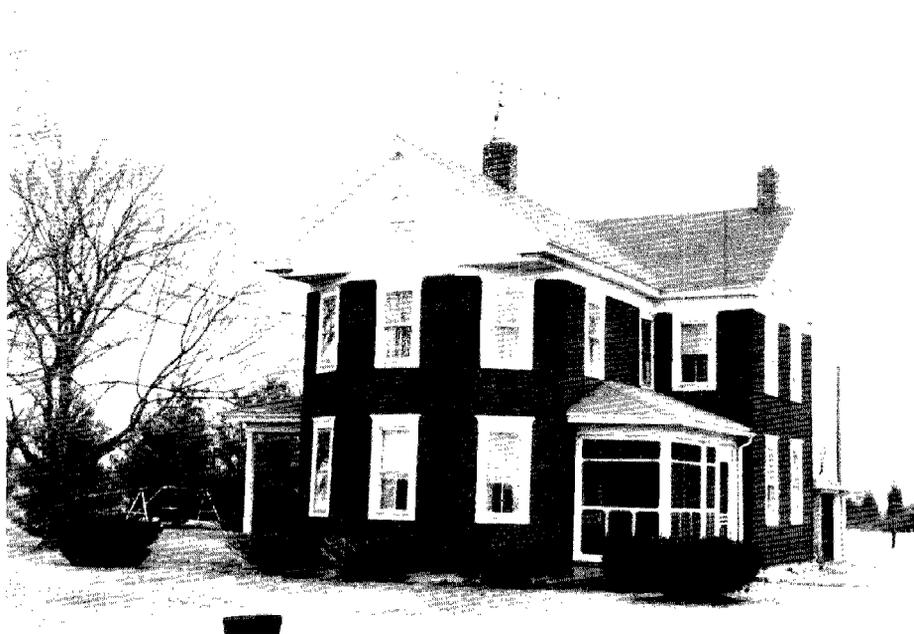
PLATE 128: CRS S-1712
View of west and south facades of house, looking east.
Note large cross gable, original windows and shake siding.

This T-plan I-house is located on the east side of Route 13 Business, outside of Bridgeville and was previously surveyed. The main block of the house is two and one-half stories, three bays wide and two bays deep with a gable roof. A two and one-half story, two bay wide and three bay deep wing projects outward from the west facade. One story, hipped roofed porches are present on the north and south facades of the projecting wing. There are entrances into the house from both of these porches. The west facade of the wing is canted in both stories with three, two over two, double hung windows. An interior, brick chimney is centrally placed along the ridge in this section of the house. The house is clad in dark brown, composition shingle siding and is raised on a concrete foundation.

It appears that the east facade, with a center entrance, may have been the original front facade at one time. Currently a small, one story, gable roofed section is attached to the facade, with the roof line running perpendicular to the main block of the house. There is an entrance into this section on the south facade. The windows are small, square casement type openings. There is an interior, brick chimney along the east facade. This section also rests on a concrete foundation.

This dwelling complex appears to be individually eligible. The house is an unusual plan with the large, two story, canted bay wing on the west facade. The house retains its original fenestration and is in excellent condition. In addition, the one story kitchen wing adds to the overall integrity of the complex, and may predate the main house. The house is significant within the temporal period of 1830-1880, and is significant architecturally within the priority of Agriculture (Ames et. al. 1989).

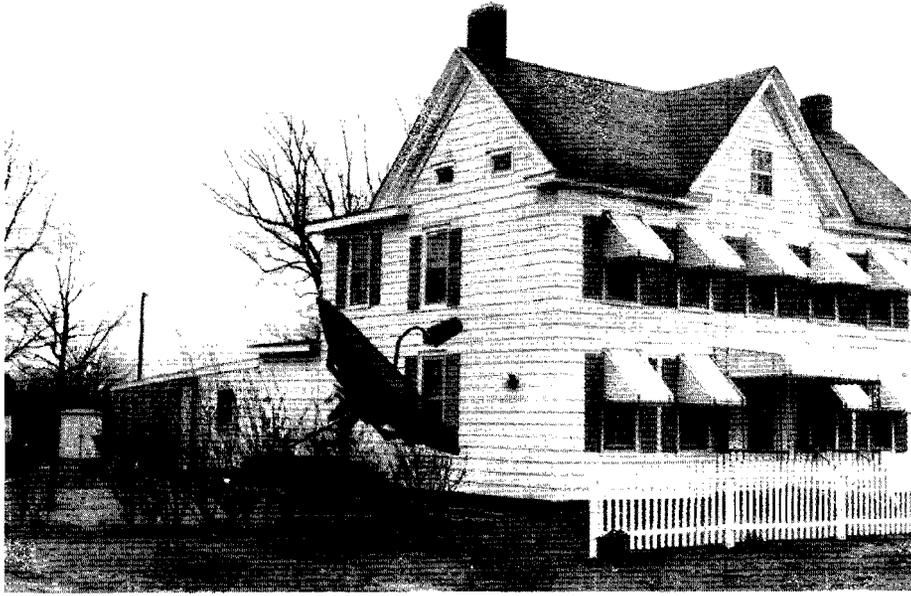
PLATE 129: CRS S-1713
View of west and north facades of house, looking southeast.
Note window hoods and series of additions on rear.

The rear wing is two and one-half stories, two bays wide and one bay deep. A two story addition has been added to the north facade of the rear wing. A one story, shed roofed addition has been constructed on the south facade. The one story addition contains a second entrance into the house. A one story, flat roofed, partially enclosed, carport has been attached to the east facade of the rear wing. There are two, small, fixed, four pane windows in the attic story of the east facade. There is no other fenestration visible. The entire house is covered in white, aluminum siding and has a combination brick and concrete foundation. There is a modern, gambrel roofed shed just east of the house.

This late nineteenth century house is not eligible either individually or as part of the proposed, Five Bay, I-House, Multiple Property Submission. The original form of the house has been compromised by several rear additions including a modern carport. Blue, louvered shutters and metal awnings over the front door and windows also detract from the overall integrity of the house. There are other examples of the five bay I-house throughout the corridor which better exemplify the style and form of the building type.

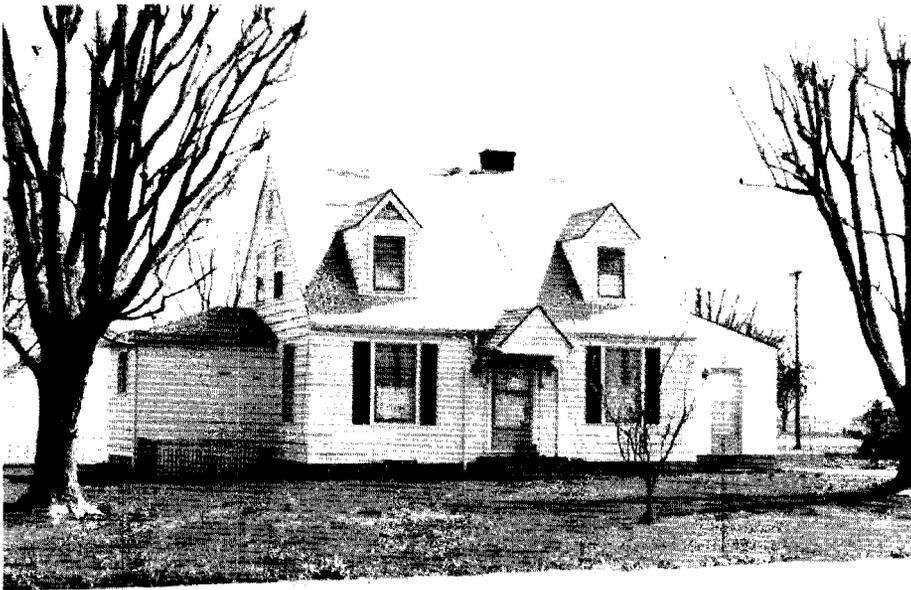
PLATE 130: CRS S-8456
View of west and north facades of house, looking east.

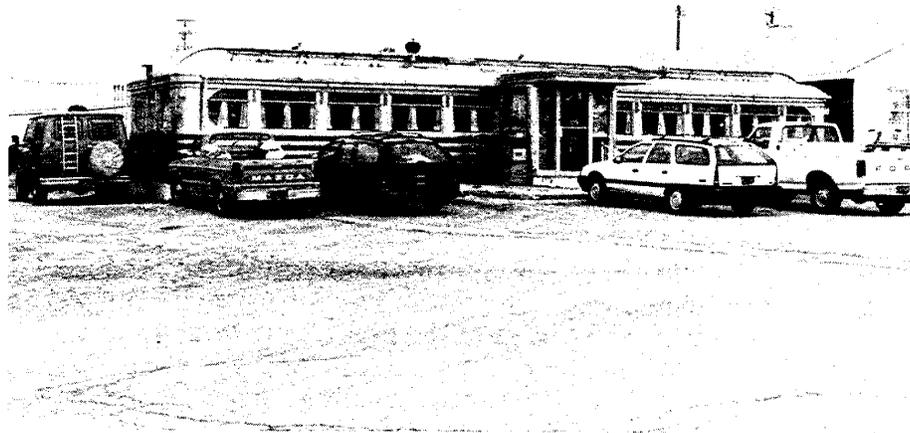
PLATE 131: CRS S-8457
View of north facade of diner, looking south.
Note unusual design, excellent condition and integrity.

This restaurant is situated at the junction of Route 13 and Route 13 Business, outside of Bridgeville. A dining car is attached to a modern, one story, gable roofed structure that is used for additional seating. The car itself is stainless steel with blue and red tile trim. Pairs of small windows, reminiscent of railroad coaches and buses, run along the sides of the car. The entrance is located within a glass enclosed portico on the north facade. The car is in excellent condition. It retains the original interior, including a lunch counter with stools, small booths, and cooking equipment.

This property appears to be eligible as a contributing member of the proposed, Commercial Roadside, Multiple Property Submission. The dining car is the only one of its kind in the project corridor, and still functions as a popular restaurant today. The date of construction of the dining car is unclear, although it seems logical that the diner was put into operation sometime after the establishment of the Dupont Parkway or Route 13. Route 113 or the Coleman Dupont Highway to the east, was completed by 1924 (Catts, Custer and Hoseth 1991:). It appears that Route 13 was constructed at the same time, although in 1934 it was known as the Cape Charles Route, not the Dupont Parkway as it is called today (State Highway Department 1934). The diner is located in an ideal spot to attract travelers using the busy roadway, between Wilmington and Cape Charles, Maryland. The diner also attracts local citizens living in and around Bridgeville.

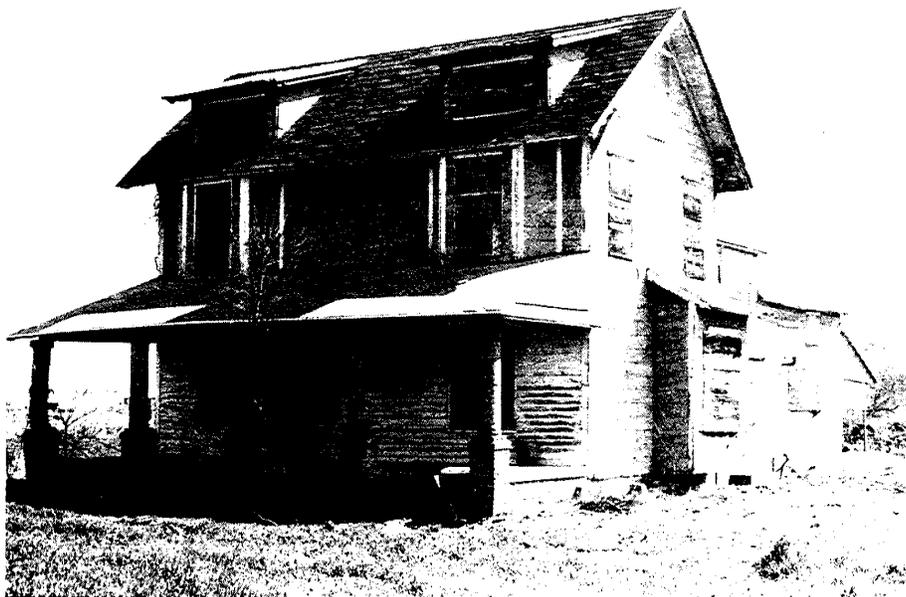
PLATE 132: CRS S-1708
View of west and south facades of house, looking east.
Note coverings over all windows and doors.

This previously surveyed, abandoned I-house sits on the east side of Route 13, approximately seventy-five yards from the road. The two and one-half story house is three bays wide and two bays deep with a gable roof and large, rear, two story addition. Extending across the front facade is a shed roofed porch supported by gray, brick columns resting on brick piers. The house is covered in asphalt shingle siding. All of the windows and doors have been boarded over. A deteriorating silo is located behind the house. No other outbuildings are extant.

This building is not eligible either individually or as part of the proposed, Three Bay, I-House, Multiple Property Submission. The house has been heavily altered and is in poor condition. The original symmetry and form of the house have been greatly compromised by the insertion of two, shed roofed dormers in the front facade, and the addition of a concrete block and brick front porch, as well as a large, rear addition. There are better examples of the three bay I-house with greater integrity throughout the corridor.

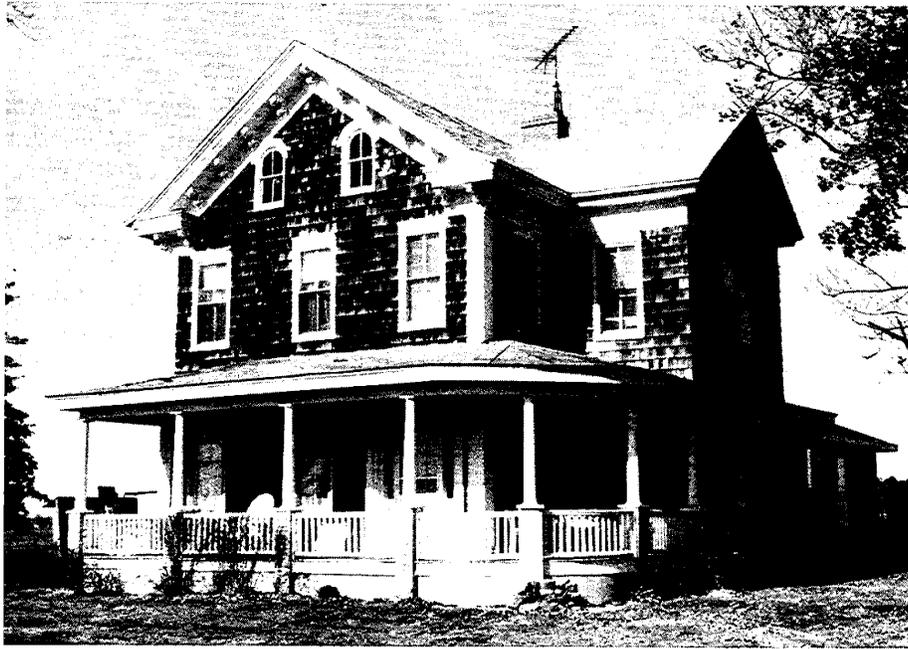
PLATE 133: CRS S-1714

View of south and east facades of house, looking northwest.
Note original windows, doors, wraparound porch, and cornice detailing.

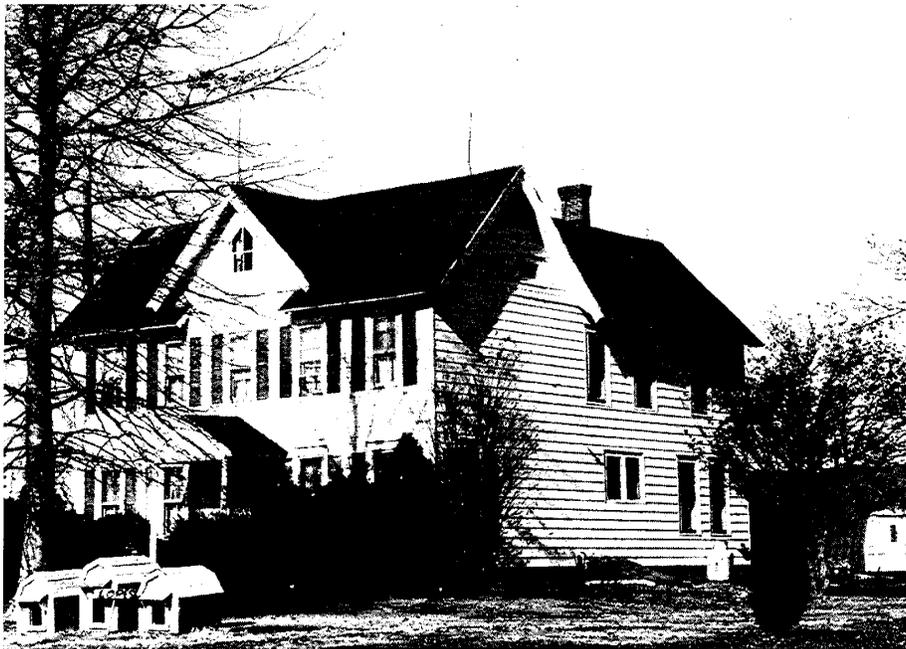
PLATE 134: CRS S-1715

View of south and east facades of house, looking northwest.
Note five bay fenestration, cross gable, original windows on main facade.

This late nineteenth century dwelling complex is situated on the north side of Route 404. The house is two and one-half stories, five bays wide, and one bay deep with a two story, rear wing. The front or south facade, has a center doorway flanked by two, single, two over two, double hung windows with louvered shutters. A modern, gable roofed pediment supported by square, wooden posts extends over the entrance. There are five, symmetrically placed, two over two, double hung windows in the second story. All of these window have louvered shutters. A cross gable with a single, four pane, Gothic style window is centrally placed in the front facade.

This house is eligible as a contributing part of the Five Bay, I-House, Multiple Property Submission. The house is in excellent condition and retains its original form and fenestration, with few alterations. Individual elements such as the box cornice with returns; the fixed windows in the attic story; the cross gable; and two over two, windows all add to the overall integrity of the structure. As an example of the adaptation of the I-house form with the Georgian style, and as a representative example of domestic architecture utilized by the wealthiest level of landowner in the corridor, this property is significant. Both of the properties in this submission, including this one, were part of working agricultural complexes, and are also significant under the priority of Agriculture (Ames et. al. 1989:79, 83).

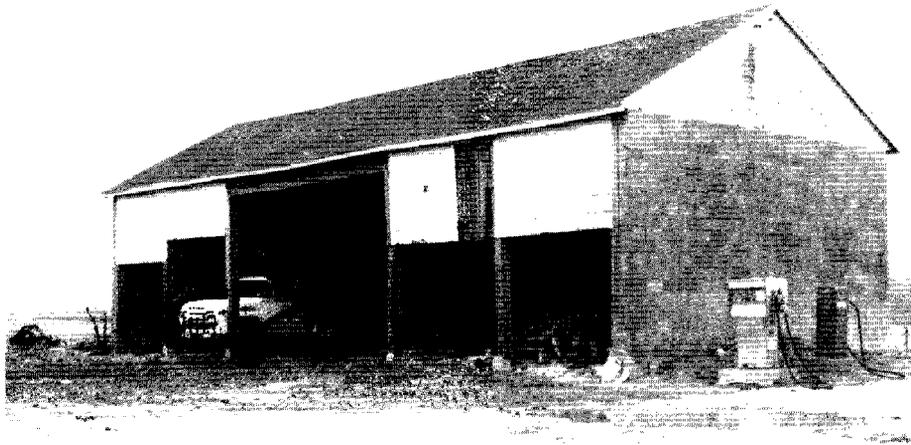
PLATE 135a: CRS S-8458
View of agricultural building, looking southwest.

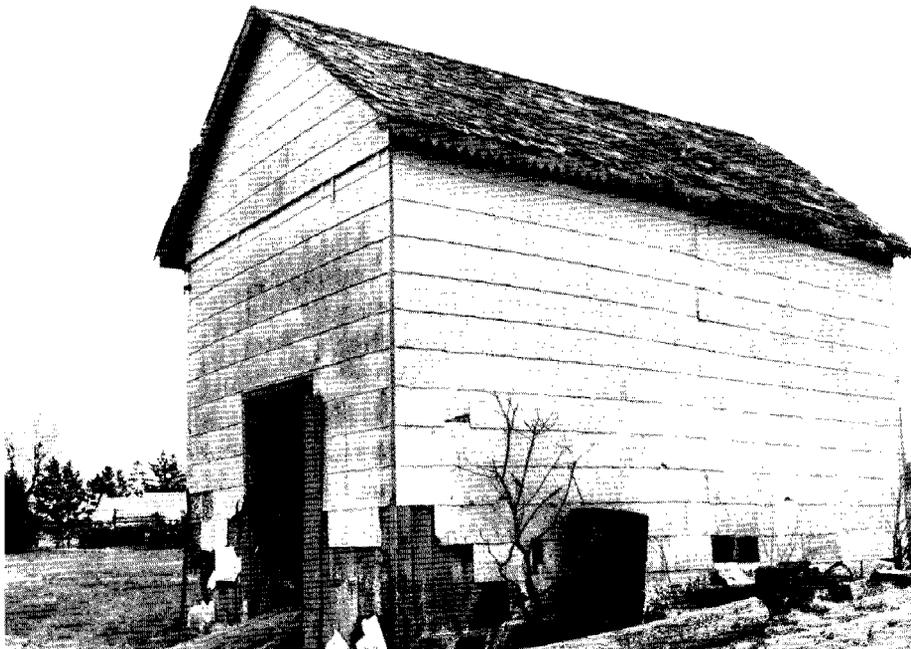
PLATE 135b: CRS S-8458
View of south and west facades of abandoned agricultural structure, looking north.

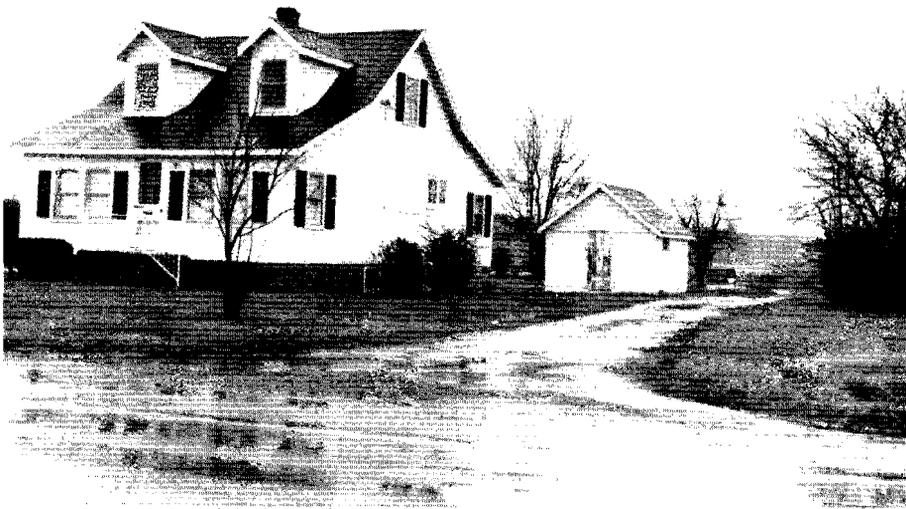
PLATE 136: CRS S-8459
View of south and east facades of house, looking northwest.

This cottage is situated on the north side of Route 404. The house is one and one-half stories, three bays wide and deep. It has a flared, gable roof and two, gable roofed dormers on the front facade. The entrance is centrally placed in the front or south facade facing the road. It is flanked by a pair of one over one, double hung windows with louvered shutters. A brick chimney is centrally placed along the ridge. The roof is sheathed in composition shingles. The house rests on a molded, concrete block foundation and is clad in white, composition shingle siding. The house appears to have a basement. A concrete block and frame shed with a gable roof is situated just behind the house. There are a series of abandoned chicken houses west of the house, but it is unclear if they are part of this property.

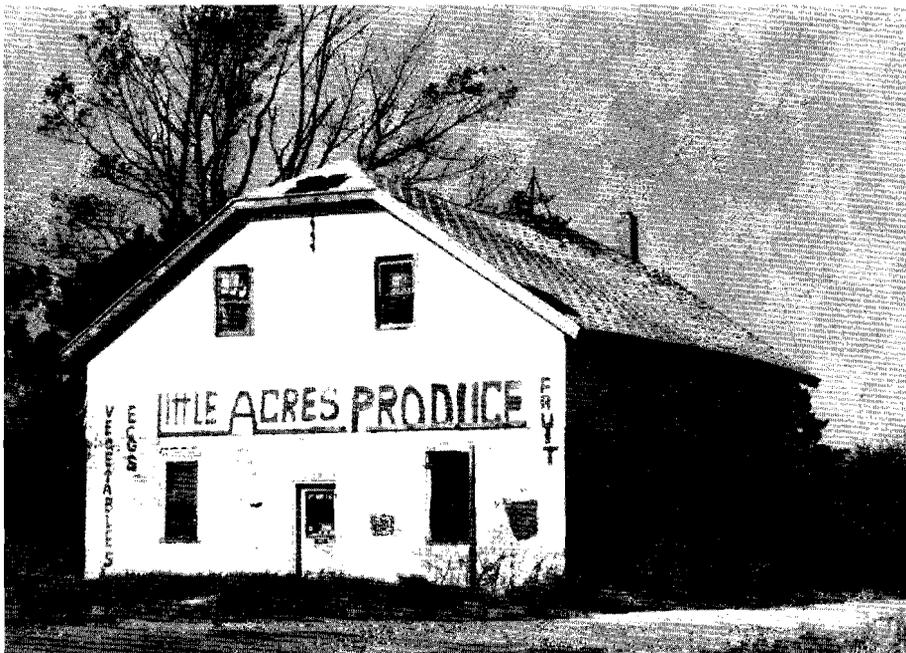
PLATE 137: CRS S-8460
View of south and east facades of house, looking northwest.
Note concrete first story and unusual design.

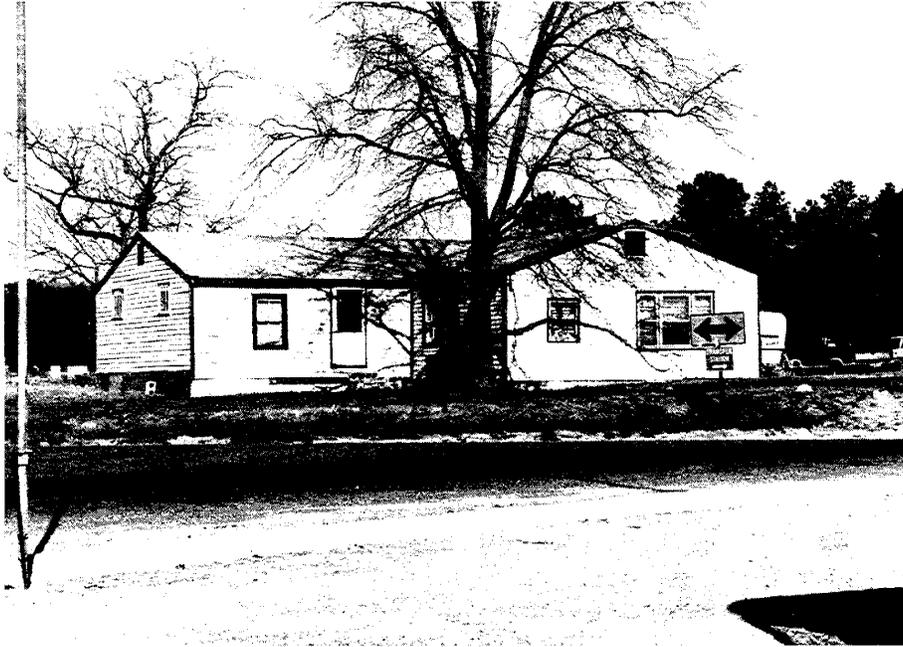
PLATE 138: CRS S-1890
View of south facade of dwelling, looking north.

Located at the northwest corner of Route 404 and Road 18, this building was previously surveyed. The one story building is L-shaped, three bays wide and two bays deep with a gable roof and a concrete block foundation. The house has a combination of modern and two over two, double hung windows. The building is clad in horizontal, wood siding.

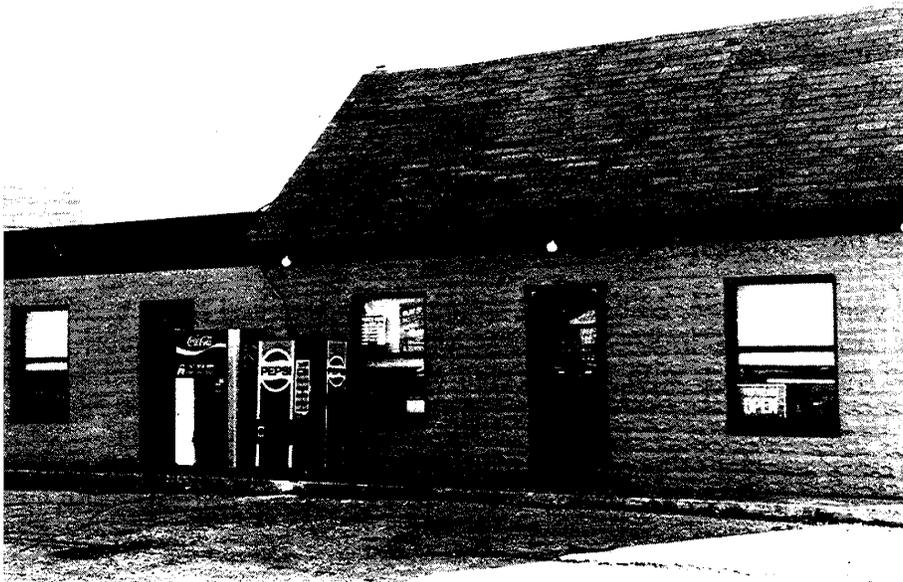
PLATE 139: CRS S-6066
View of north facade of store/former gas station and restaurant, looking southeast.

This previously surveyed, commercial structure is positioned at the southeast corner of the intersection of Route 404 with Road 18. The small building is rectangular in plan. It is three bays wide and one bay deep with a gable roof and one story, flat roofed addition on the east facade. The main block of the building is constructed of molded concrete block.

This building appears to have had several functions over the years. It was used as a gas station, seafood restaurant, and currently as a store specializing in fishing and hunting supplies. The building was most likely constructed during the first half of the twentieth century, as the molded concrete block exterior was one of the most popular forms of construction used between 1905 and 1930 (Simpson 1989:108). Due to its location at the intersection of two major roadways in Sussex County, the establishment of a gas station at this corner would have been an ideal commercial venture. Although the function of the building has changed over the

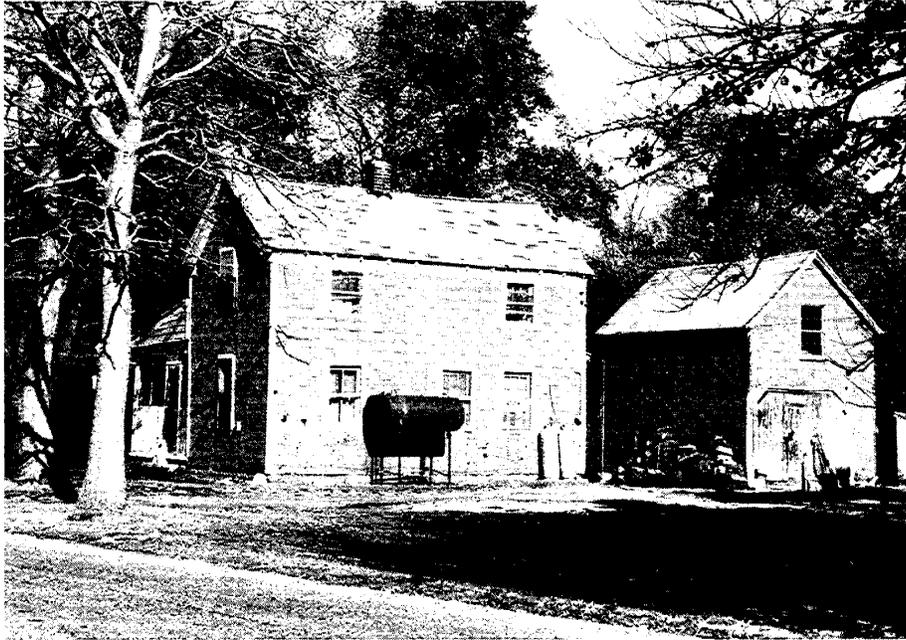
PLATE 140: CRS S-6052
View of south and west facades of house, looking north.
Note frame garage to east of house. Also note original windows on dwelling.

This previously surveyed, two story I-house is three bays wide and one bay deep. A one story porch is constructed across the first floor of the main facade. The frame structure is clad in asphalt shingle siding and is in fair condition.

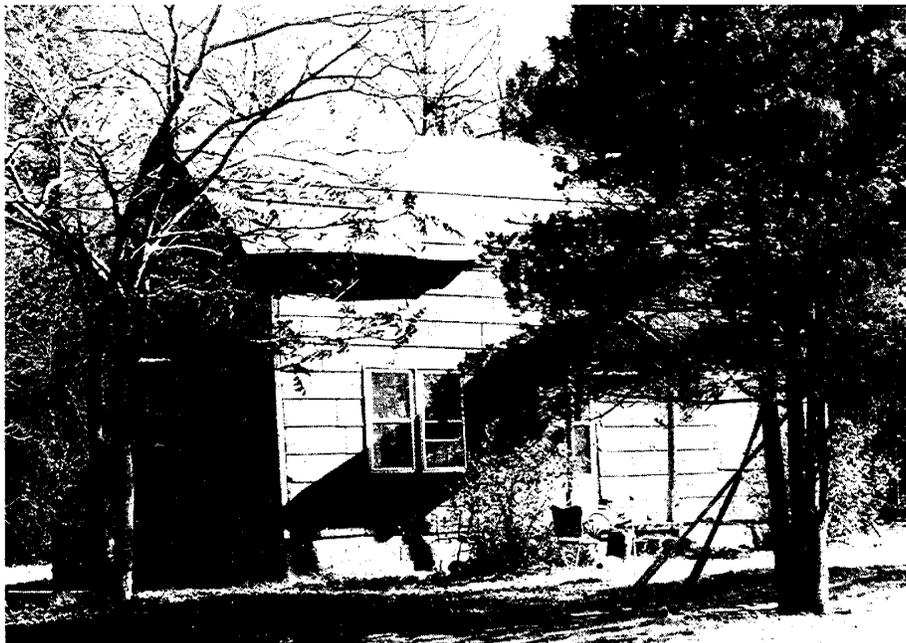
PLATE 141: CRS S-6053
View of west and north facades of dwelling, looking southeast.

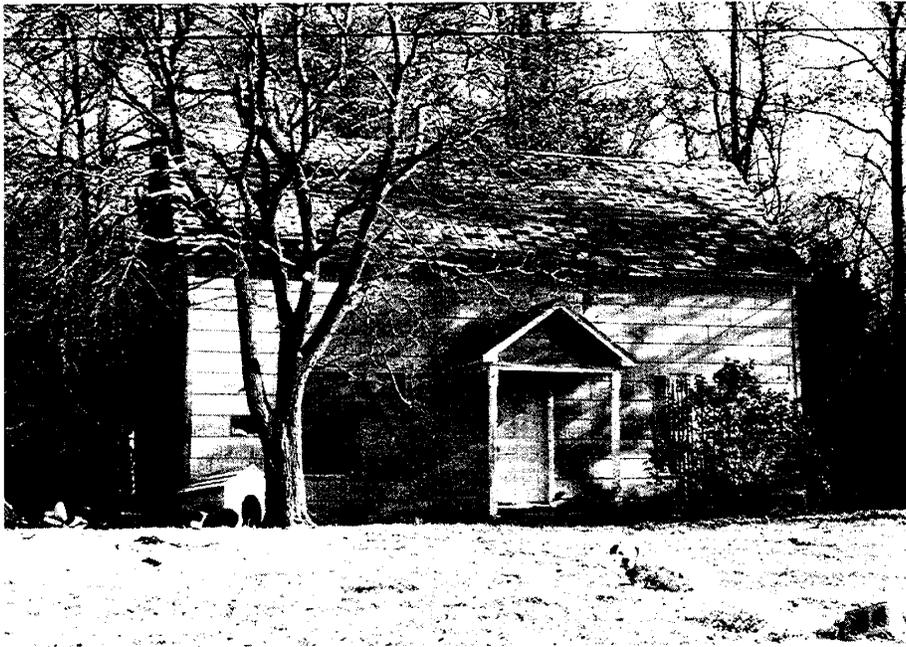
PLATE 142: CRS S-6054
View of west facade of dwelling, looking east. Building is currently vacant.

This previously surveyed building is identical to its neighbor to the north, CRS S-6053. It is a one and one-half story, frame dwelling that is three bays wide and two bays deep with a gable roof. The windows in this condemned structure have been boarded over.

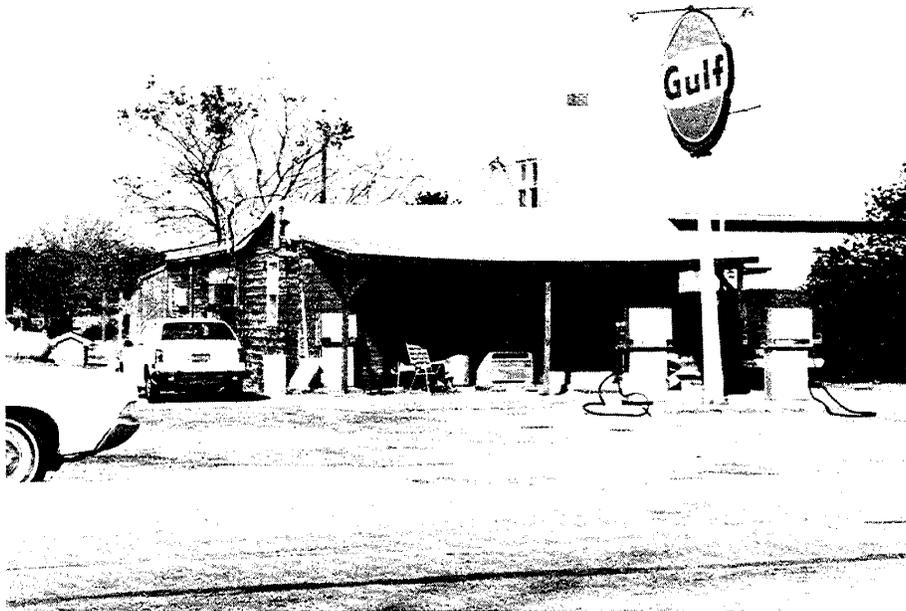
PLATE 143: CRS S-8461
View of south facade of gas station, looking north.
Note small scale, frame construction.

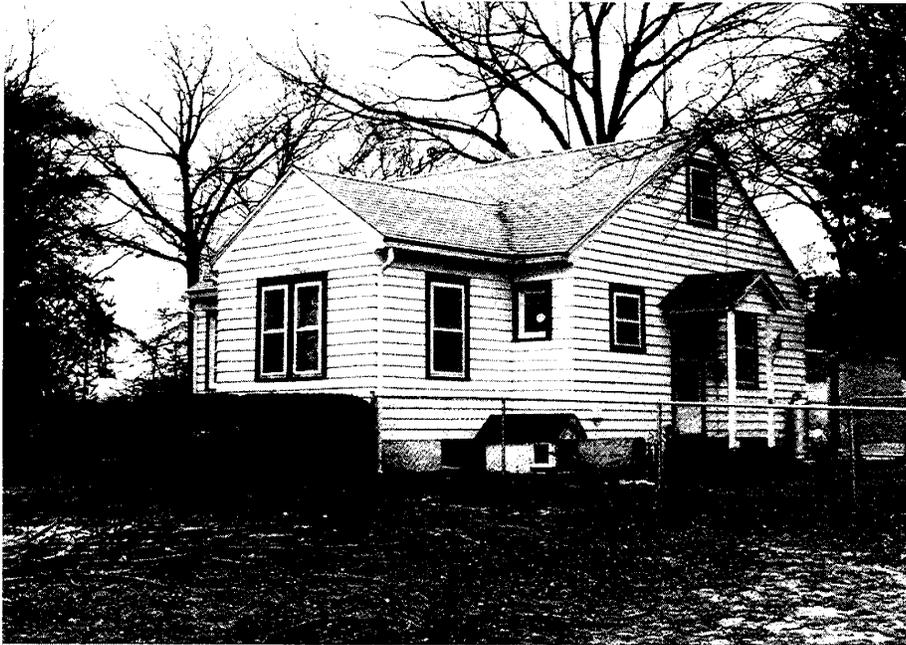
PLATE 144: CRS S-8462
View of main and side facades of house, looking southeast.

This one and one-half story cottage is located on the south side of Route 404, almost directly across from the intersection with Road 594. The house is rectangular in plan with a projecting cross gable, one bay wide and deep section on the north facade. The entrance is present on the west facade. The windows are both paired and single, one over one and double hung. The south facade contains an interior, brick chimney. The house rests on a concrete block foundation and appears to have a basement. The building is clad in white, vinyl siding. A frame, gable roofed shed/workshop with an interior, brick chimney is located behind the house.

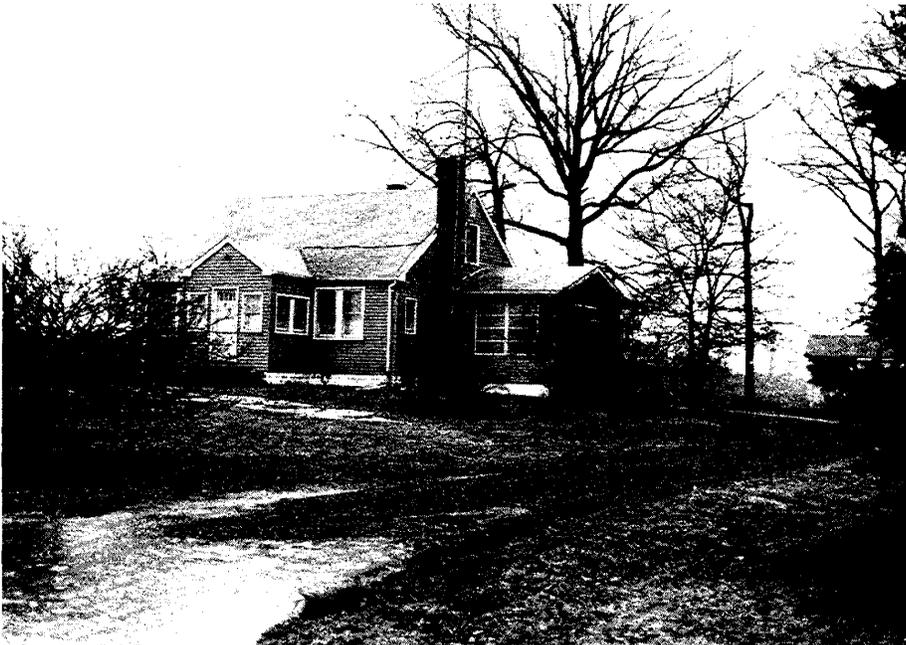
PLATE 145: CRS S-5091
View of north and west facades of house, looking southeast.

This previously surveyed, one and one-half story cottage sits on the south side of Route 404, directly across from the intersection with Road 594. The house is almost identical in plan to its neighbor to the west, S-8462. The cottage is rectangular in plan with a projecting cross gable, one bay wide and deep section in the center of the front facade. The entrance is placed in the center of this section. A one story, gable roofed addition has been built on the west facade. This addition seems to be used as a sunroom. An exterior, brick chimney is situated between the house and the sunroom on the west facade. All of the windows are one over one and double hung. The house rests on a raised, concrete foundation and appears to have a basement. The building is clad in green, vinyl siding. To the east of the house is a modern, gable roofed garage. A frame shed is just to the west of the building.

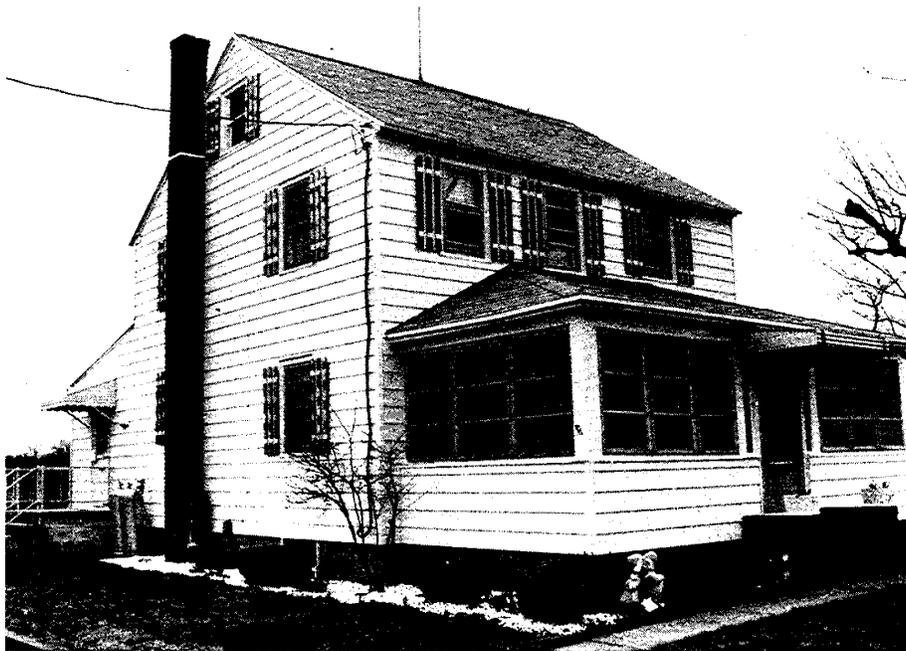
PLATE 146: CRS S-5089
View of north and east facades of house, looking southwest.
Note large enclosed front porch, replacement windows, external chimney stack.

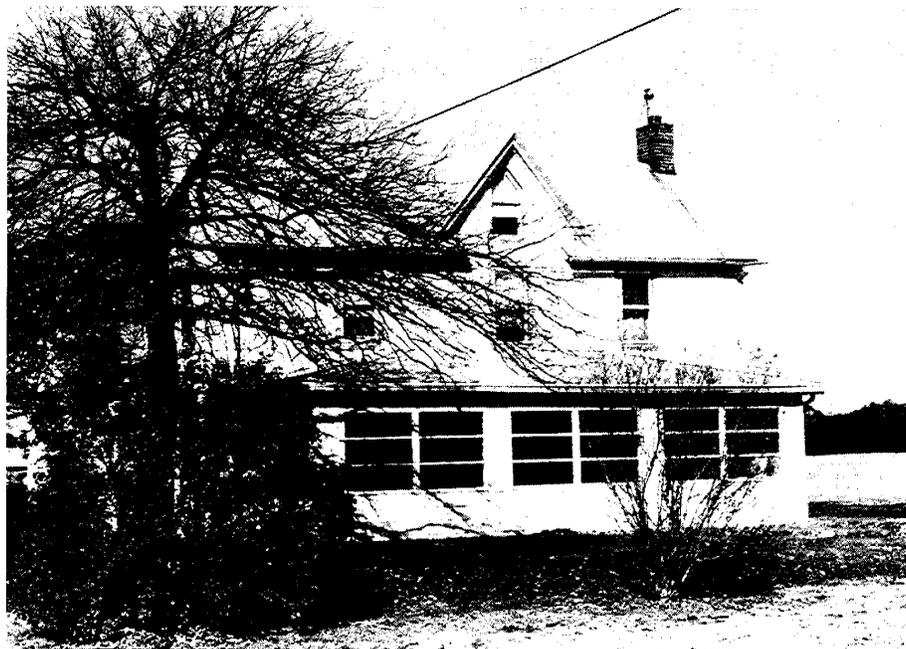
PLATE 147: CRS S-5090
View of south facade of dwelling, looking north.
Note large, enclosed porch and modern windows.

This building does not appear to be eligible either individually or as part of the Three Bay, I-House, Multiple Property Submission. The front facade has been significantly altered with the addition of a one story, enclosed porch across the entire length of the house. This porch obscures the original, three bay placement with a center entry, typical of this building type. In addition, all of the windows have been replaced with a variety of modern, one over one, double hung sashes. Many other examples of the three bay I-house that possess greater integrity are present throughout the project corridor.

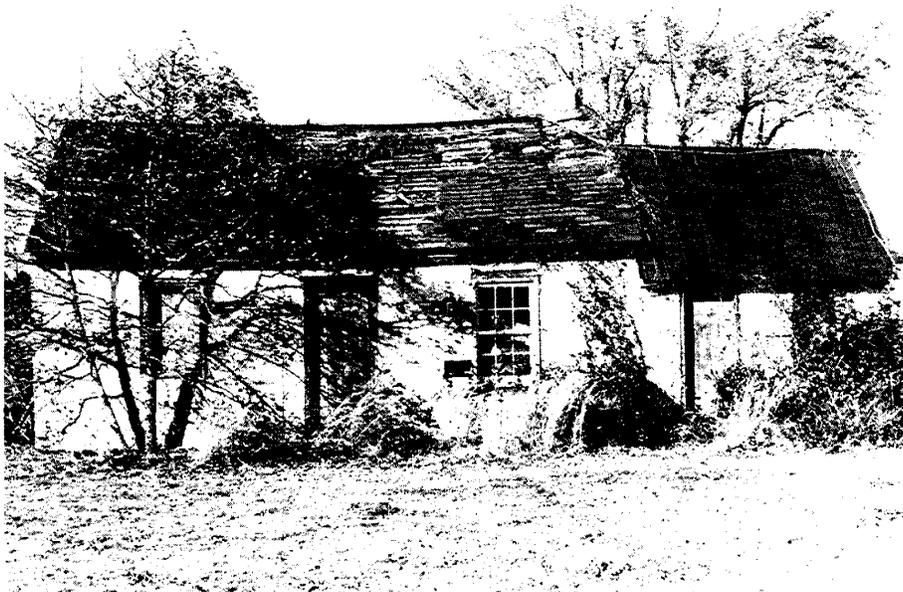
PLATE 148: CRS S-5087
View of south facade of dwelling, looking north.
Note original windows and fenestration.

This small dwelling sits on the north side of Route 404. The building is frame, one and one-half stories, three bays wide, and one bay deep with a gable roof. A one story addition with a standing seam, metal, gable roof is located on the east facade of the house.

This small structure appears to be an early nineteenth century example of the Chesapeake Bay Vernacular style. This house is only one of a handful of this building type left within the project corridor, and is perhaps the least altered of any of the other extant Chesapeake Bay Vernacular dwellings. As an intact example of the style in relatively good condition, the dwelling appears to be individually eligible. As an important example from an early period of Sussex County history, this building is significant under temporal period 1770-1830 and the theme of Settlement Patterns (Ames et. al. 1989; Herman et. al. 1989).

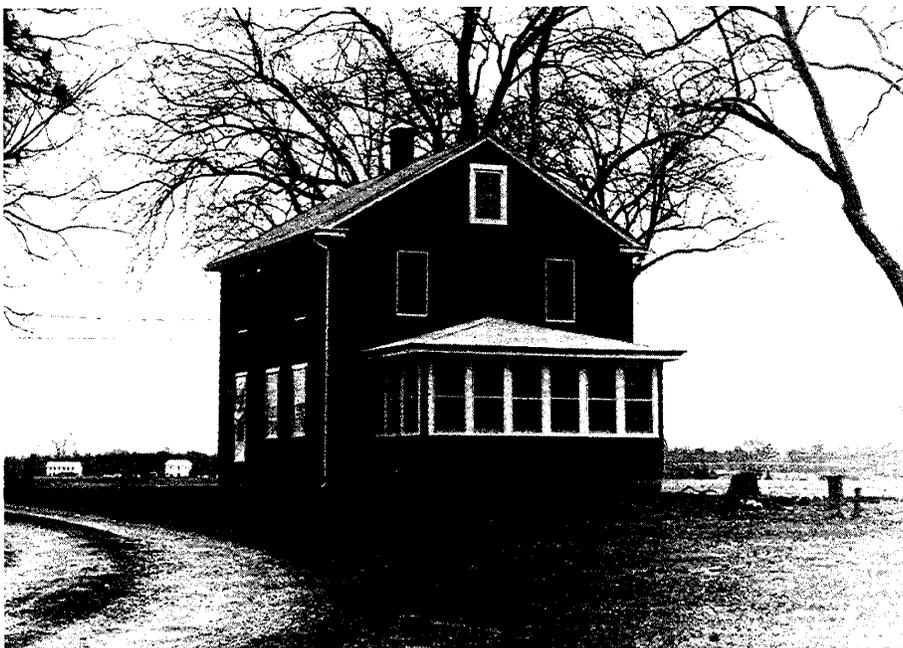
PLATE 149: CRS S-5088
View of north and west facades of house, looking southeast.
Note replacement windows and altered fenestration on north facade.

This house sits on the south side of Route 404, approximately one hundred yards from the road. The previously surveyed building is rectangular in plan. It is two and one-half stories, three bays wide and two bays deep with a gable roof. The entrance is in the eastern end of the north facade. Two, one over one, double hung windows occupy the remaining bays. There are two, one over one windows symmetrically placed in the second story. An enclosed, hipped roofed porch has been added onto the west facade. The house is clad in blue, wood shingle siding and rests on a concrete foundation. A modern, aluminum sided garage with a gable roof is located southwest of the house.

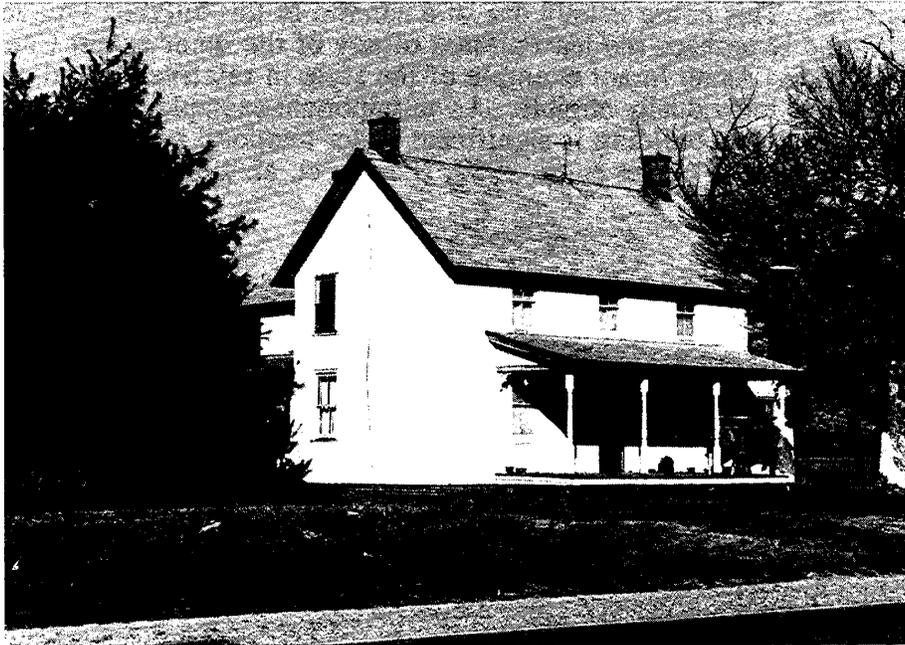
PLATE 150: CRS S-5086
View of south and west facades of house, looking northeast.
Note three bay fenestration, original windows, turned posts on porch.

This previously surveyed, mid-nineteenth century I-house is located on the north side of Route 404. The house is two stories, three bays wide, two bays deep, with a gable roof. There is a rear, two story wing on the north facade. The house has a brick foundation and two over two, double hung windows.

This property is eligible as a contributing part of the Three Bay, I-House, Multiple Property Submission. The building retains its original form and fenestration as well as several frame outbuildings. Three bay I-houses are significant remnants of the basic vernacular dwelling type found throughout Sussex County. The majority of the houses in this submission, including this one, were part of working agricultural complexes, and are also significant under the priority of Agriculture (Ames et. al. 1989:79, 83).

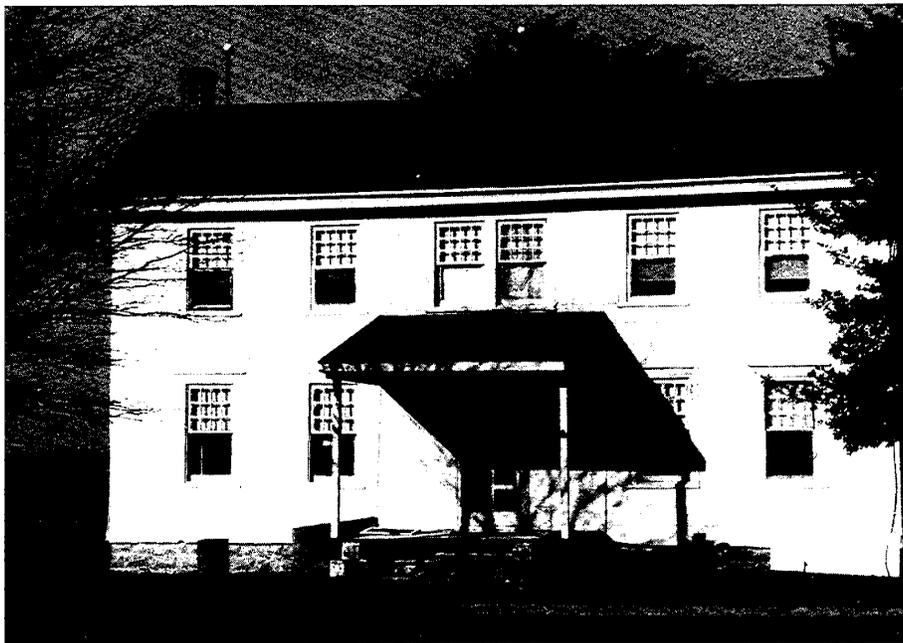
PLATE 151: CRS S-5085
View of south facade of dwelling, looking north.
Note five bay fenestration, unusual sash pattern, and excellent condition.

Located on the north side of Route 404, this dwelling complex was previously surveyed. The house is two and one-half stories, five bays wide, two bays deep with a gable roof and a rear, two and one-half story ell. A hipped roofed, wraparound porch encircles the rear wing.

The windows are twelve over one and double hung. There is an old, frame store and modern machine shed positioned behind the house.

This property is eligible as a contributing part of the Five Bay, I-House, Multiple Property Submission. The building is in excellent condition and retains its original form and fenestration. According to a previous survey, the property belonged to C.A. Rawlins in 1868, and the house was built circa 1865 (Corkadel 1984). The small, frame structure with a projecting gable roof located behind the house was apparently used as a store, and was moved to the property at some point (Corkadel 1984). As examples of the adaptation of the I-house form with the Georgian style, and as representative examples of domestic architecture utilized by the wealthiest level of landowner in the corridor, the Five Bay, I-House, Multiple Property Submission is significant (Ames et. al. 1989:79, 83) under the priority theme of Agriculture.

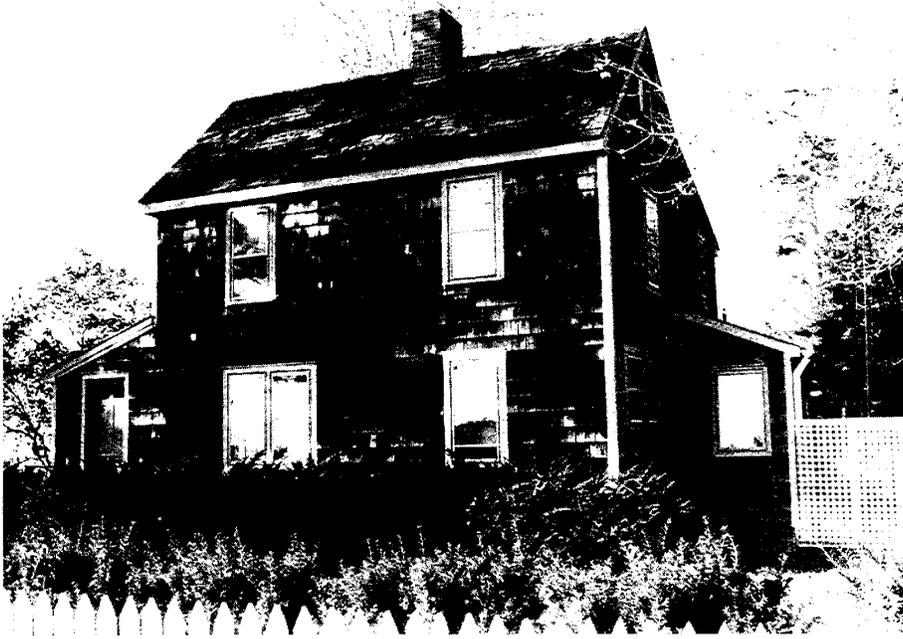
PLATE 152: CRS S-5082
View of south and east facades of house, looking northwest.
Note original fenestration, shake siding, centered chimney, and excellent condition.
