This picnic area appears to be an individually eligible complex constructed by the Civilian Conservation Corps during the Great Depression in 1937 (F.W.P. 1938). The Redden Forest was designated a state forest a year later. Although the CCC did vast amounts of work all over the country during the 1930s, very little was actually done in Delaware (LeeDecker et. al. 1989:90). This picnic area recreates, on a much smaller scale, the Adirondack woodland retreats of New York State that captivated thousands of tourists a year. The CCC did much to turn inhospitable woodland settings along America's rural highways into inviting and charming rest stops for travelers. A two mile hiking trail along the stream was also laid out by the CCC when this shelter was built (F.W.P. 1938). A similar CCC camp still exists on Route 113 (LeeDecker et. al. 1989:90), but this is the only one located within the project corridor.

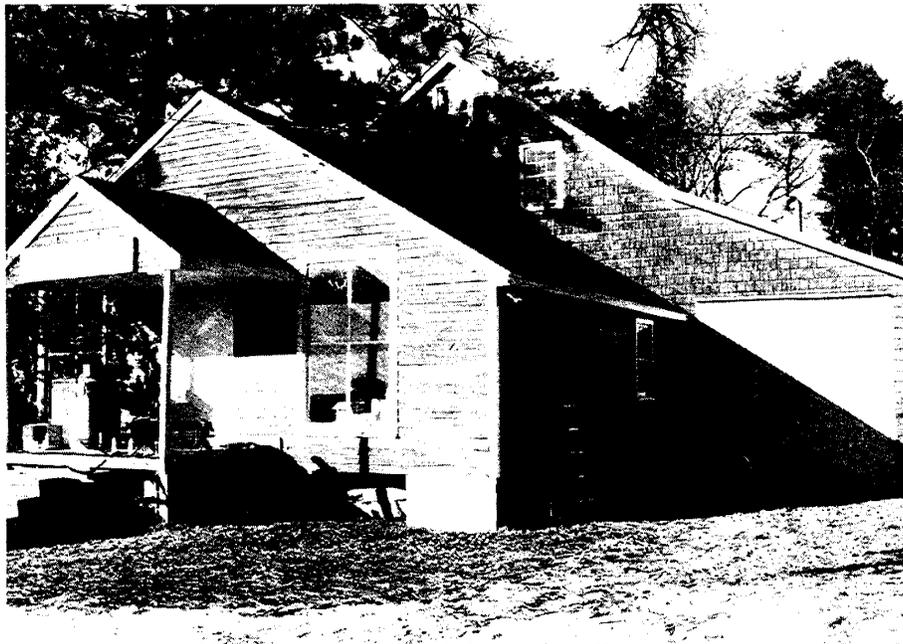
PLATE 153: CRS S-5083
View of south facade of barn/antique store, looking northwest.
Note frame construction, unusual design, excellent condition.

Figure 12; Plate 153; Appendix A, Plat 11

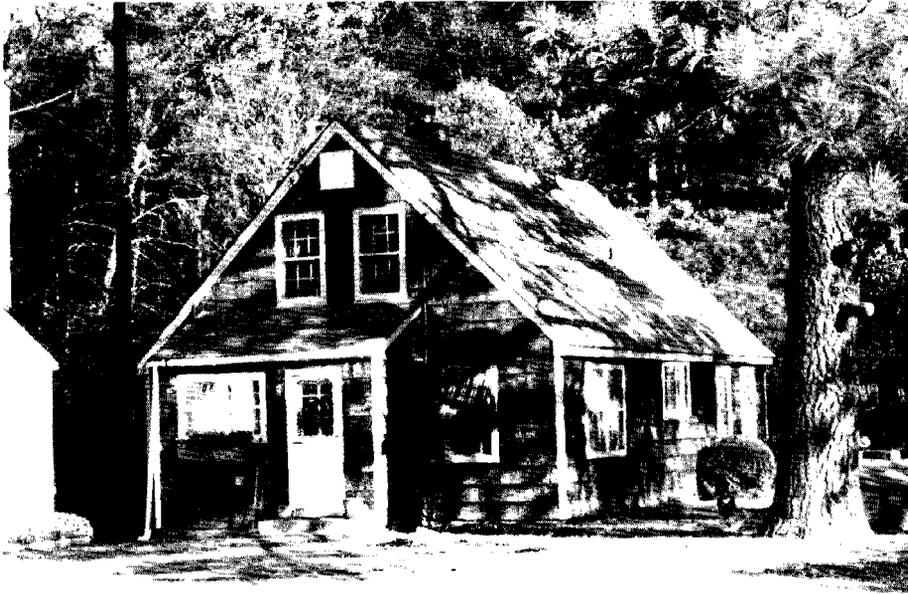
PLATE 154a: CRS S-5084
View of west and south facades of former carriage house, looking east.

CRS S-5084
Previously Surveyed
Eligible: Governor Collins Historic District
Figure 12; Plates 154a and 154b; Appendix A, Plat 13

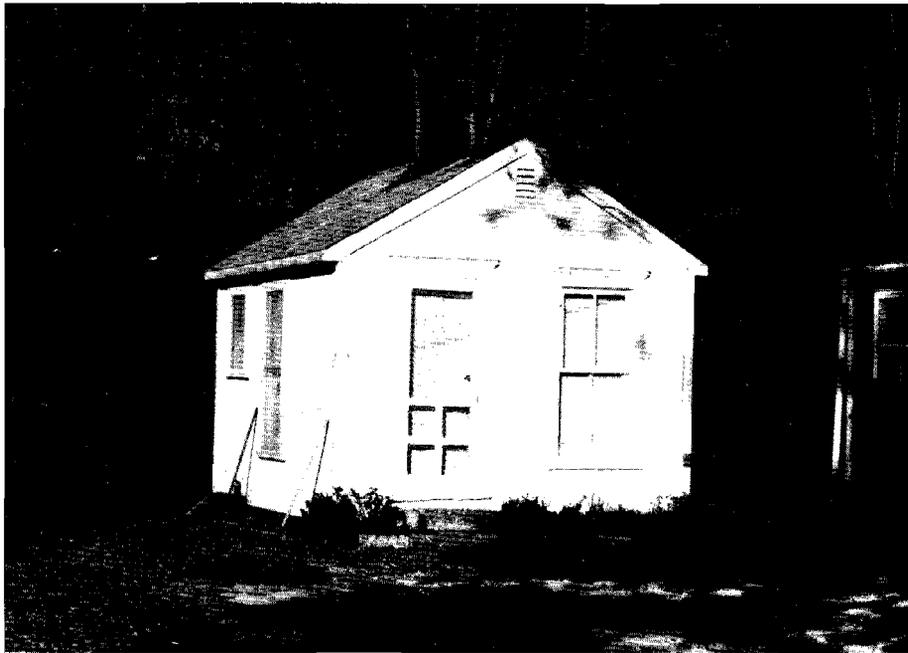
PLATE 154b: CRS S-5084
View of south and west facades of former pumphouse, looking northeast.
Note original fenestration, window and door surrounds.

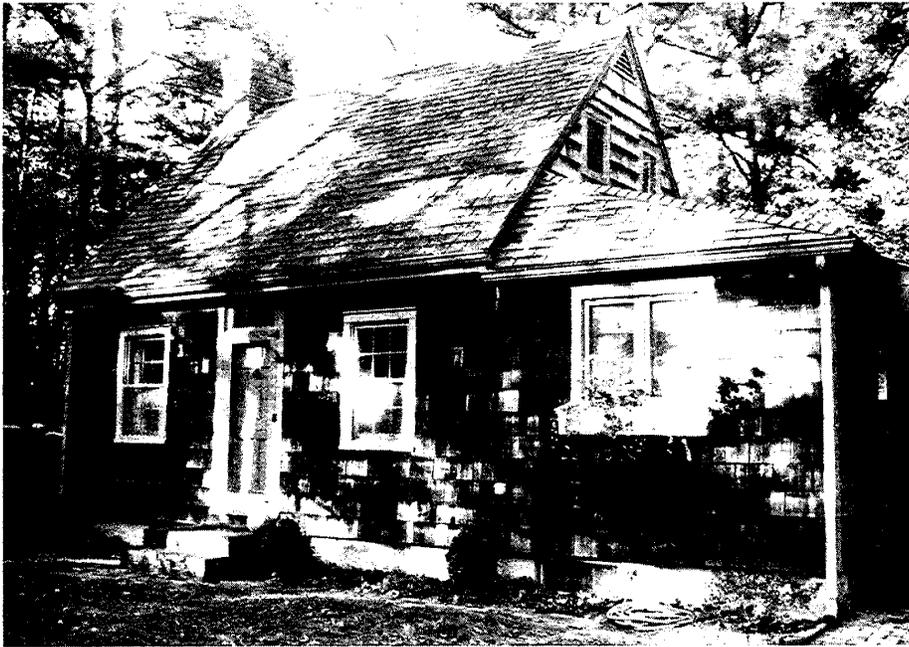
PLATE 155: CRS S-5080
View of south facade of dwelling, looking northwest.
Note early windows, paneled door, and good condition.

CRS S-5080
Previously Surveyed
Eligible: Governor Collins Historic District
Figure 12; Plate 155; Appendix A, Plat 13

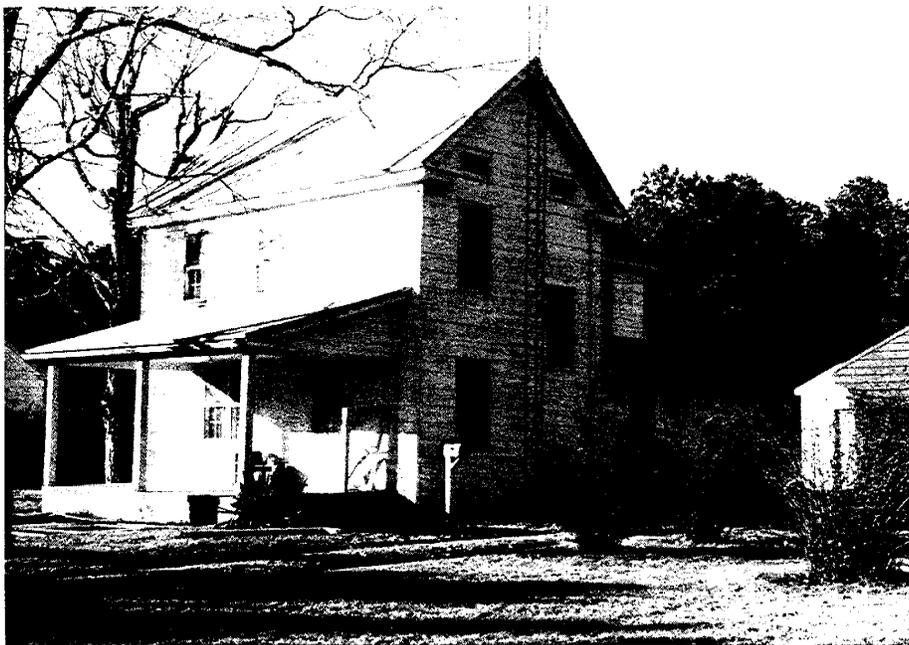
PLATE 156: CRS S-5081
View of south and east facades of house, looking northwest.
Building has since been resided and the windows replaced with modern sash.

This small cottage resembles its neighbors to the east and west (CRS S-5082 and S-5079). This dwelling is believed to be a late seventeenth century structure that was moved from the former Governor Collins' homestead on the opposite side of the pond (Personal Communication: Kevin Cunningham 1991) According to the property owner's sister the house was moved to its current location in the 1950s. The building is part of the proposed Governor Collins District, along with CRS S-5082, S-5083, S-5084, and S-5079. This eligible district is significant as a collection of buildings that were once associated with the homestead of Delaware Governor John Collins, as well as with Collins Mill and Bog Iron operations. The district is important for its association with early nineteenth century industrialization in Sussex County. It is also significant for its association with the theme of Major Families during the period 1770-1830. Further research into the mill operations, structures, and peoples associated with this complex is needed.

CRS S-5081
Previously Surveyed
Not Eligible
Plate 156; Appendix A, Plat 13

This structure, while it is relatively intact and in good condition, fails to meet the criteria for inclusion in the Three Bay, I-House, Multiple Property Submission, due to the alteration of the main facade. In addition, the fenestration on the east facade has been changed and the exterior chimney has been removed. There are no historic outbuildings associated with the property. This property does not appear to be eligible, as there are better examples of three bay I-houses throughout the corridor.

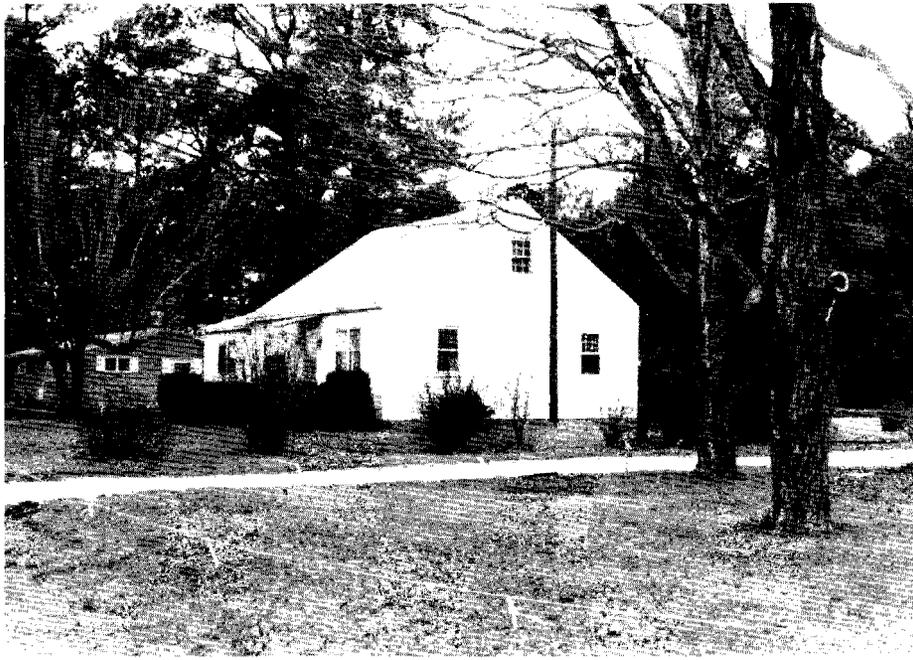
PLATE 157: CRS S-8516
View of south and east facades of house, looking northwest.

CRS S-8516
Not Eligible
Plate 157; Appendix A, Plat 13

This one and one-half story, rectangular plan cottage is situated on the north side of Route 404, west of Collins Pond. The house is three bays wide and two bays deep with a one bay wide addition on the west facade. The entrance is centrally placed in the south or front facade, facing the road. The doorway is flanked by a pair of modern, six over six, double hung windows. The gable roof is sheathed in composition shingles, and the house rests on a concrete foundation. The building is clad in white, composition shingle siding. A gable roofed, one car garage with a projecting overhang, is located off of the northwest corner of the house.

This house appears to date to the 1930s or 1940s. It possesses little architectural significance, and is therefore not eligible. In accordance with guidance from the BAHP, these buildings do not form a preservation priority within the project corridor (Personal Communication with Steve DelSordo May 1991).

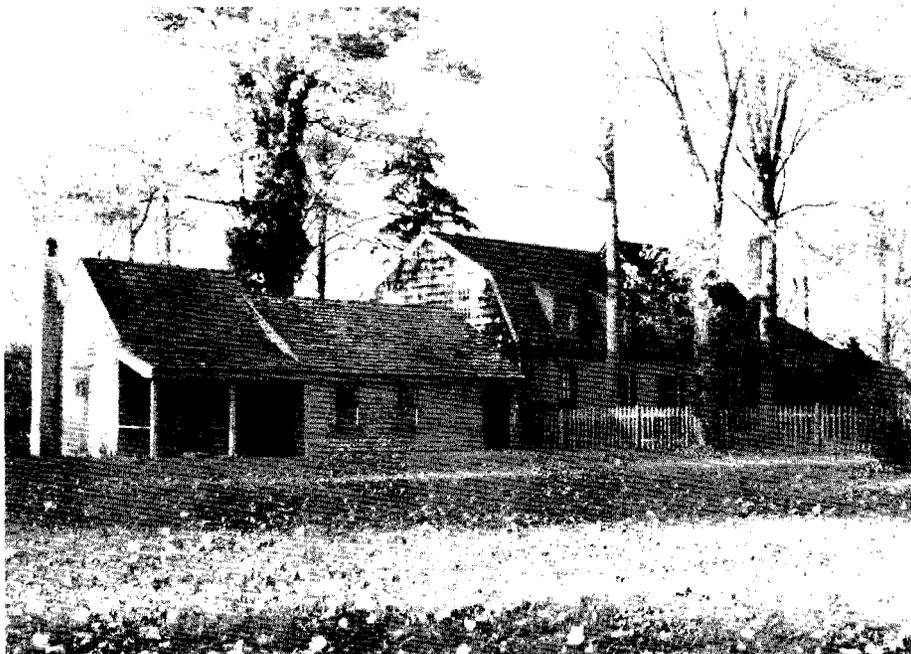
PLATE 158a: CRS S-5079
View of east facades of buildings and structures, looking northwest. Buildings on left may be forge structures, buildings on right of photo are part of dwelling complex.

CRS S-5079
Previously Surveyed
Eligible: Governor Collins Historic District
Figure 12; Plate 158; Appendix A, Plat 13

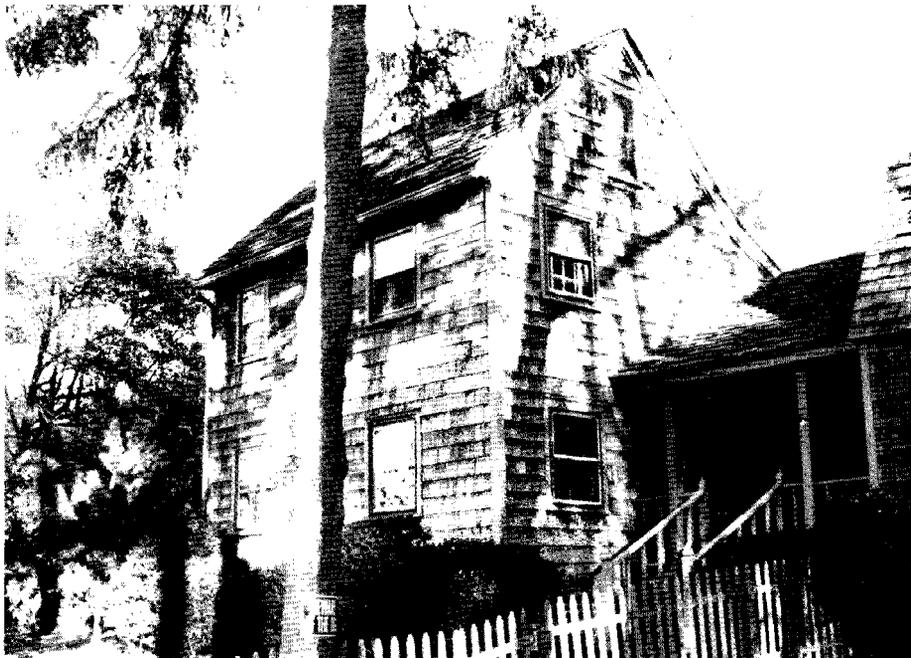
PLATE 158b: CRS S-5079
View of northernmost section of dwelling, looking northeast.

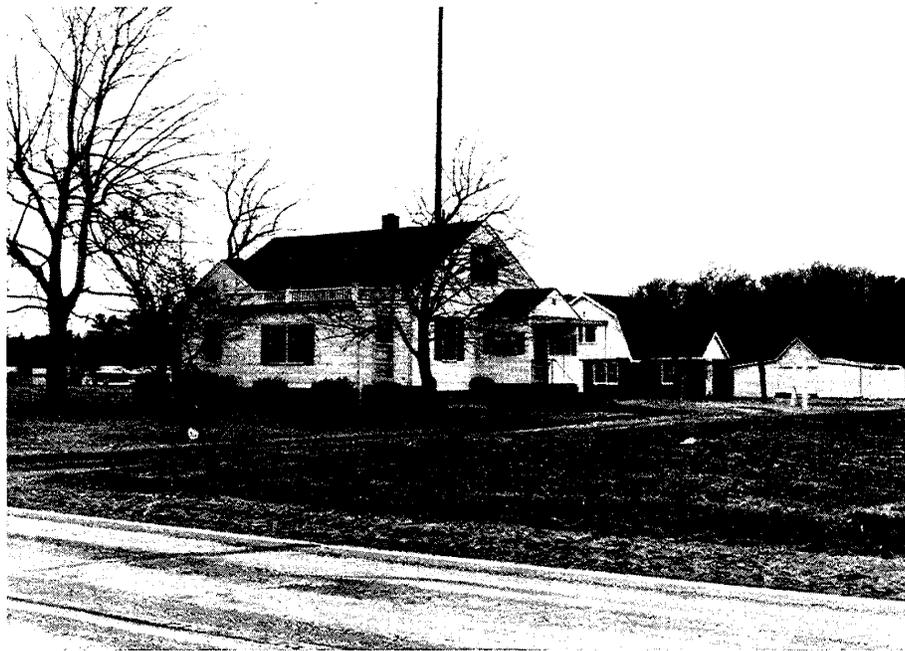
PLATE 160: CRS S-8464
View of south and east facades of house, looking northwest.

CRS S-8464
Not Eligible
Plate 160; Appendix A, Plat 13

This dwelling complex sits on the north side of Route 404. The house is a one and one-half story cottage, three bays wide and two bays deep with a gable roof and a concrete foundation. Constructed across the entire front facade is a one story, enclosed section with a flat roof and a projecting cross gable. A wooden balustrade runs the length of the flat roofed section of the addition. The entrance is centrally placed in this facade. The windows are a combination of pairs and single, six over six, double hung windows with louvered shutters. An enclosed entry porch with a gable roof is located on the east facade. An interior, brick chimney is placed in the western end of the north facade.

There is a one and one-half story, gambrel roofed garage on the property. This garage is constructed of concrete block in the first story and frame in the upper story. The garage door is situated in the south facade. A one bay wide and deep, concrete block addition has been added to the garage on the east facade. A gable roofed, one story, frame shed constructed of vertical boarding sits next to the garage. This shed has flanking side additions. This house appears to have been built in the 1930s or 1940s. While it is in excellent condition, this property is not architecturally significant, and therefore not eligible. In accordance with guidance from the BAHP, these buildings do not form a preservation priority within the project corridor (Personal Communication with Steve DelSordo May 1991).

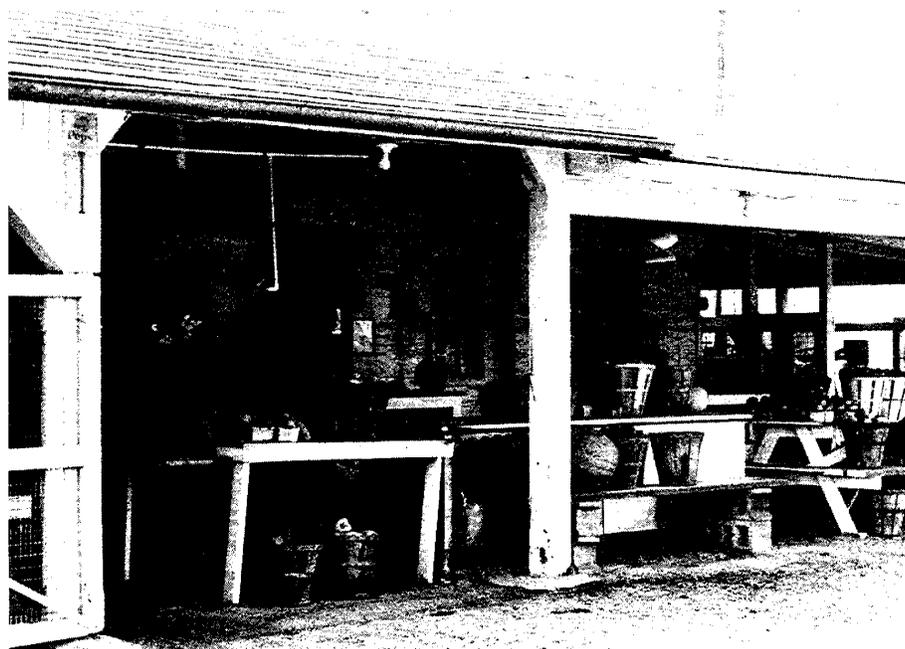
PLATE 161: CRS S-5078
View of O'Day's Market, looking south.
Note concrete block core building, surrounded by timber and frame market stands.

CRS S-5078
Previously Surveyed
Eligible: Commercial Roadside, Multiple Property Submission
Figure 9; Plate 161; Appendix A, Plat 13

This previously surveyed agricultural/retail complex is located on the south side of Route 404. O'Days market/produce stand faces the road. It is a one story, frame and concrete block structure with a gable roof. An overhanging, open porch extends across the front facade. Portions of this porch are screened in. There are various additions on the rear or south facade. All of these additions are one story with gable roofs. According to a previous survey, there are a variety of outbuildings on the property including: various corncribs, storage sheds, garages, and restrooms (Corkadel 1984).

This property is eligible as a contributing member of the Commercial Roadside Multiple Property Submission. The property continues to function as a produce store, and as such, is one of a vanishing number of roadside structures still extant in Sussex County. The building appears to date to the 1920s/1930s era, when the use of the automobile gave rise to the establishment of many roadside transportation facilities. This building is one of only seven such remaining structures in the study area. This property is significant for its association with the historic context of Suburbanization and the temporal period of 1880-1940 (Herman et. al. 1989:59).

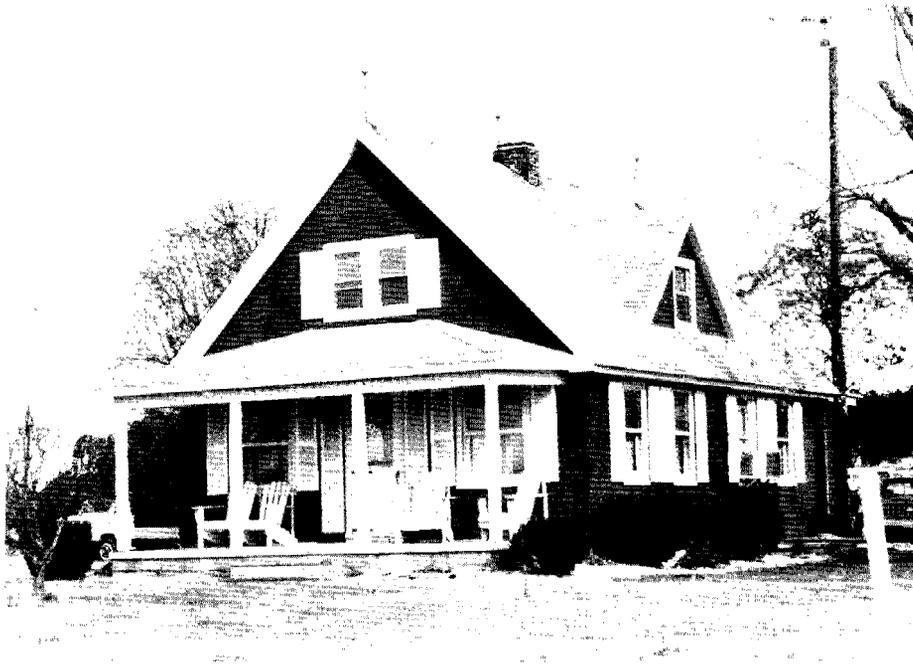
PLATE 162: CRS S-5077

View of south and east facades of house, looking northwest.
Note paired windows, cross gable, central chimney, and front porch.

CRS S-5077
Previously Surveyed
Individually Eligible
Plate 162; Appendix A, Plat 13

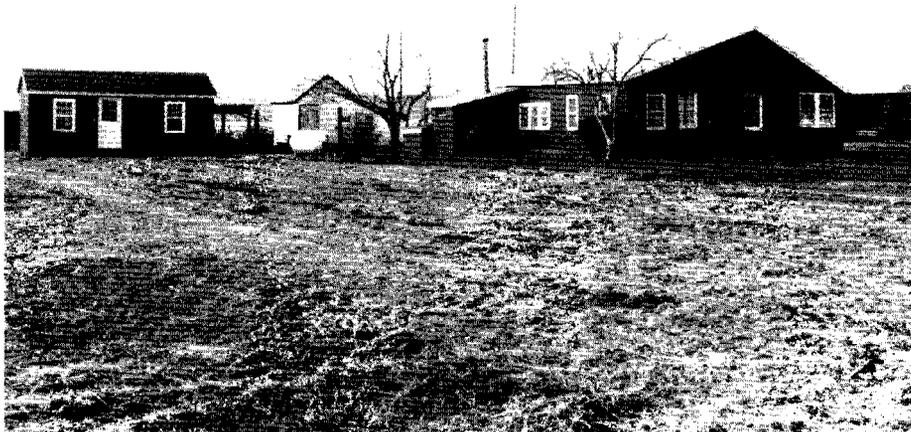
PLATE 163: CRS S-5075

View of north and east facades of dwelling, looking south.
Also note series of outbuildings.
Dwelling has modern windows irregularly placed on all facades.

CRS S-5075
Previously Surveyed
Not Eligible
Plate 163; Appendix A, Plat 13

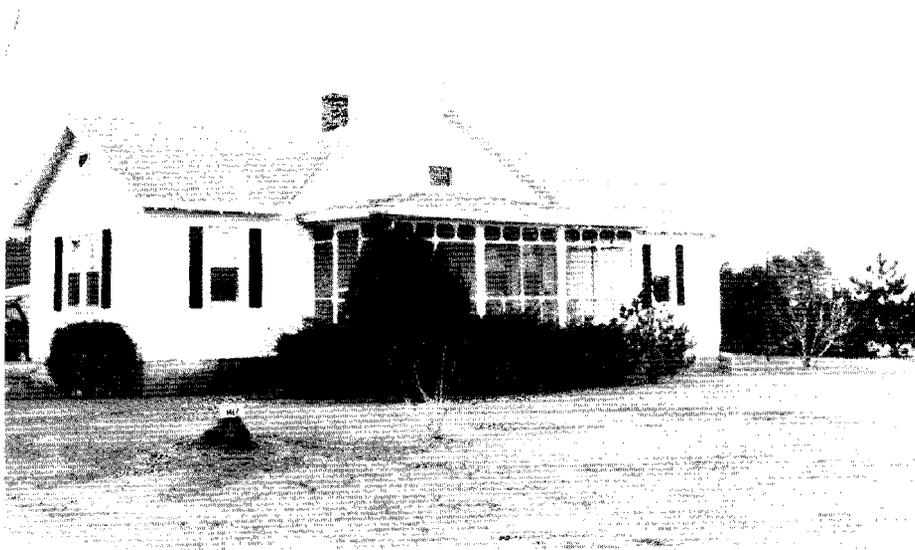
PLATE 164: CRS S-5074
View of west and north facades of house, looking southeast.

CRS S-5074
Previously Surveyed
Not Eligible
Plate 164; Appendix A, Plat 14

This previously surveyed, cross-plan cottage is located on the south side of Route 404. The house is one and one-half stories, five bays wide and two bays deep with a hipped roofed, screened in porch in the center of the front facade. The house sits on a concrete foundation and is clad in composition shingle siding. A gable roofed, frame shed is present behind the house. According to a previous survey, this house was constructed circa 1942 (Corkadel 1984). Although the building is in good condition, it possesses little architectural significance and is therefore not eligible. In accordance with guidance from the BAHP, these buildings do not form a preservation priority within the project corridor (Personal Communication with Steve DelSordo May 1991).

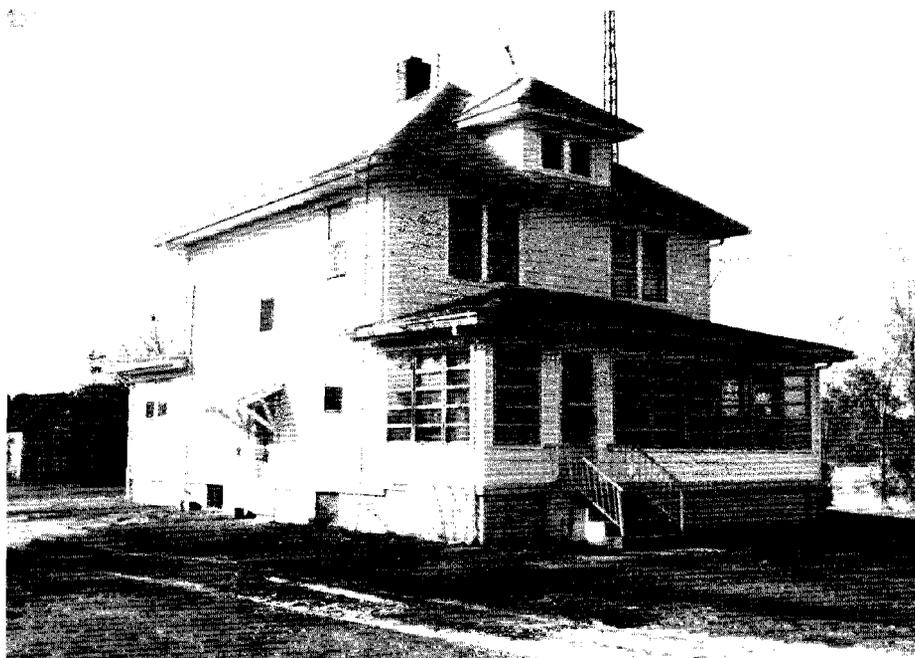
PLATE 165: CRS S-5073
View of north and east facades of house, looking southwest.
Note pyramidal roof, facade-wide porch, square plan.

CRS S-5073
Previously Surveyed
Eligible: Classical Box, Multiple Property Submission
Figure 8; Plate 165; Appendix A, Plat 14

This Classical Box house, located on the south side of Route 404, approximately one hundred yards from the road, was previously surveyed. The building is square in plan, two and one-half stories, three bays wide and two bays deep with a pyramid roof. The house is in excellent condition. A two and one-half story, frame, gambrel roofed barn and a frame shed are also present on the property.

This house appears to be eligible as part of the proposed Classical Box, Multiple Property Submission. The building is characterized by symmetry of form, fenestration, pyramidal roof line and plan. It is one of only twelve examples of the Classical Box style found within the project corridor. Of these twelve, were chosen as the most representative of the style to be included in the multiple property submission. These houses date to the early twentieth century, circa 1910. As an example of the important trend of suburbanization within the corridor, this property is significant within the submission (Herman et. al. 1989:61-2).

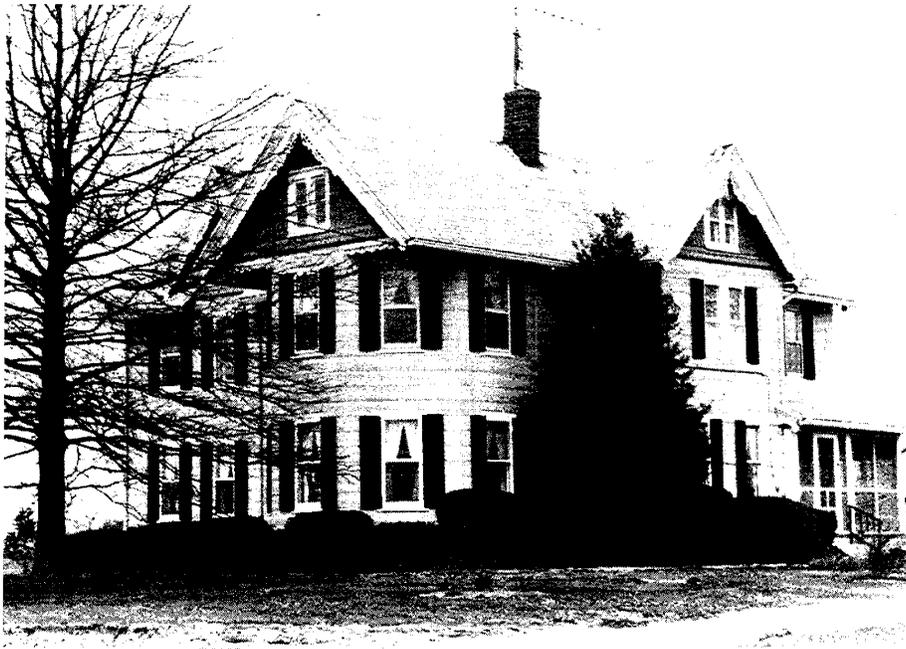
PLATE 166: CRS S-5072
View of south and east facades of house, looking northwest. Note large cross gable, Victorian detailing at the eaves and gables, and excellent condition.

CRS S-5072
Previously Surveyed
Individually Eligible
Plate 166; Appendix A, Plat 17

This dwelling appears to be an individually eligible property. The cross plan form and Victorian details make this house unique to the project area. The dwelling appears to date to the mid-nineteenth century. A structure is shown in this location on an 1868 map of Sussex County, as belonging to H. Swain (Beers 1868, Appendix B). The house is in excellent condition. It is a good example of a mid-nineteenth century which was commonly part of the landscape, falling into the temporal period 1830-1880, historic context Agriculture (Ames et. al. 1989).

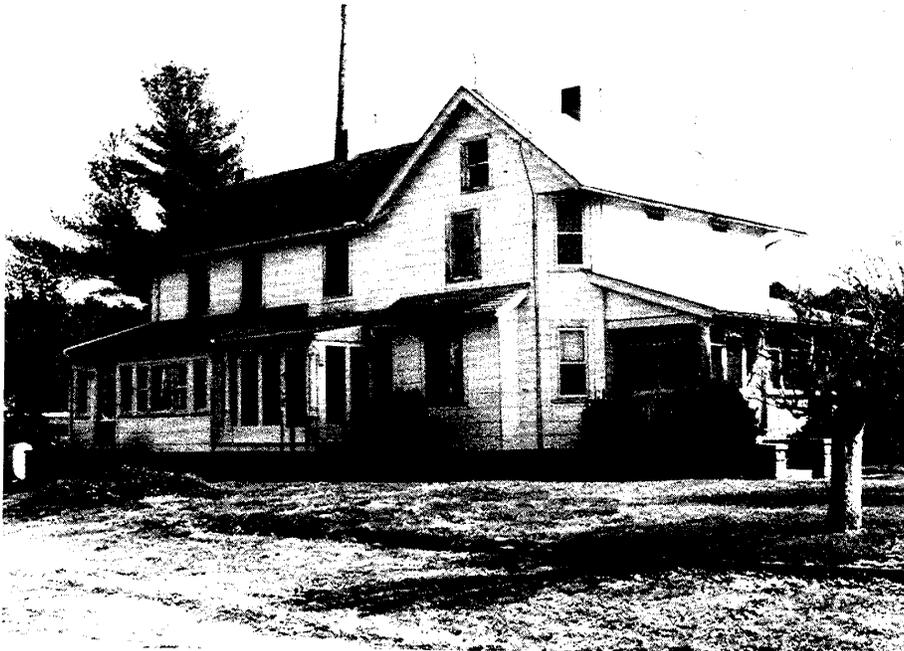
PLATE 167a: CRS S-5071
View of south and west facades of house, looking northeast.
Note clipped corners of dwelling and large kitchen wing.

CRS S-5071
Previously Surveyed
Individually Eligible
Plates 167a, 167b, 167c, 167d, 167e, 167f, 167g; Appendix A, Plat 17

This previously surveyed agricultural complex is situated on the north side of Route 404, just west of the intersection with Road 529. The dwelling is a two and one-half story, L-plan I-house that is two bays wide and deep. A shed roofed, screened in porch extends across the front facade. There are a variety of nineteenth century outbuildings on the property. These outbuildings were noted in a previous survey and include: a meat house, two sheds, a granary, a kitchen, and a sweet potato house (Corkadel 1984). There was also a twentieth century chicken house, barn, meat house and garage listed in the description of the property.

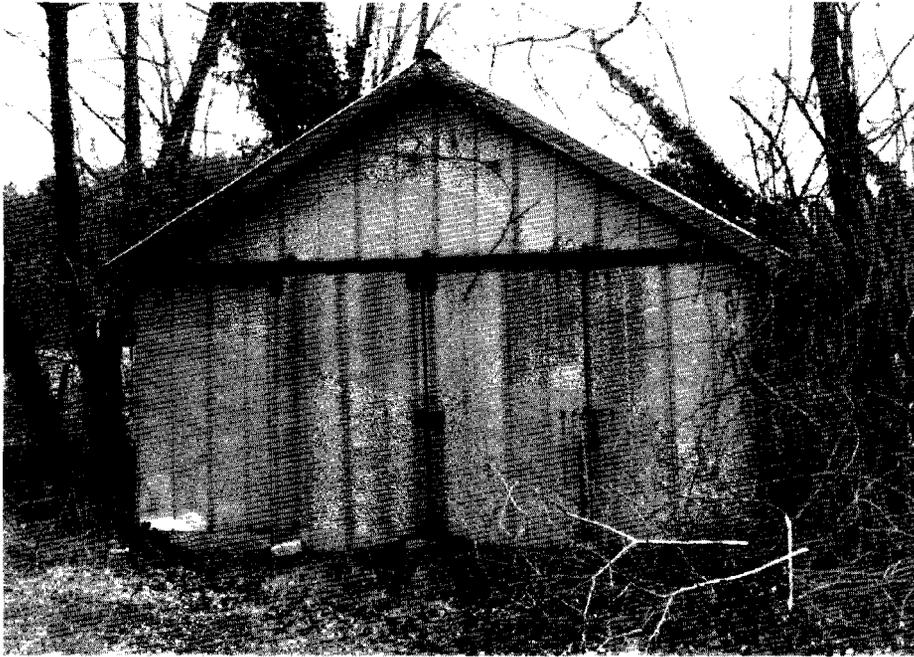
PLATE 167b: CRS S-5071
View of metal garage to north of house, looking north.

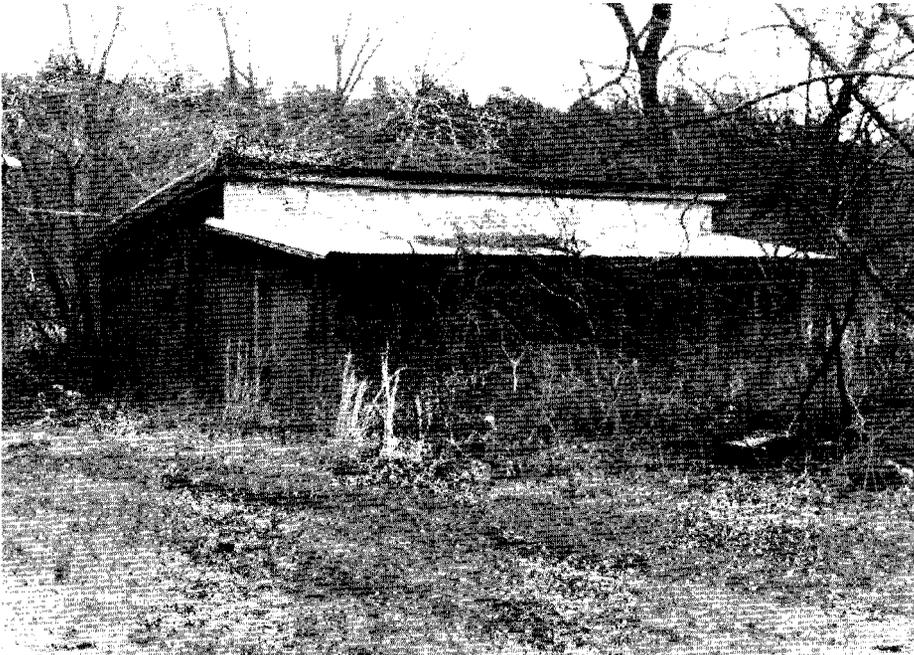
PLATE 167c: CRS S-5071
View of frame chicken house, located north of the house, looking northeast.
