APPENDIX A FEATURE DESCRIPTIONS

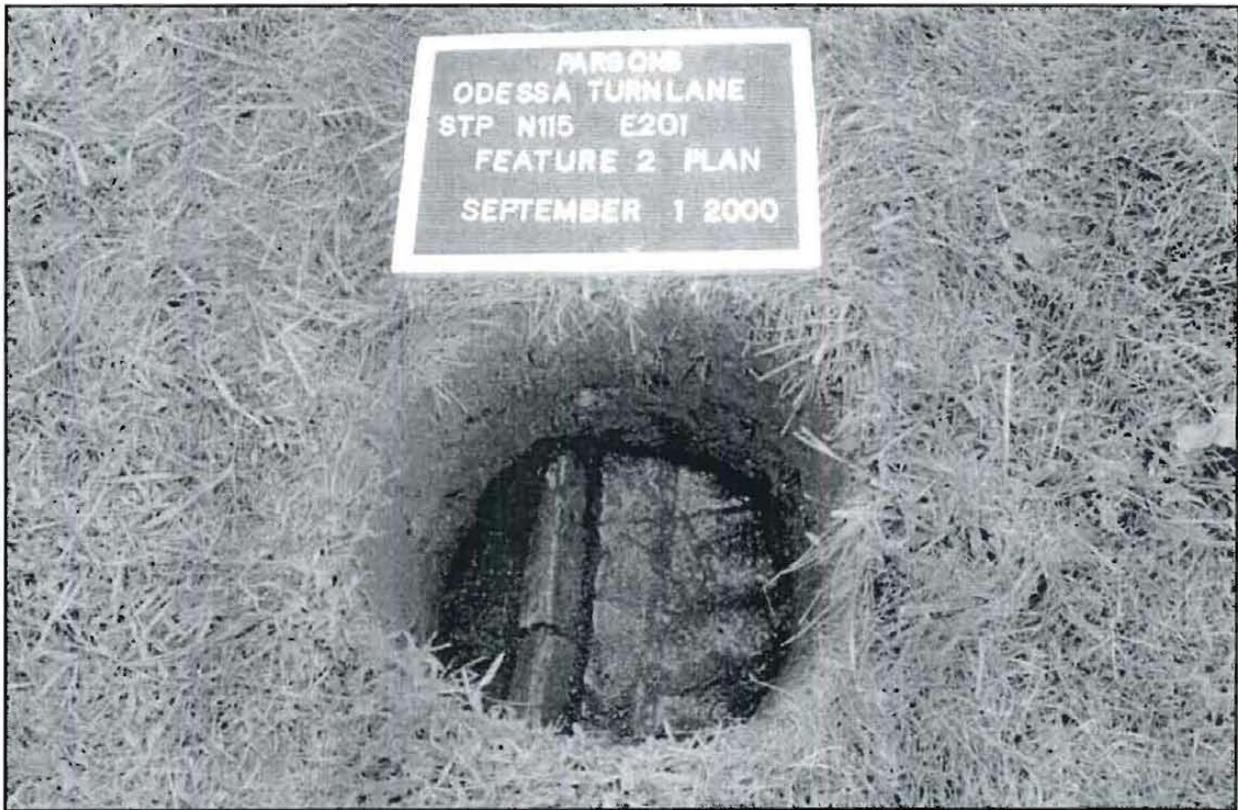
Feature 2 was a historic sidewalk from the Du Pont Highway construction early 1900s (Figure 30). Concrete sidewalk edged with brick; feature was defined on the west side of the walkway. It is not known if the concrete section of the sidewalk was contemporaneous with the concrete/cement sidewalk in front of the Kielkopf House seen in Figures 8, 11, and 12).

Figure 30: Historic sidewalk (Feature 2)

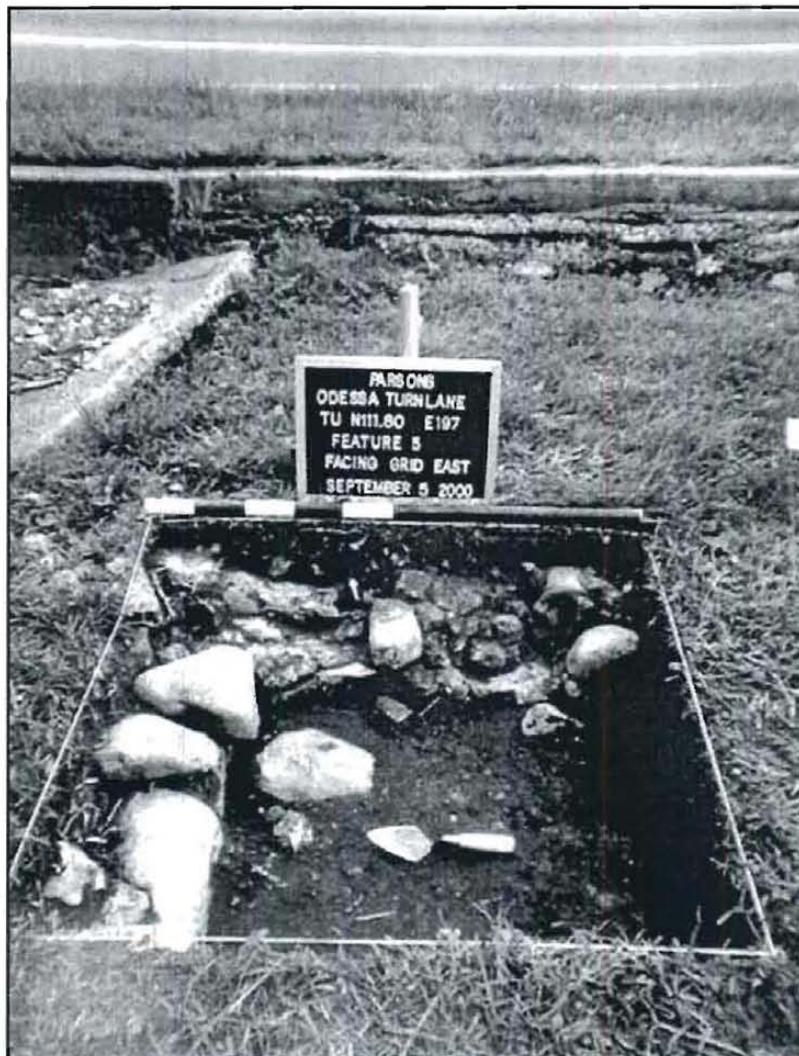
Feature 5 consisted of the walls of a full cellar found in three locations in front area (east portion) of the Kielkopf house (Figure 31). Large water-worn cobbles and lime mortar were used in the construction of the cellar, located under the front room of the house. The walls were partially intact in TU2 (northeast corner of cellar) where the bulldozer could not easily push in the walls. The upper 1 meter of the west and south walls of the cellar (TUs 6 and 8) were bulldozed into the cellar. The two units contained large chunks of concrete from the area between the house and blacksmith shop, which was almost entirely covered with concrete by the 1980s. The entrance was from the center of the north side of the house, and after the shed roof addition was added on the north side, the entrance to the cellar was then covered. All three units contained modern fill from the bulldozing of the house. TU 8 straddled the south wall and revealed no exterior construction trench for the cellar walls.

**Figure 31: Northeast Corner of Feature 5, Cellar Wall (TU2).
Note the Facia Board Impression in the Concrete Curb**

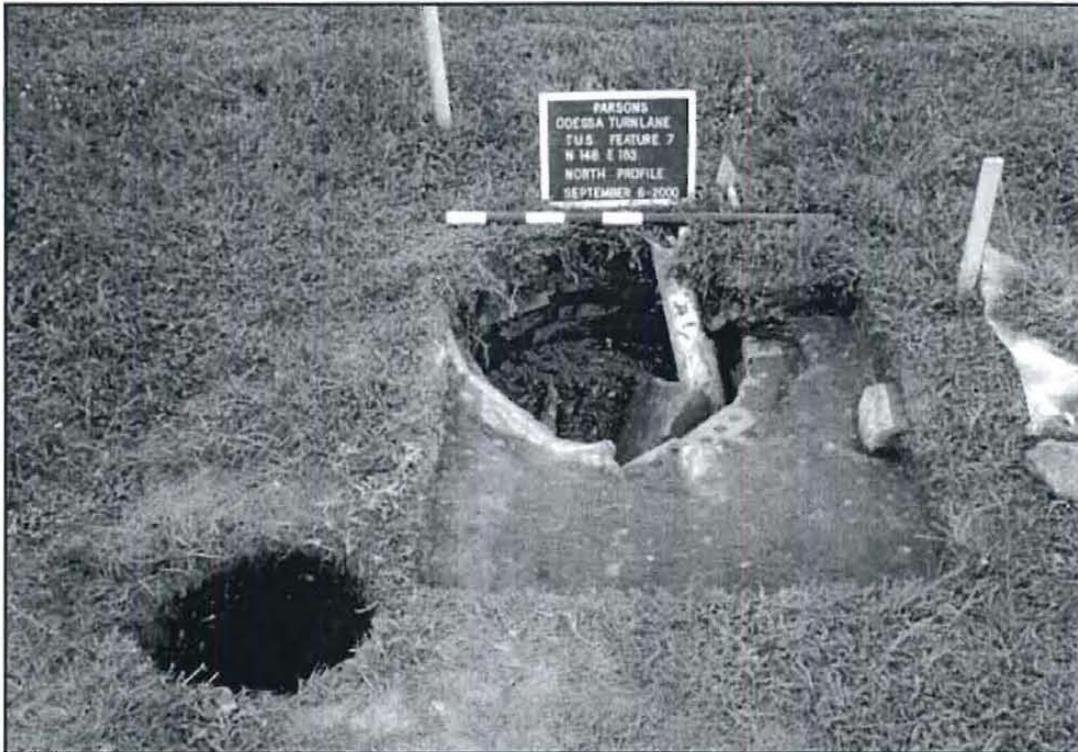
Feature 7 was a brick lined well on the Dugan/Carty lot north of the Kielkopf property. The well was located south central in the lot. The construction of the well was mixed solid brick and three holed brick and capped with concrete (Figure 32). A poor job of filling in the well left cavities and concrete slabs thrown into the hole, and part of the wall was collapsing, but largely still intact. Nearby STP encountered sinkhole on outside of well revealing the exterior of the brick feature.

Figure 32: Brick-lined well (Feature 7) located on the Dugan/Carty property north of the Kielkopf House; STP in forefront

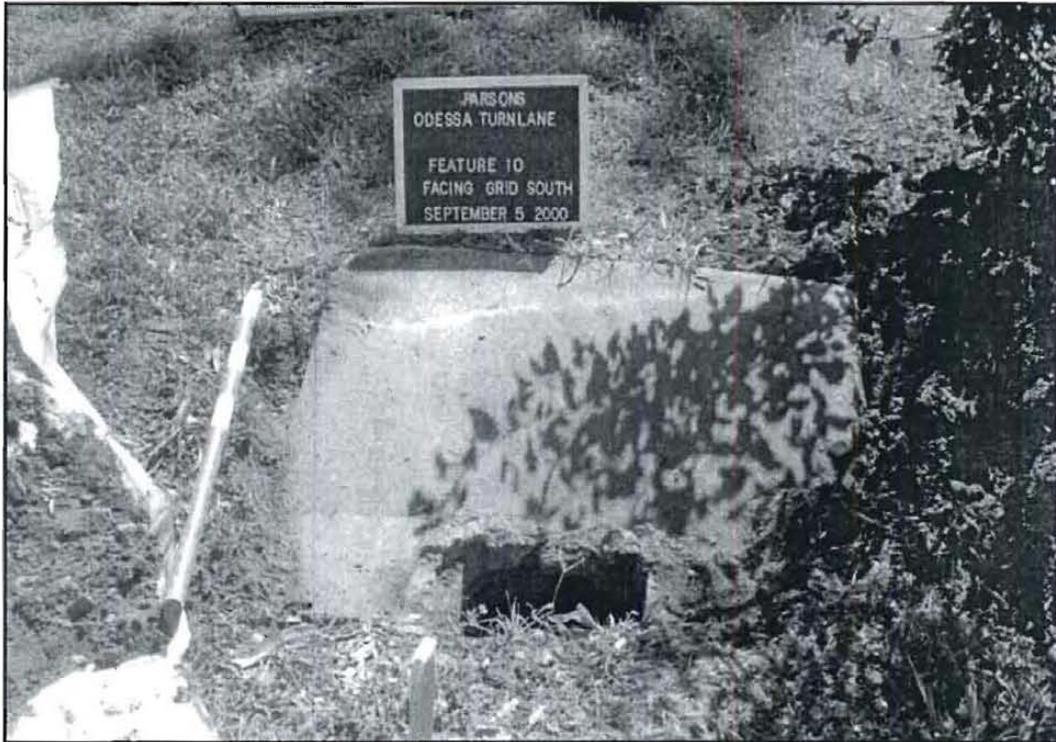
Feature 10 was a WPA-era privy slab, for a one-hole outhouse (Figure 33). Two metal braces were present on the top of the slab for holding down the upper framework of the latrine. Construction impacted the privy shafts of Features 8 and 9. The area under the slab was still not filled in during the current investigations. Mr. Kielkopf remembered when his parents bought the privy from a WPA representative in the 1930s, similar to that depicted in Figure 34.

Figure 33: WPA Concrete Privy Slab (Feature 10)

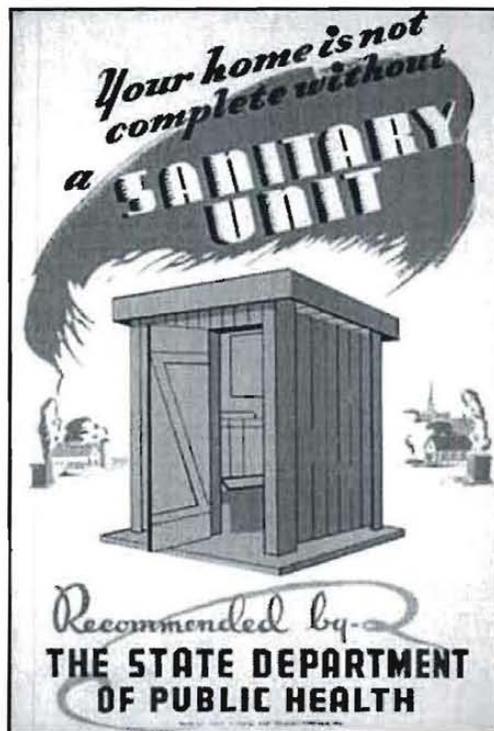
Figure 34: Privy from the WPA era (Library of Congress' American Memory website at <http://memory.loc.gov/>)

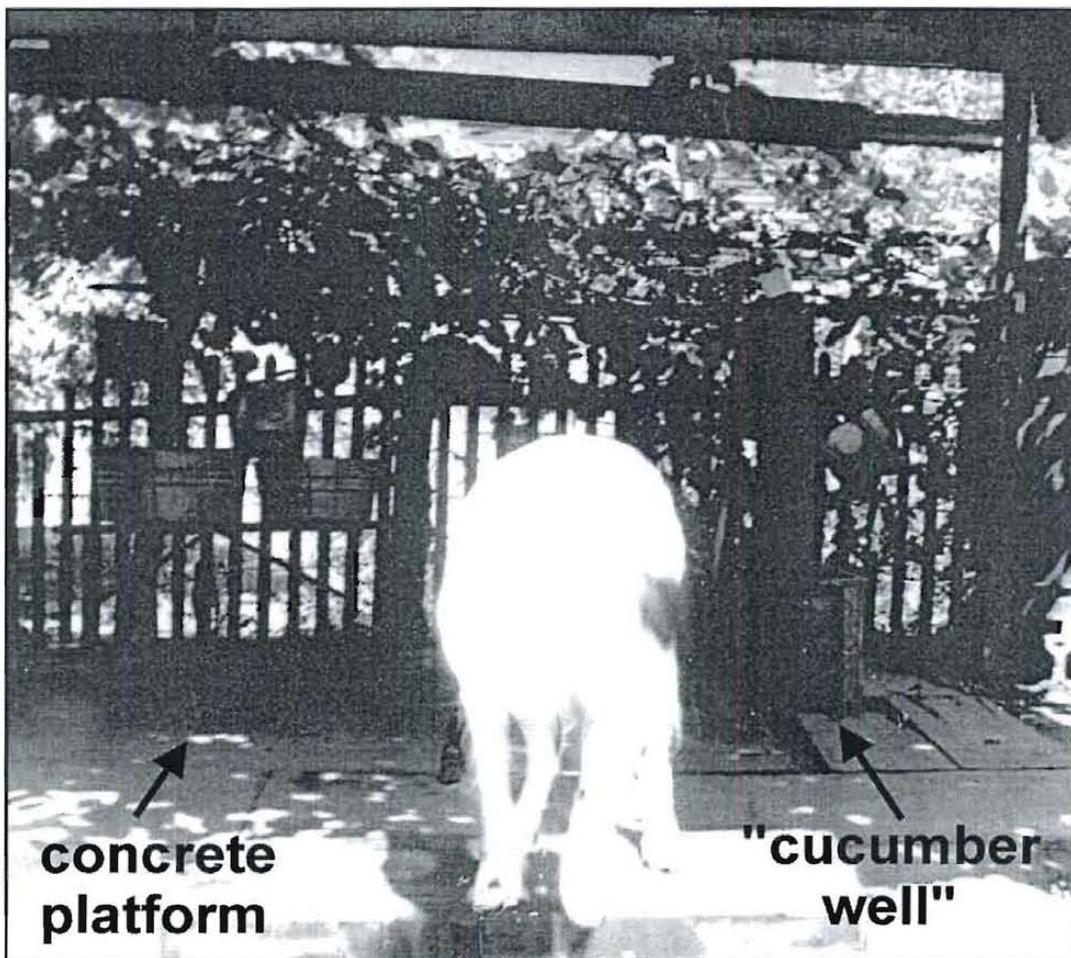
Feature 11 was a hand dug, brick lined well, believed to date to the construction of the Kielkopf House, in the late 1880s. Mr. Kielkopf stated that the well was a “cucumber well”, a wooden feature using a wooden post inside a wooden shaft to siphone water up from the well into the catch basin. The well was filled in during the 1940s or early 1950s, and the upper layers of brick either collapsed or were robbed (personal conversation with Fred Kielkopf, September 7, 2000). A concrete slab with a built-in “trough” was located next to well area to the west and was used as a platform for a catch basin (Figure 35). A modern metal drainpipe took overflow water to the storm drain to the south of the house by the highway curb. Brick was not encountered during the current investigations, but a reddish orange subsoil fill was found in approximately 25% of the circumference of the well in TU7. Four bricks were in alignment just below the ground surface, believed to represent the base of a platform around the well area. A concrete “post” was seen under the edge of the concrete platform (Figure 36). Concrete had been poured into a form made by narrow wooden slats, possibly for a support post for the concrete slab.

Figure 35: The “Cucumber Well” and Concrete Platform Between the Kielkopf House and Newer Blacksmith Shop

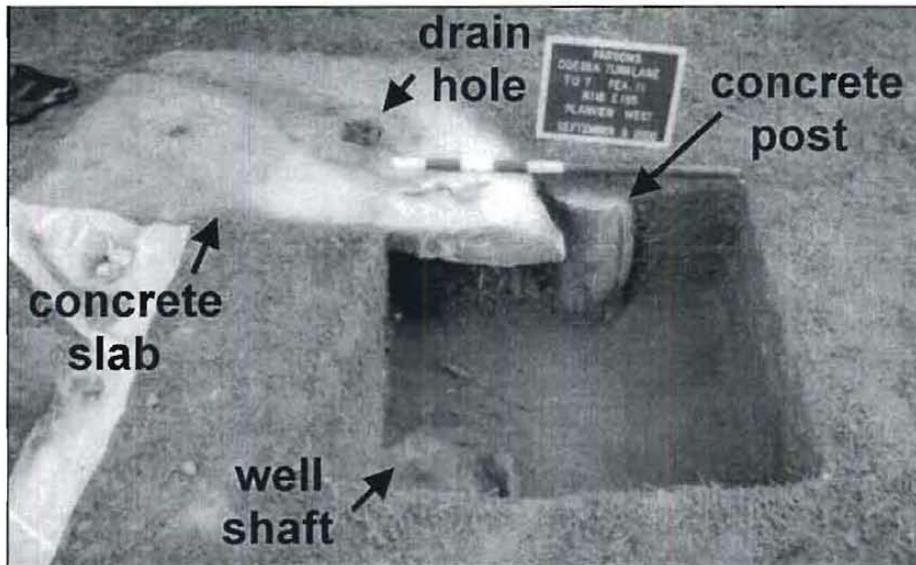
Figure 36: Kielkopf House Well (Feature 11), Concrete Post and Concrete Platform

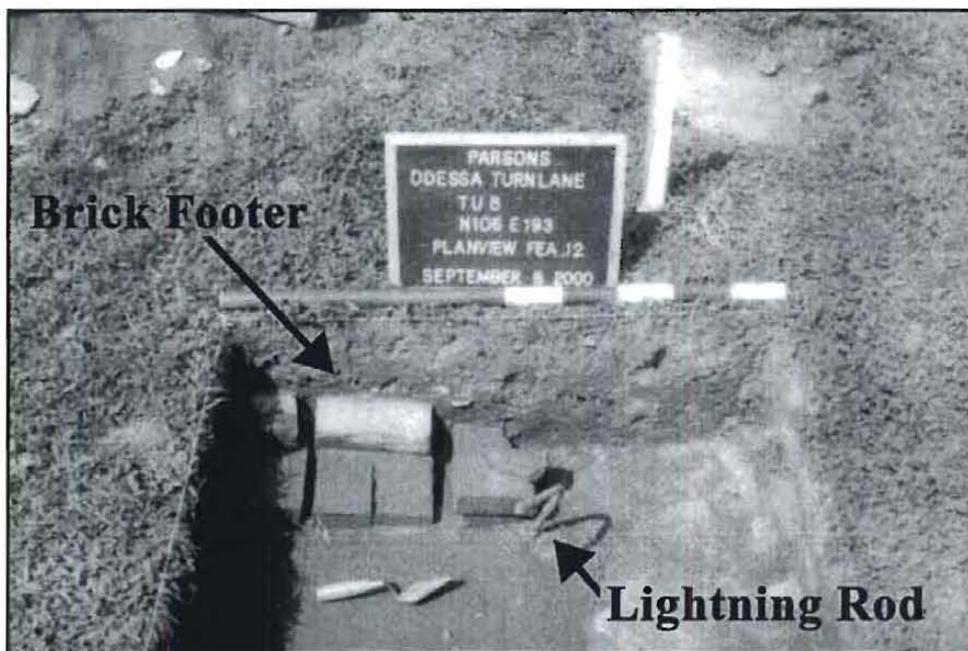
Feature 12 consisted of a series of bricks used for the footers of the small south side porch observed in Figure 12 (Figure 37). The construction probably dates to the construction of the newer front porch, sometime between 1905-1915. Located on the north side of the alignment next to cellar/foundation wall was a thick copper rod/wire extending into the ground, probably a lightning rod ground cable.

Figure 37: Brick Footers (Feature 12) for the South Side Porch on the Kielkopf House
