6. FIELD INVESTIGATIONS

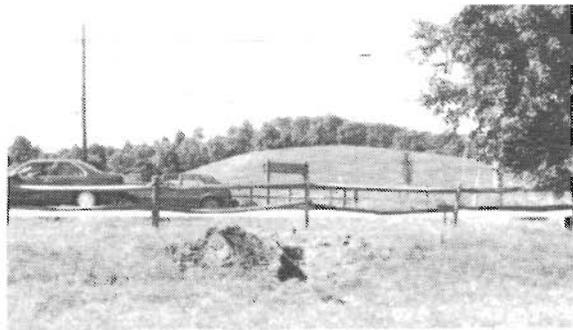
Plate 11
View southward across unit 1

The first test (PLATE 11) was a hand-dug trench ten feet long and about 18 inches wide (FIGURES 5 AND 6) across the apparent edge of the mill race berm. In this location, the race had been considerably flattened, compared to the remains a short distance to the east.

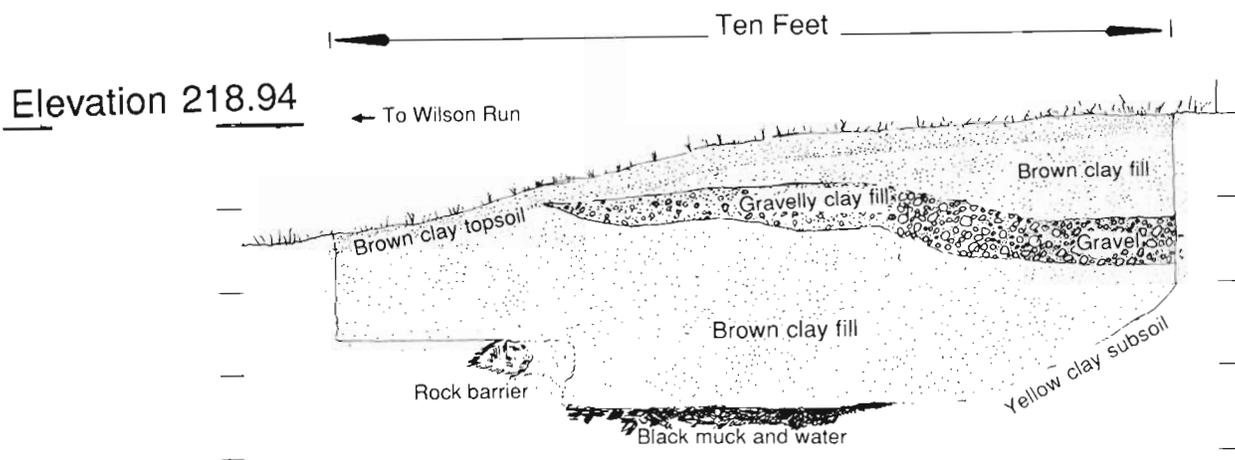
At the surface was a refined pebble-free turf apparently prepared for landscaping purposes. Under this layer was a uniform brown clay fill, which overlay a gravel-filled depression that appears to be a roadway. This lay on top of another uniform brown clay fill. On the high side of the trench, the hard yellow clay subsoil had evidently been cut down to make a depression for the raceway in the hillside.

The yellow clay subsoil gave way at the bottom to a layer of black muck filled with organic matter; this level could not be investigated because it filled almost immediately with water. Near the toe of the slope, some large rocks were found in place.

Figure 6
Test Trench, unit 1, east profile

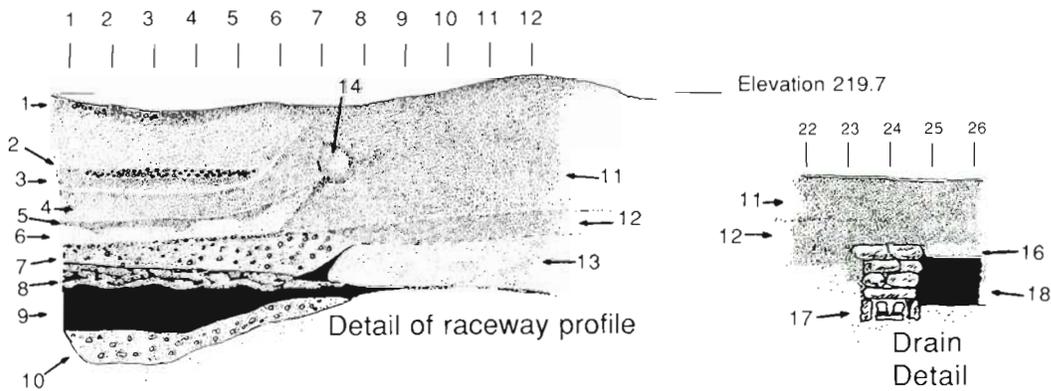
The machine-cut profile revealed a series of construction stages of the race, probably spanning more than a century. Periods of abandonment and rebuilding were visible in detail.

The profile reveals that several operators had attempted to raise the race. Since a miller is concerned with the top, or head, of the race, the bottom of the race can be allowed to fill as the walls are raised; this is apparently what happened here on more than one occasion. Finally, the race was filled in and a gravel metalling was installed. This was replaced by a layer of second gravel, probably to create a dry bridle path or cartway.

The first raceway, represented by strata 8, 9, and 10, was dug out of the natural subsoil at the edge of the slope. Its wall was not well-defined and while it was open, it was allowed to fill with rotten organic matter, which slopped over the edge.

Figure 7
Profiles of Unit 6, machine cut

See table 3, page 24,
for interpretation

The machine cut trench, opened September 27, extended eighty feet long and four feet wide (FIGURE 7). At its deepest point, the trench was more than six feet deep. Beginning point was chosen as near to the road as possible, in order to intercept any back side that might exist. As it turned out, the cut apparently barely missed the back bank.

A clay bank, stratum 13, raised the race by a foot. This race was filled with gravel, stratum 7, and the topsoil, stratum 12, developed over the clay.

The loam layer, stratum 4, may have been part of a repair, or it may have been eroded in after the race was abandoned. Strata 2 and 3 represent deliberate filling; the rounded pebble layer at the top of stratum 2 probably was a pavement, as was the crushed gravel at the top of stratum 1.

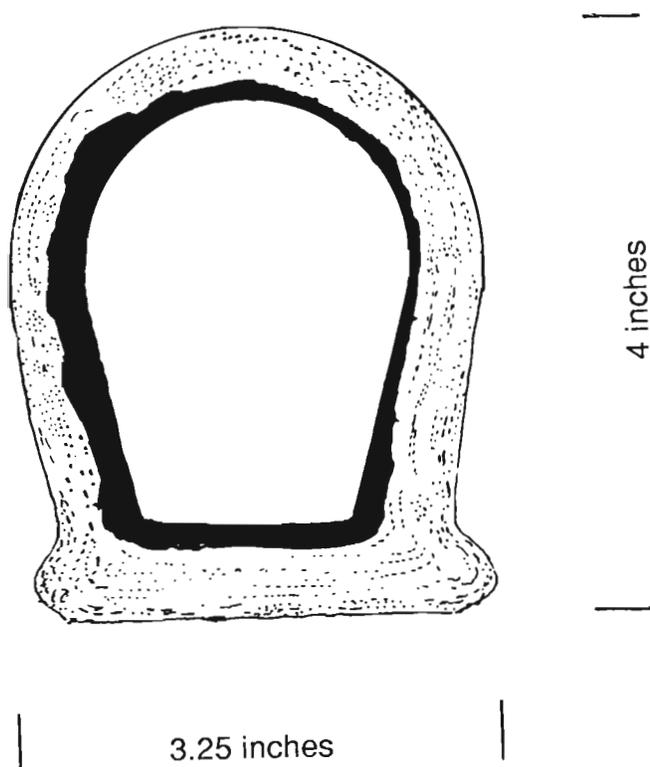
Figure 8
Cross section of a drain tile

The only artifact recovered was a section of extruded red-clay drain tile, illustrated above (FIGURE 8), 13.5 inches long. It was turned over to the Island Field Museum for preservation under accession number 90/55.

Flat stones were set on edge beside the tiles and a row of stones was set as a roof over the structure. Rocks were then piled on top, to create a dry-laid stone structure about a foot high above the tile. Since this drain was parallel to the race, it probably was intended to intercept any groundwater seeping out of the race. A second drain, without the elaborate covering structure, was found farther along the trench, crossing in a diagonal direction (FIGURE 8).
