Traffic Engineering Study

**DE Route 8 (Forrest Avenue, K051)
&
Chestnut Grove Road (K158) /
Nault Road (K199)**

Kent County, Delaware

July 11, 2012

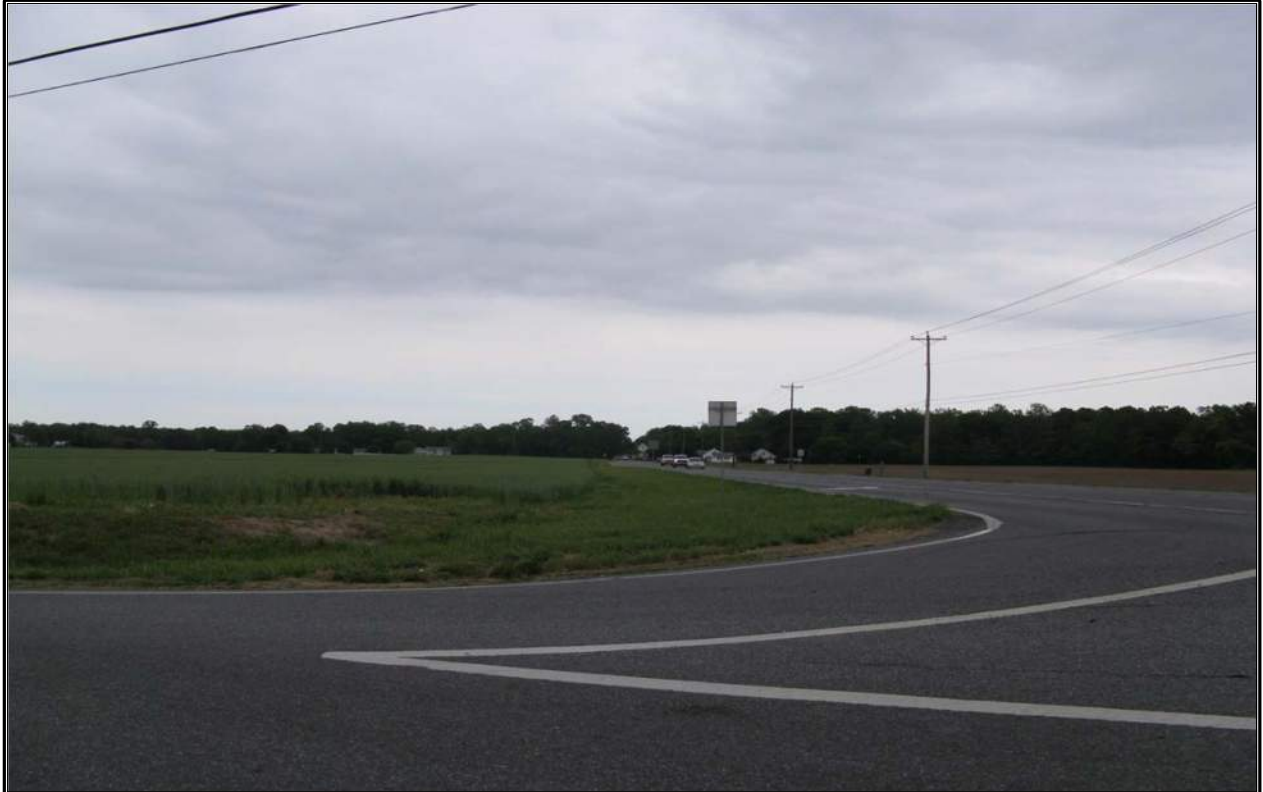
5) Southbound Chestnut Grove Road Looking Left (East)

From the Chestnut Grove Road approach and the Nault Road approach, the measured available intersection sight distance for vehicles looking left and right are greater than the distance recommended by AASHTO.

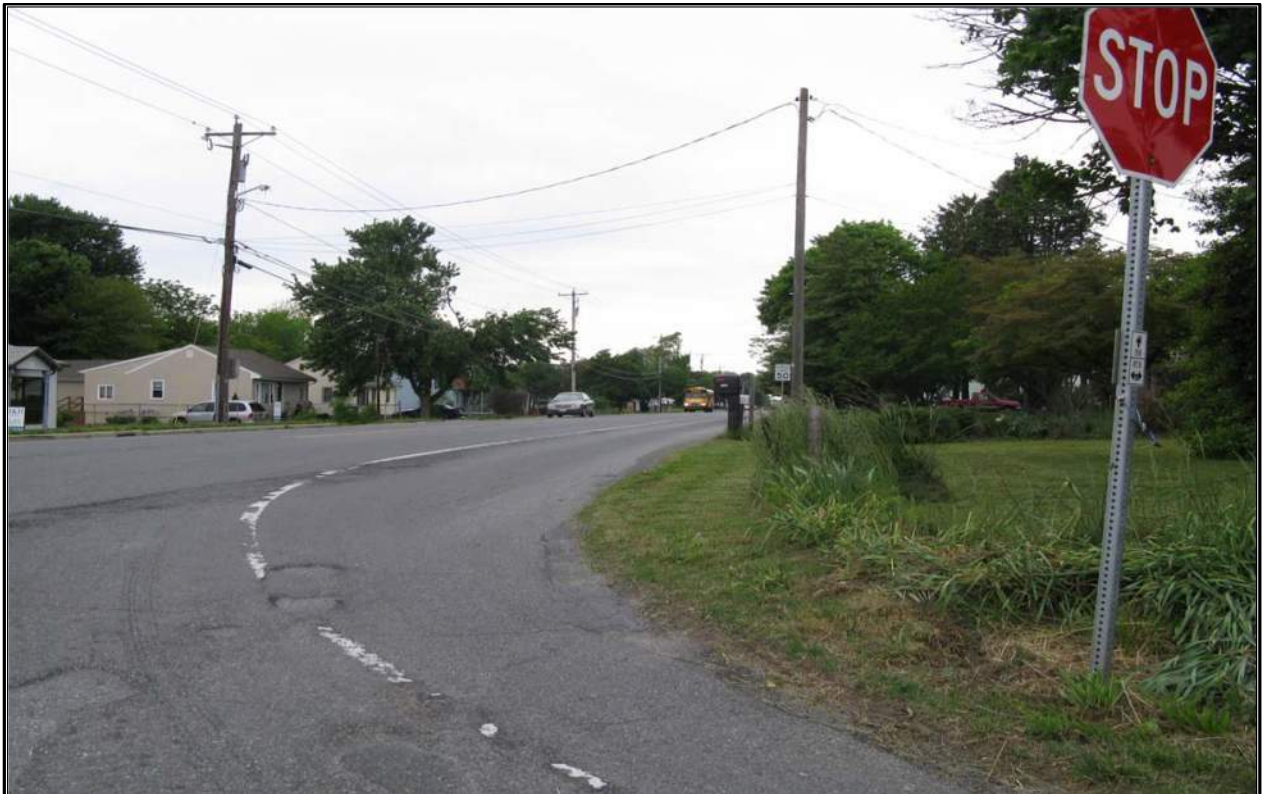
6) Southbound Chestnut Grove Road Looking Right (West)

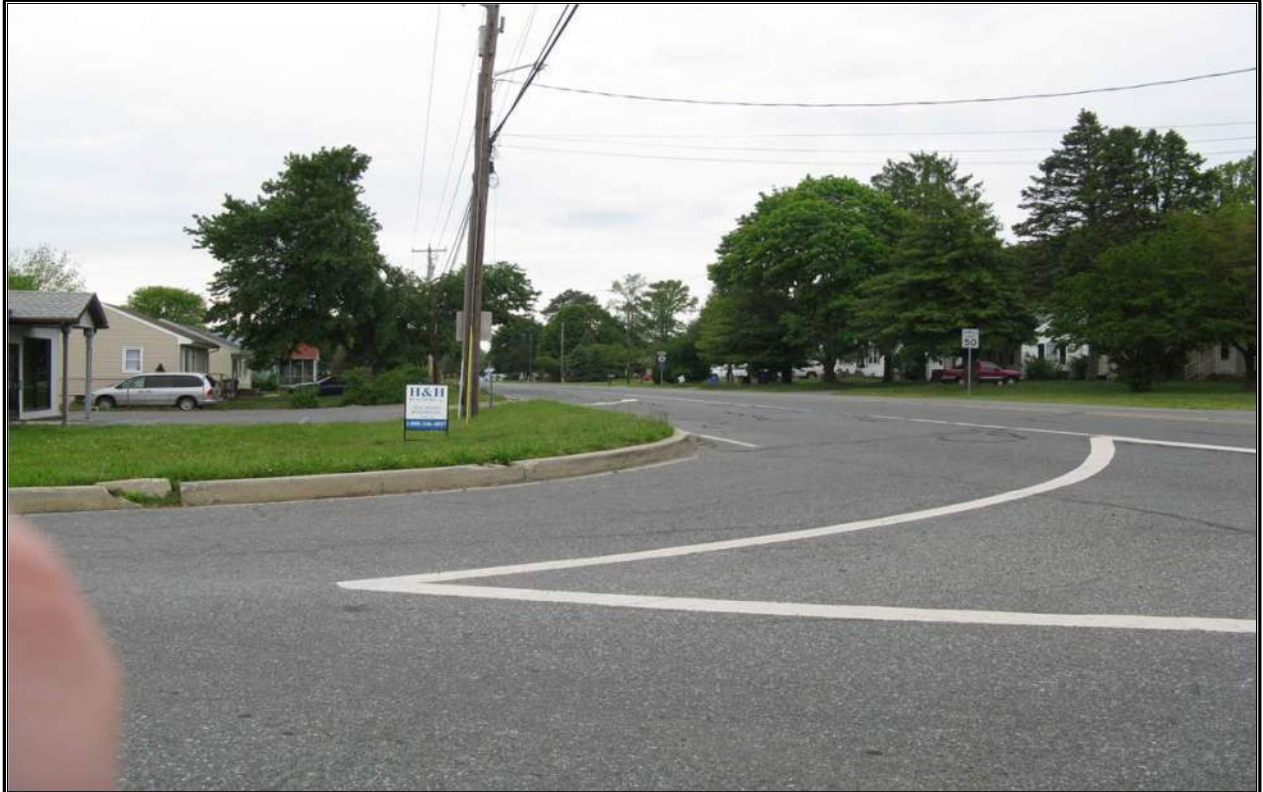
7) Northbound Nault Road Looking Left (West)

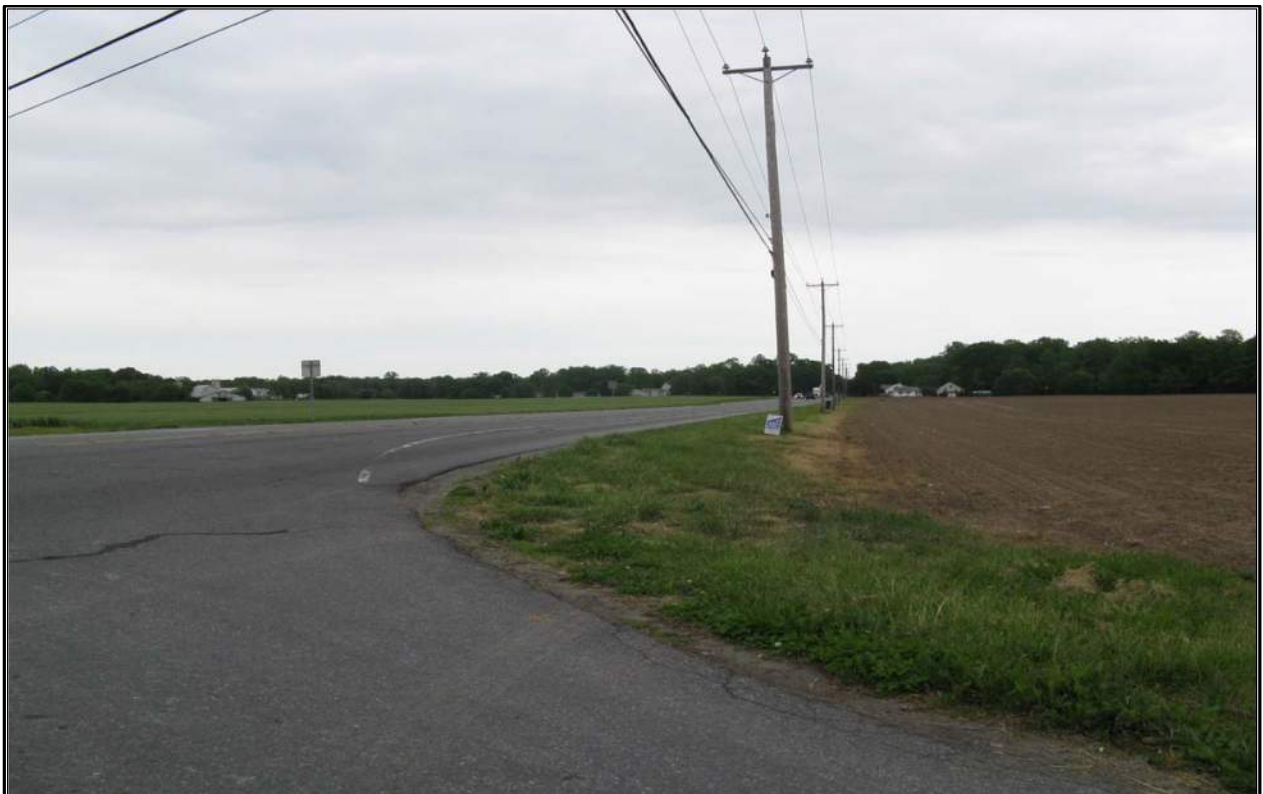
8) Northbound Nault Road Looking Right (East)
