**Rehoboth Beach Entrance Improvements Project  
SUSSEX COUNTY, DELAWARE**

**Historic Architectural Investigation  
Phase 1 Study Area**

**SUPPLEMENTAL REVISION**

4.1.7 (S-1088) Charles E. Marsh House, Rehoboth Avenue (tax parcel 3-34-13.20-109)

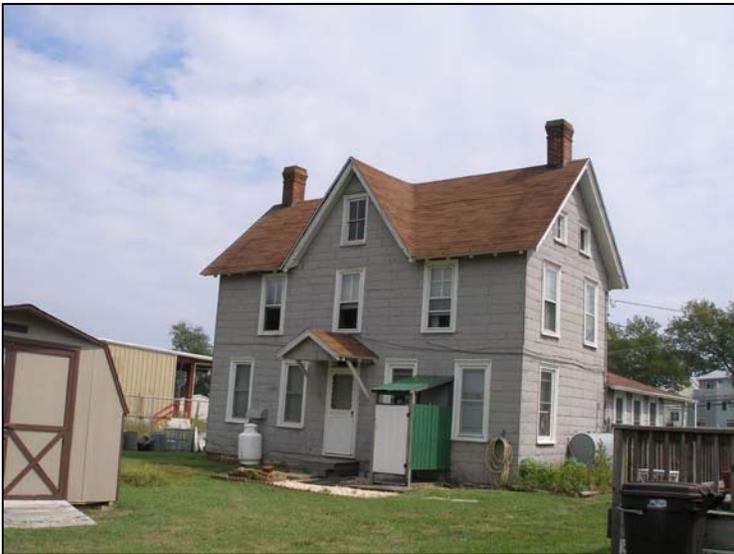
Plate 14 Front of Dwelling Looking South

The late nineteenth century I-house constructed as a T-plan circa 1870 (Plates 14, 14A, 14B, 14C and 15 and 15A). The 2 and ½ story, 5-bay dwelling features an original façade with side gable roof facing Church Street. The gabled roof is pierced with a center cross-gable peak in the front. The wood frame dwelling has an entry door in the center of the first story façade. The door is flanked by paired one-over-one-windows at each end. The entranceway is sheltered by a front-gabled-hood. A U-shaped driveway provides access towards the rear of dwelling.

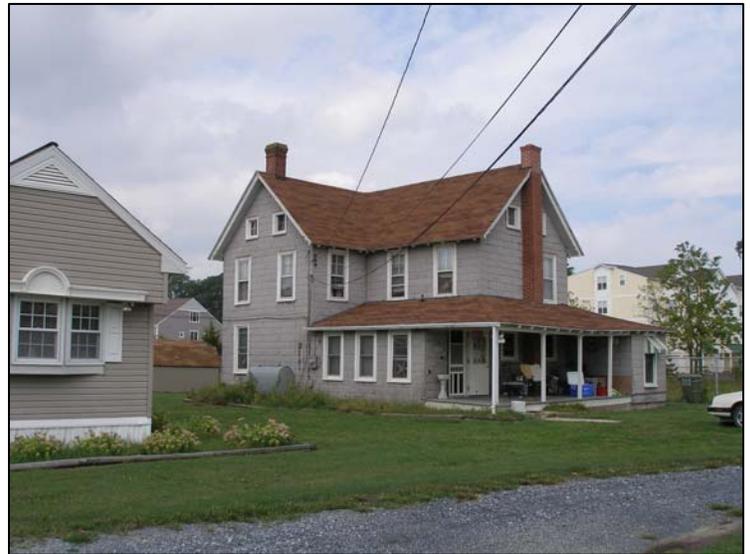
Plate 14A Rear and West Side Looking Northeast

The rear block of the dwelling adjoins a hipped roof porch. The wraparound rear porch is enclosed with modern additions on both sides and rests on a cinder block foundation. Except for most of the rear porch, the T-plan is now enclosed. The alterations were already evident in 1987 when John Milner Associates, Inc. (JMA) first evaluated the property as part of a previous federal undertaking. Despite alterations and without National Register evaluation form being filled out, the SHPO later recommended and agreed that the property is eligible for the National Register of Historic Places in 1988 as part of the West Rehoboth Beach Multiple Property nomination.

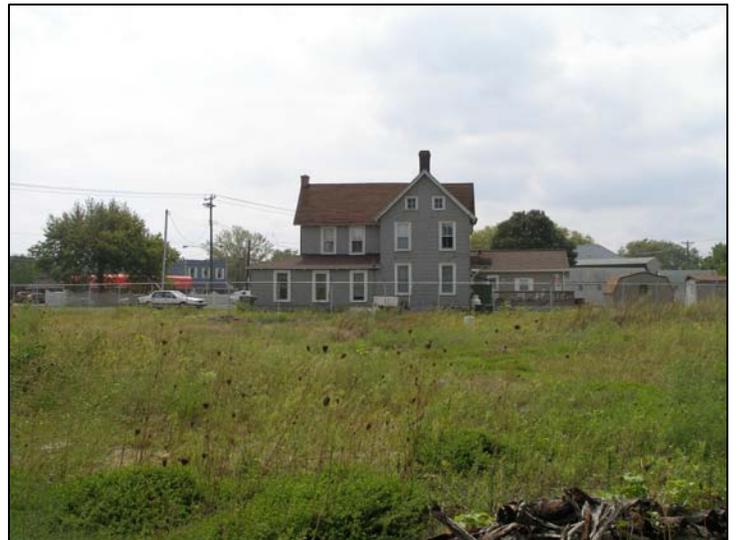
Plate 14C Eastern End Looking West

sheathing was also evident in 1987. Two corbelled interior end chimneys project from either end of the roof ridge of the main block. A third exterior chimney with extensive repair to the top portion is centered on the southeastern elevation of the rear block.

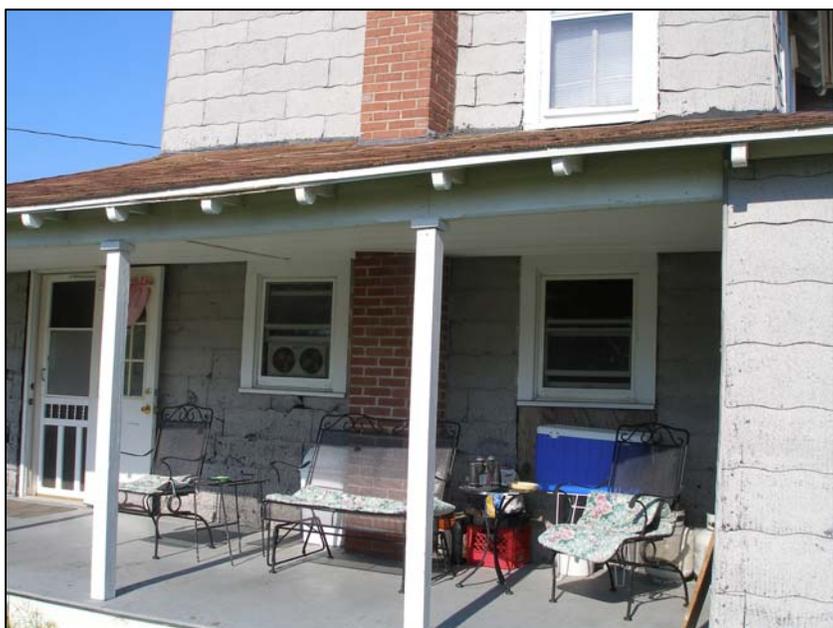
Plate 15 Window Alterations

Fenestration of the house consists of replacement one-over-one, double hung aluminum frame sash windows on the first story. Two redesigned first floor windows towards the rear of the dwelling are approximately 3/4 the height of the originals (Plate 15). Three bays are evident on the second story front façade, while four bays exist along the sides of the dwelling. The two-over-two double hung sash windows in the second story and the four-light windows in the gable peaks all appear to be the original windows. During the winter, storm windows cover most of the windows on a temporary basis.

According to the 1987 JMA assessment and now this 2006 re-assessment, all the first floor windows have since been replaced as well as the size orientation of the two rear windows under the porch have been altered (Plate 15). In 1987 and in 2006, one of the bay windows is missing on the west side of the dwelling (i.e. covered over). This is also evident in the second story bay towards the rear of the dwelling.

Since 1988, all the first floor windows were replaced and two windows on the south side (under the remaining rear porch) were reduced in framing or sash size. A large section of the rear hipped roof wraparound porch was enclosed and stands on a concrete foundation. Bricks were replaced in the top portion of an exterior chimney centered on the southeastern elevation of the rear block. A shed-roof outdoors shower has been constructed on the north west side of the façade. Historically, the dwelling was probably sheathed in horizontal, wood clapboard. It has been completely resided in cement asbestos shingles.

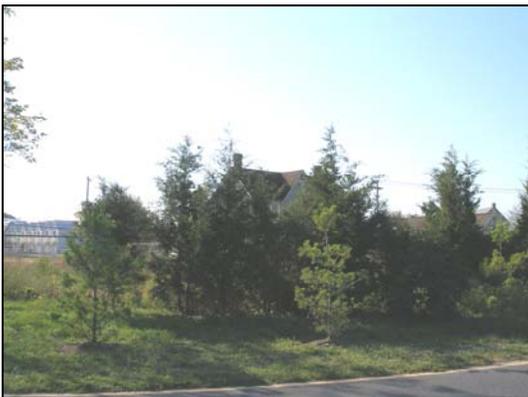
Plate 15A Frontal View from Church Street

As Jakle, et al. indicated (1989), during the mid to late nineteenth century, the I-house symbolized affluence born of the land. The strength of the form as a status symbol was maximized when the façade faced the public road projecting an impressive front elevation. This association of the house with prosperity and respectability was common among farmers and businessman and professionals in villages and towns. Much of the rural affluence could be attributed to the rise of commercial agriculture associated with the development of regional railroad networks and regional markets (Jakle, et al. 1989:121). Charles E. Marsh House cannot convey this aspect. The front of the property has been re-orientated from the main road. The front façade of the property from Church Street is also not viable due to a chain link fence with thick evergreens that shield the front of the property from the road. Modern storage buildings and an outdoor shower also block the front façade (Plate 15A).

In terms of alterations, a full front porch at the facade gable entrance has been replaced with a front-gabled-hood (see Sanborn, 1922 and 1931 under Figures 11 and 13 versus that of plate 15A). Enclosure of the rear porch at both east and west ends has also occurred. Although the alterations were known and evident in 1988, no other form changes to the main house has since occurred. However, it is of DelDOT's opinion that those alterations had not been fully elaborated or considered in 1987 architectural assessment. They were not brought to the SHPO's attention in the previous report to make a proper eligibility assessment under Criteria C.
