#### COMPARATIVE ANALYSIS

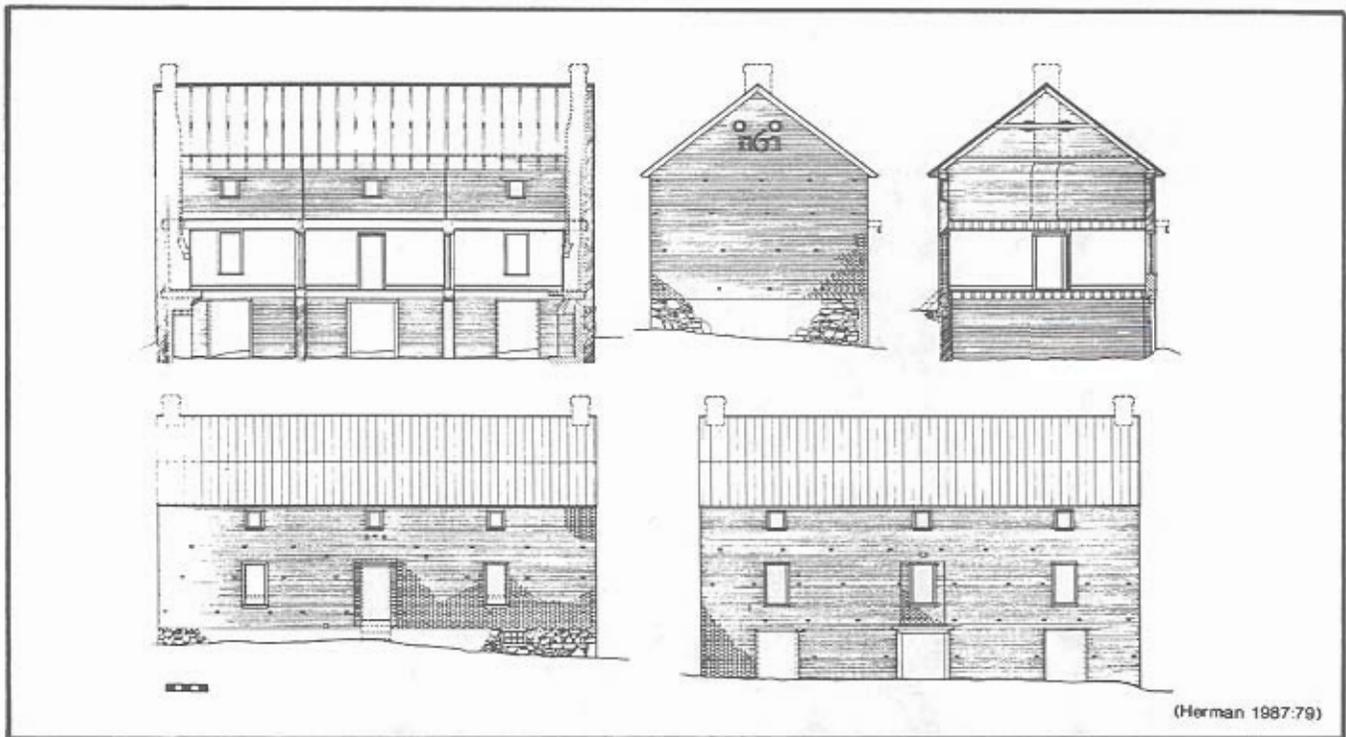
FIGURE 94  
View of Brick Store

Unlike the White-Darrach Store, Brick Store was built one bay deep and three bays in length, its exterior dimensions 23' x 46'. The first floor was originally divided into three whitewashed rooms, and the second floor loft partitioned with rough board walls into grain bins (Herman 1987:79). Its original purpose as well as design differed somewhat from the White-Darrach Store. Architectural analysis has demonstrated that it originally had no chimneys or fireplaces, and thus did not serve also as a residence. Neither did it function as a retail store, but as a warehouse for waterside storage of grain, corn, hides, and lumber awaiting upfreighting to Philadelphia (Caley 1978:142; Herman 1987:79), and for downfreighted goods awaiting distribution to retailers or directly to their buyers. By 1810, within a few years of the renovation of the White-Darrach Store, Brick Store too was converted for residential use (Herman 1987:79).

One eighteenth century brick storehouse from central Delaware, however, does survive. Located along Duck Creek also, east of the landing and store Darrach owned (later Smyrna Landing), Brick Store stands on the creek's north bank in Blackbird Hundred, New Castle County (Figure 93). Built into the creek bank, Brick Store has a full cellar (which is an exposed ground floor on the downhill side), a main floor, and second story loft (Figure 94). Constructed of brick laid in Flemish bond on a stone and brick foundation, the builder set the date 1767 in glazed brick near the gable walls' peak. Its three bay facades feature central doors flanked on either side by a symmetrically placed window. Three small windows also light the second floor through each facade. In addition, three large openings into the cellar storage areas break the brick foundation wall on the downhill elevation.

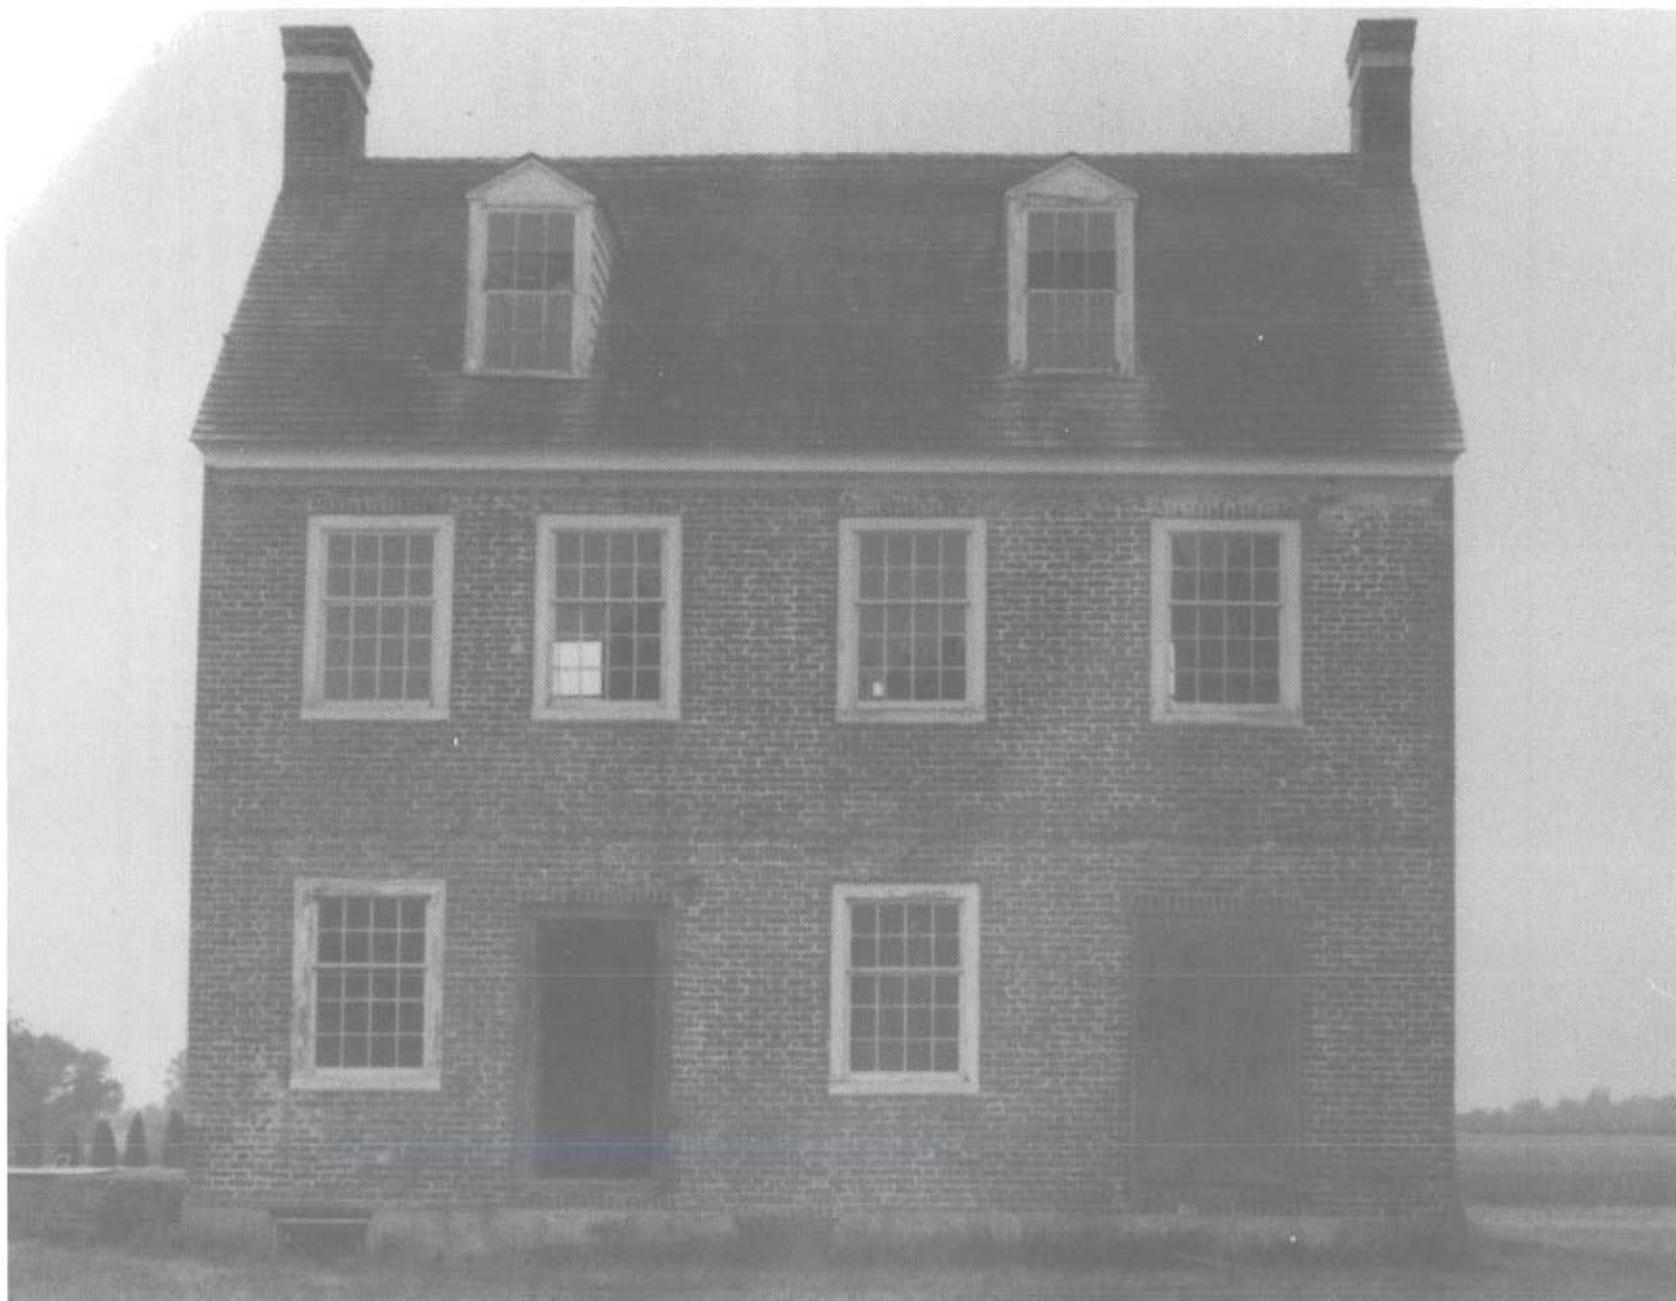
PLATE 16

Facade of Spencer's Store Prior to Restoration

Spencer's store's present owner dates the building to circa 1770-1773, and although the source of this attribution is uncertain, architecturally the building supports a date at least in the last quarter of the eighteenth century. Like the White-Darrach store, Spencer's was originally constructed as a store *cum* residence. A full two and one-half stories in height over a full cellar, Spencer's store measures approximately 32' x 16' (Plate 16). Thus it stands a single bay in depth as Brick Store, rather than the double pile square of the White-Darrach store. Its walls are laid up in Flemish bond, with a stringer course marking the second floor, and jack arched windows and doors. Originally built with only a single internal end chimney on the inhabited side (to the left in Plate 16), the other represents a later addition. The dormers piercing the gable roof are likely original, as no windows light the garret through the gable brick walls (Plate 17).

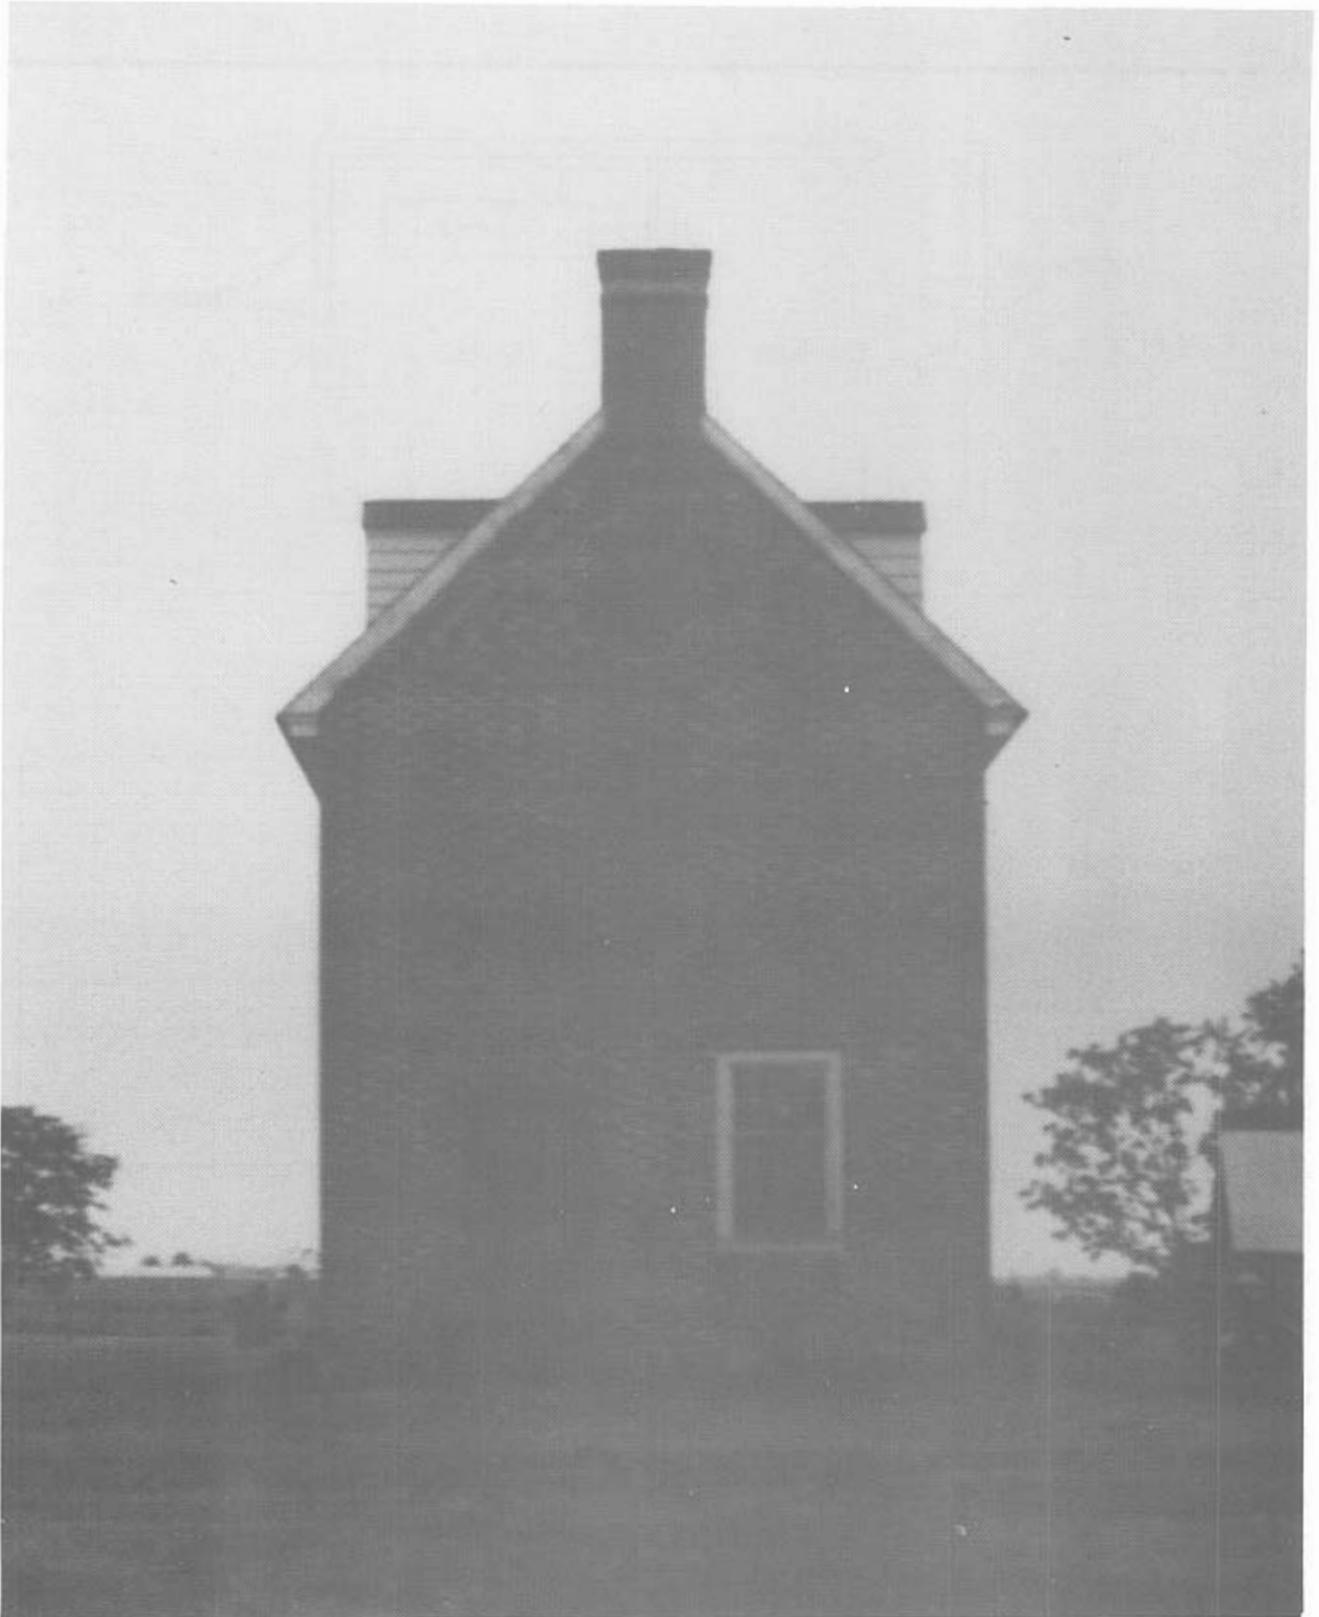
PLATE 17

Gable end of Spencer's Store, Prior to Restoration

The room adjoining the store room probably housed the storekeeper and his family. A separate exterior door in the facade accessed this space (Figure 95; Plate 17). Stairs tucked behind this door against the interior wall led to the second floor, divided into two chambers as the lower floor. Thus no direct communication linked the store room and the upper floors, suggesting that unlike at Brick Store, they housed not grain but tenants. The garret may originally have been finished. The cellar and possibly outbuildings would have supplemented the commercial storage space Spencer needed.

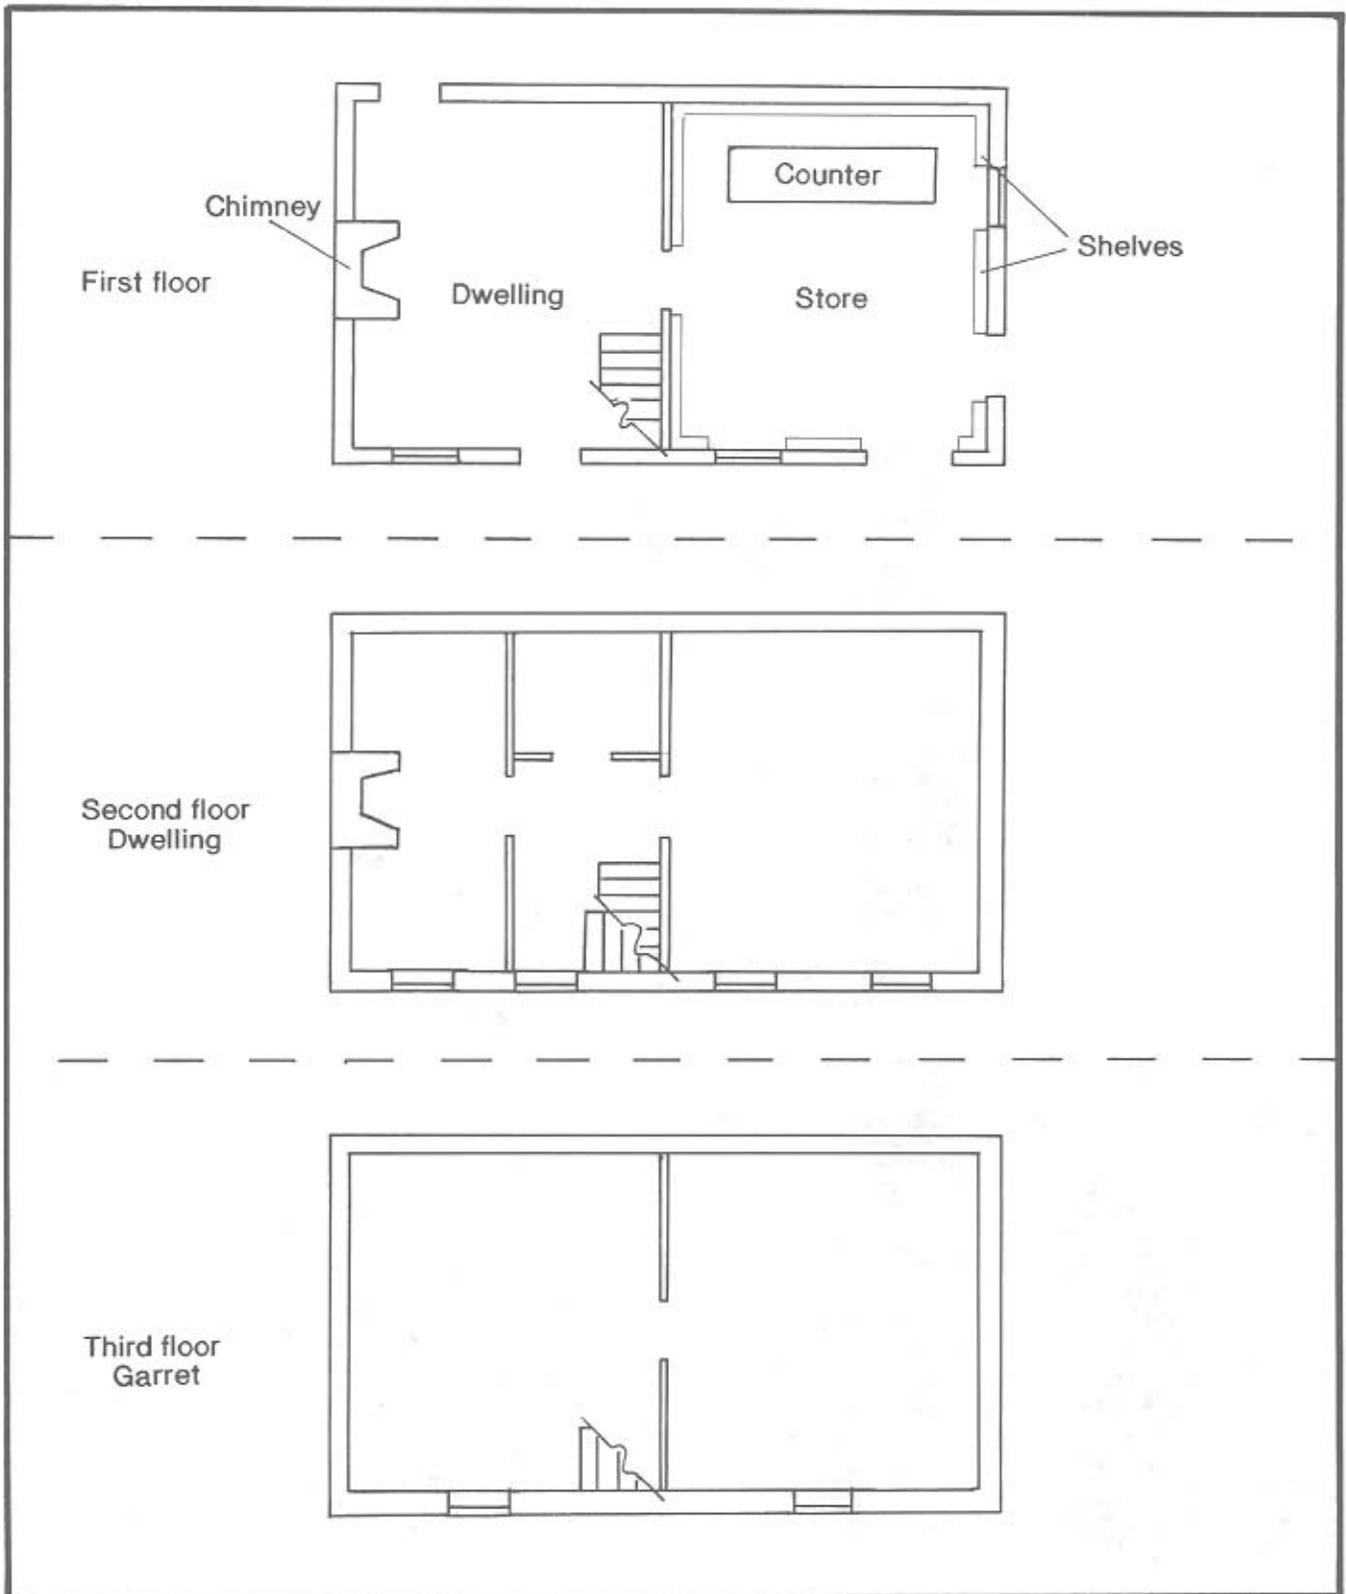
FIGURE 95

Original Plans, Spencer Store, First and Second Floors

Evidenced in the slightly asymmetrical fenestration of the facade, the structure was divided into two rooms of unequal size on the first and second floors (Figure 95). On the first floor, the larger room, that on the right, housed the store. Entered through one of two large doors in the facade and gable wall, the space was undivided. Two windows lit the store room, flanking each door. Neither doors nor windows broke the rear brick wall of the room. A single interior door provided access to the other first floor room. Evidence in the plaster uncovered during restoration marks the location of horizontal shelving units. Every available wall area held shelves, most spaced 6"-8" apart. Although not arranged in exactly this way, the shelving in the country store pictured in Willard's 1826 *Geography for Beginners* (Carson 1954) portrays the general idea of walls lined with merchandise (Figure 96). An early twentieth century tenant also remembers the store counter running parallel to and near the rear wall of this room (Catts, personal communication 1990).

This plan is applicable to the White-Darrach store with few modifications. The remnant of a brick partition preserved in the cellar floor suggests that it too was divided into two rooms of unequal size. In this case, however, the larger room lay on the opposite side of the building, or to the left as one faced the structure. No evidence indicates a chimney ever served this side of the structure. On the first floor, a similar plan would have produced a store room approximately 15' x 28'. The other, western room, thus served as a kitchen/common room for the tenant. The use of the upper floors remains unclear, as does, for example, the location of the original stairs. Perhaps the upper floors were reserved exclusively for the tenant family's use; however, given the large size of the

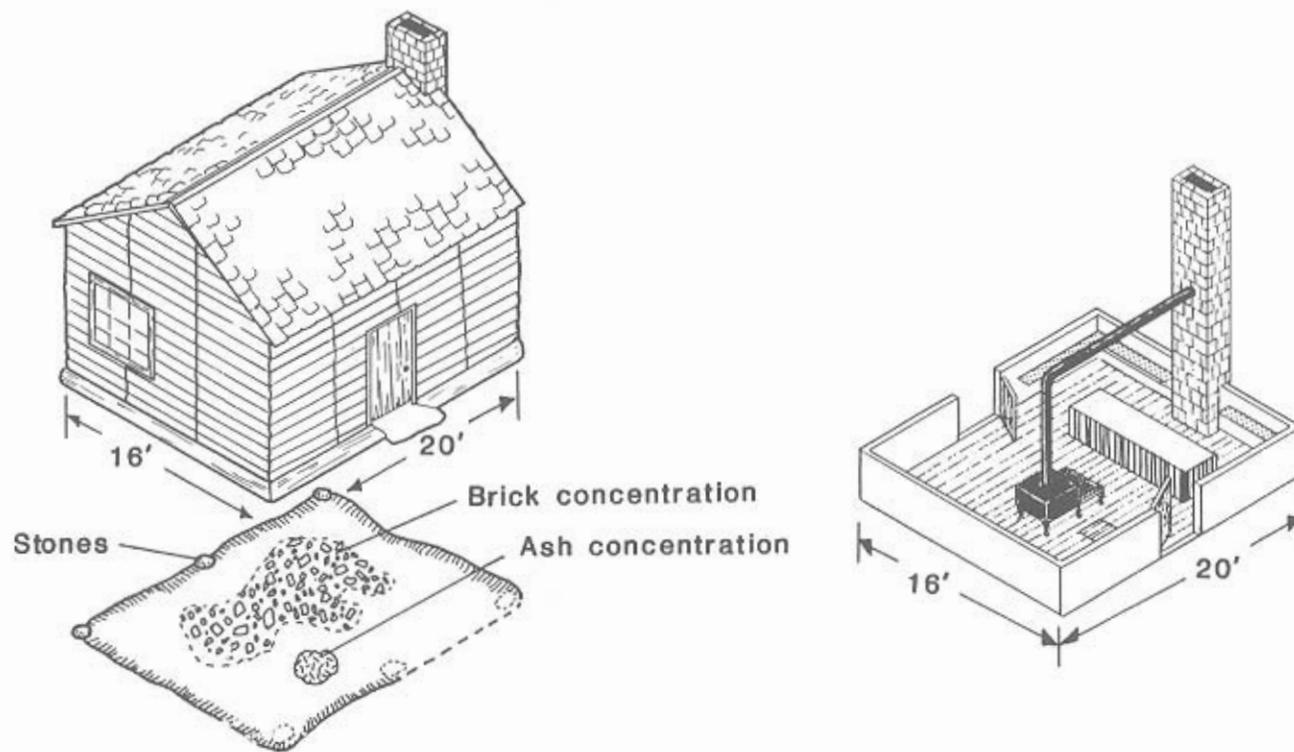
FIGURE 97  
Dickson Store, Artist's Reconstruction

But such was not the case in 1795. The store Dickson rented was small, 16' x 20', of frame construction, with sills set on limestone piers and with no cellar. A single story, one room building with perhaps additional storage space in the loft (Figure 97), it certainly did not express the same message of social and economic prominence and permanence embodied in its contemporary in Duck Creek Hundred, the brick store owned and operated by William White and then John Darrach.
