DETOUR REFERENCE #:
I-95 - -NB00638-00761-1C

CONTROL POINT C:
DELAWARE ROUTE 273 AND
I-95 ON/OFF-RAMPS

DATE: MAY 2010	BY: RTR/AM	REFERENCE NUMBER: C
--------------------------	----------------------	--------------------------------------

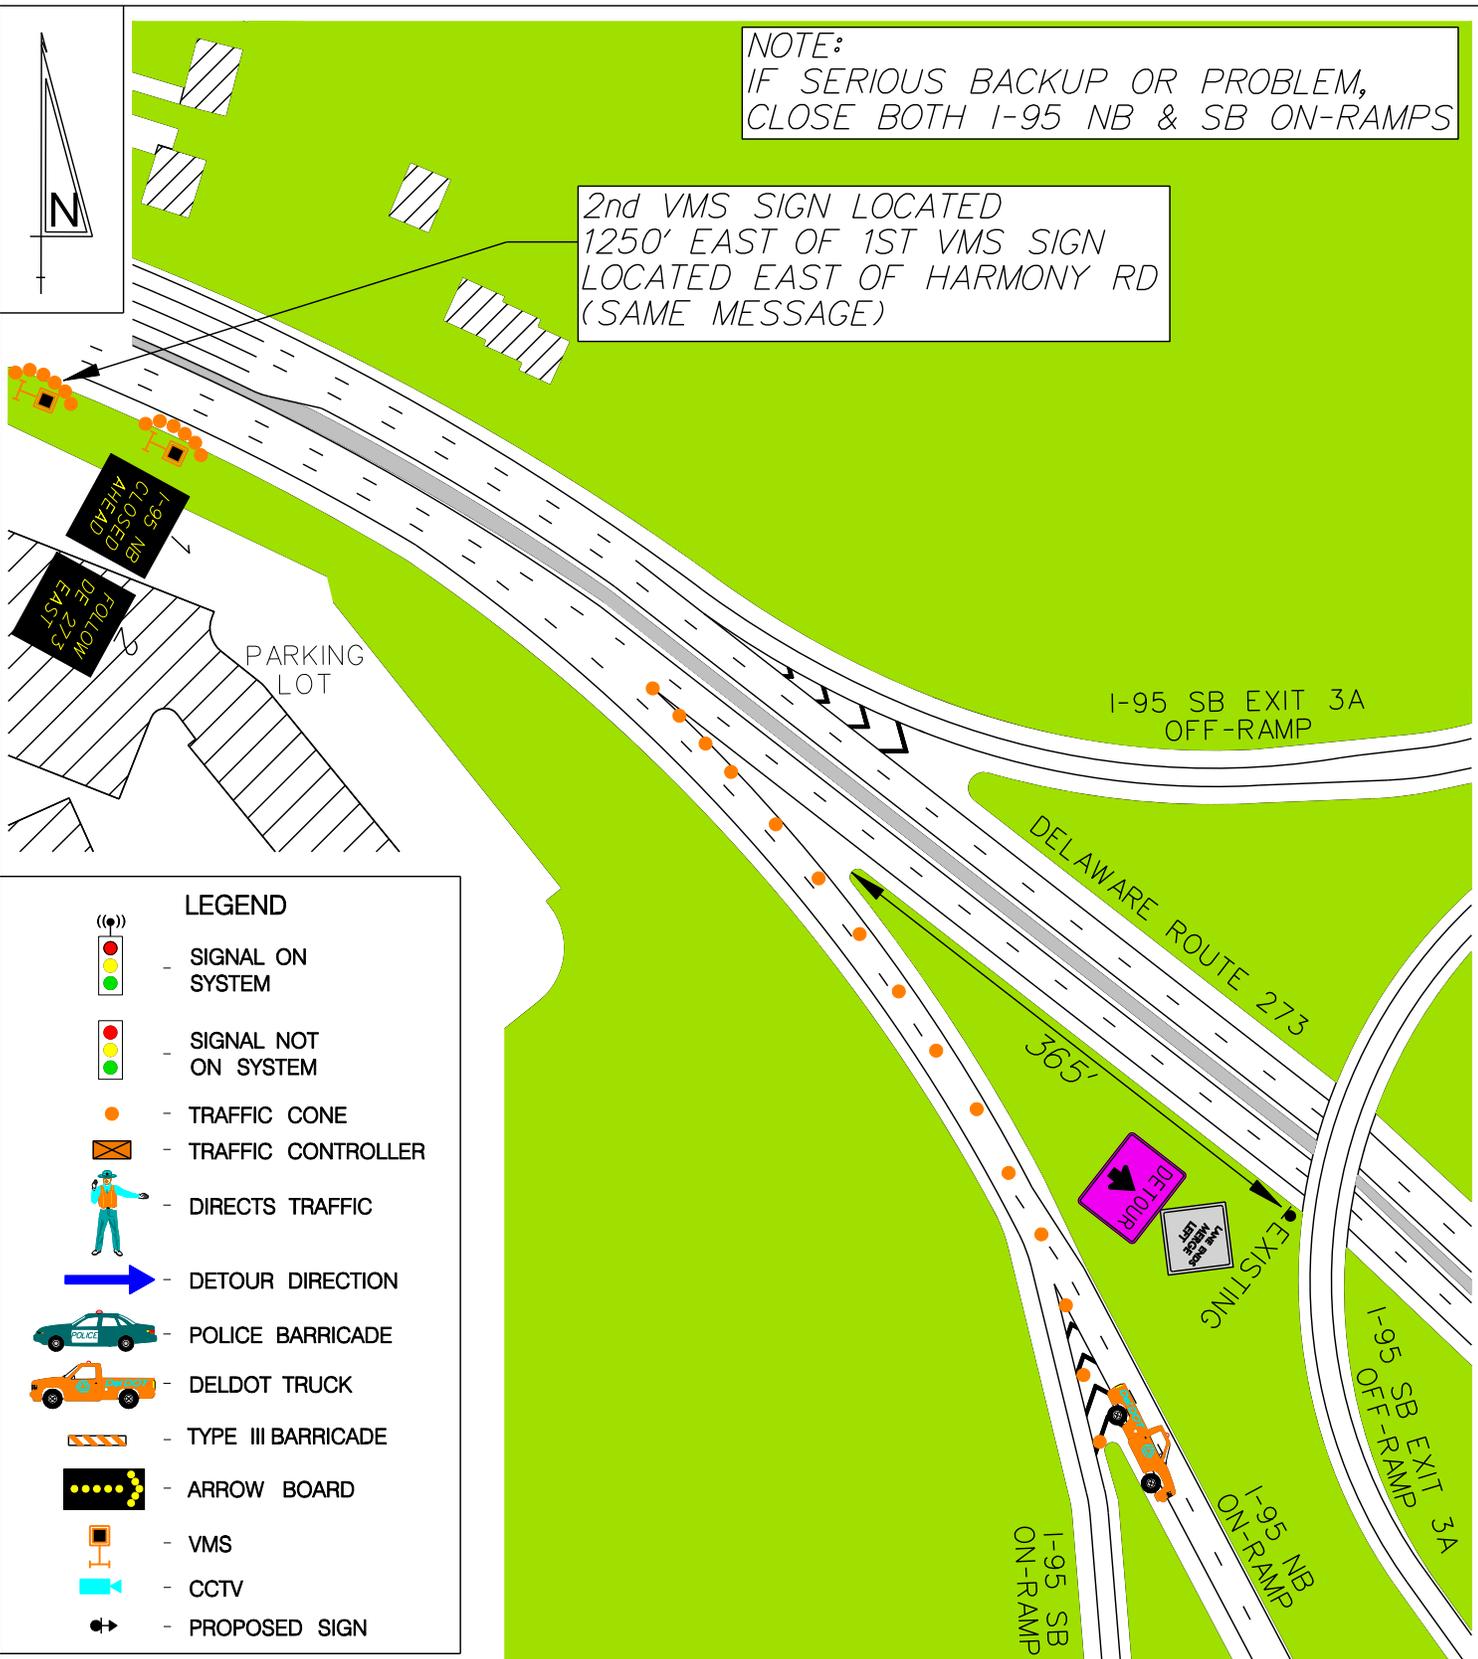
NOTE:
IF SERIOUS BACKUP OR PROBLEM,
CLOSE BOTH I-95 NB & SB ON-RAMPS

2nd VMS SIGN LOCATED
1250' EAST OF 1ST VMS SIGN
LOCATED EAST OF HARMONY RD
(SAME MESSAGE)

CONE TAPER & TANGENT LENGTHS					
APPROACH	DESCRIPTION	TANGENT	TAPER	CONES	
I-95 RAMPS	CLOSE I-95 NB ON-RAMP	100'	500'	15
